HISTORICAL ECOLOGY of the lower Santa Clara River, Ventura River, and Oxnard Plain: an analysis of terrestrial, riverine, and coastal habitats

HISTORICAL ECOLOGY PROGRAM
CONTRIBUTION NO. 641 • AUGUST 2011

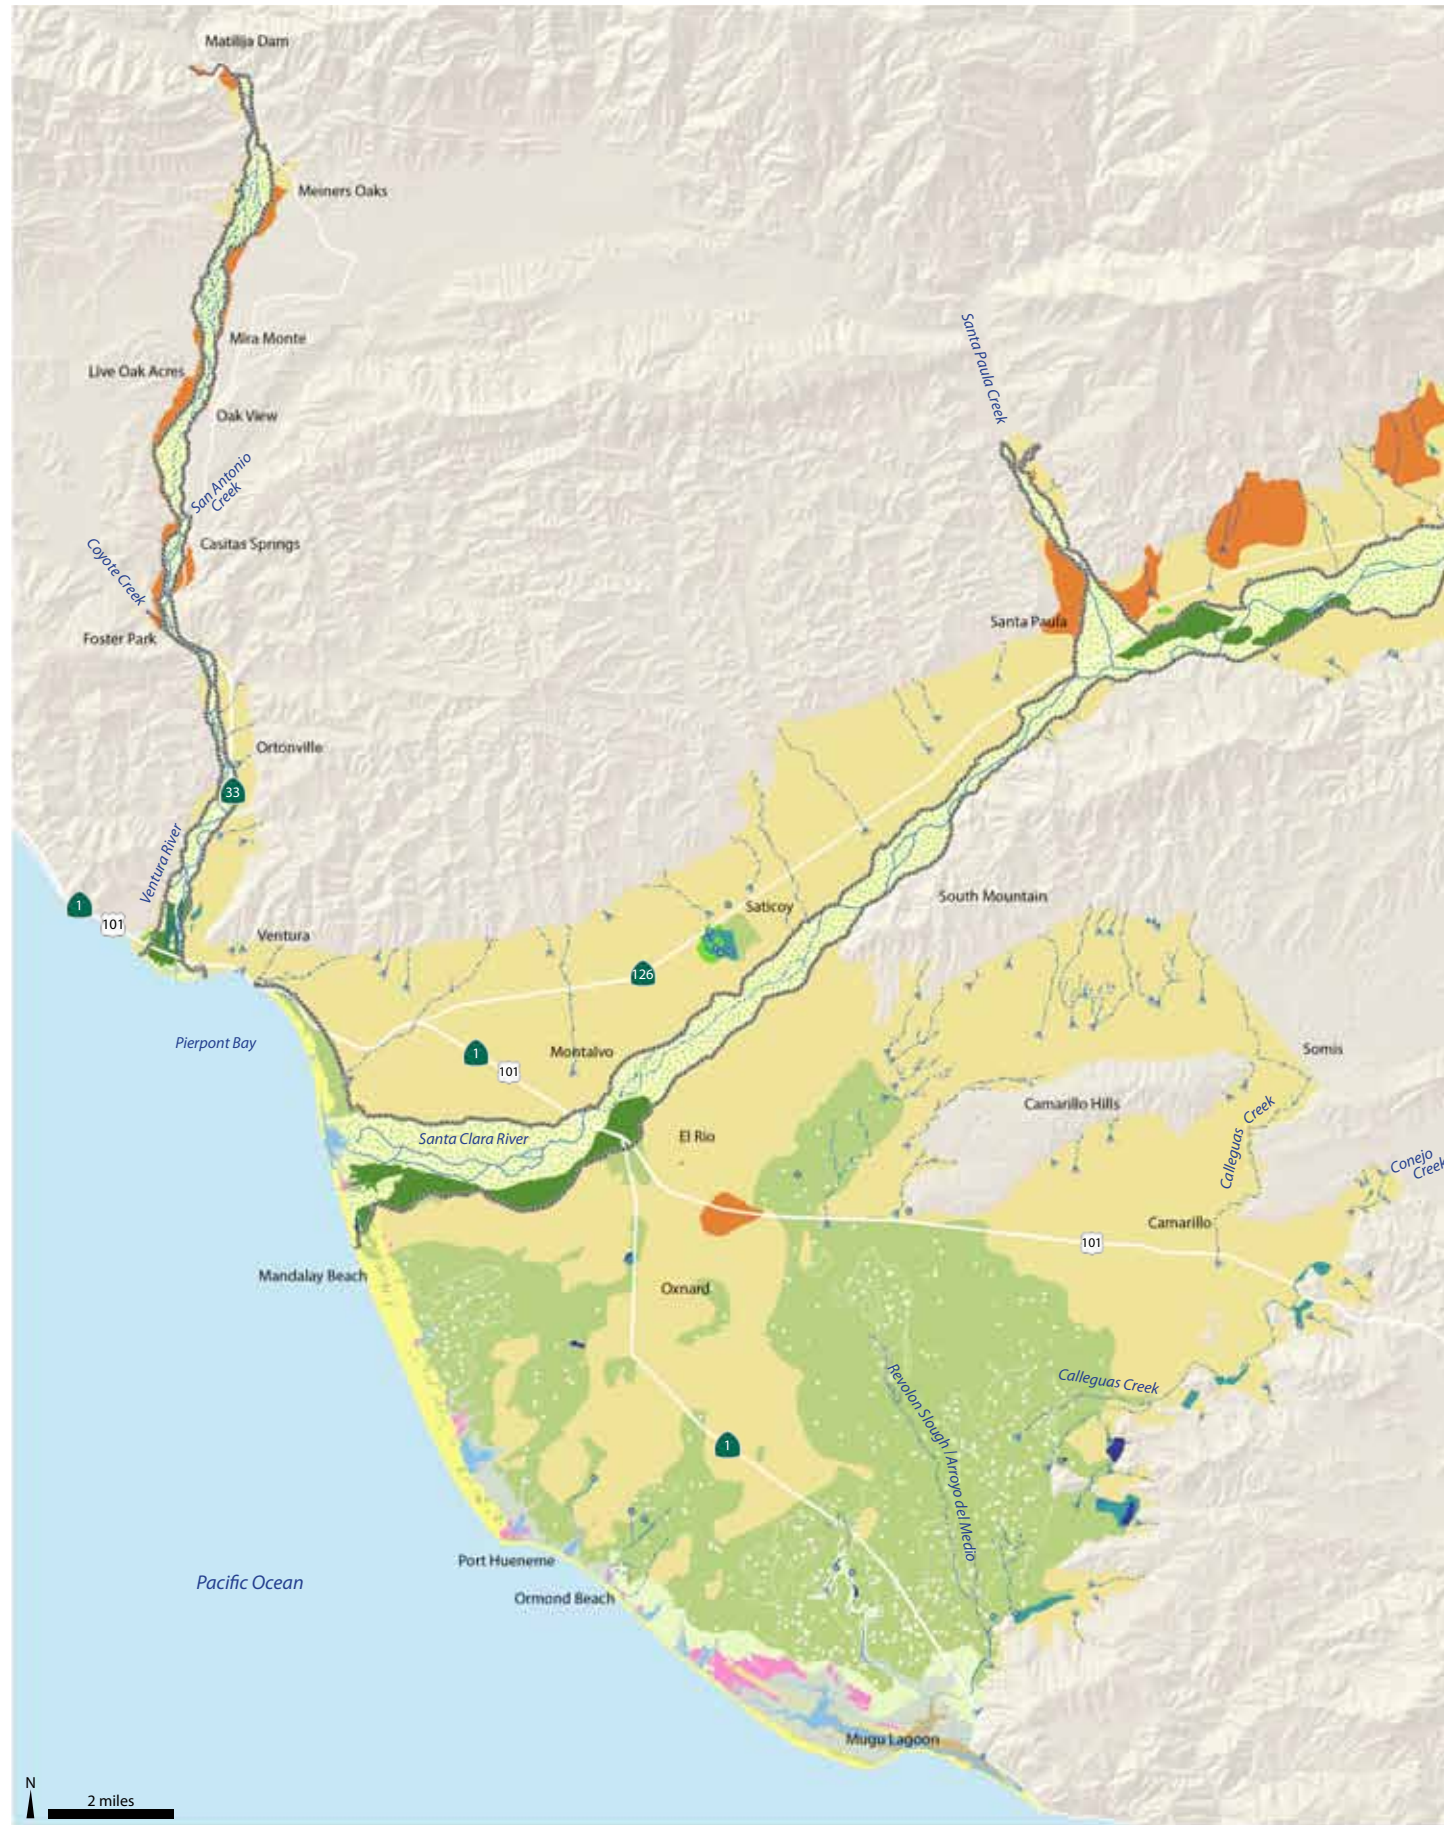
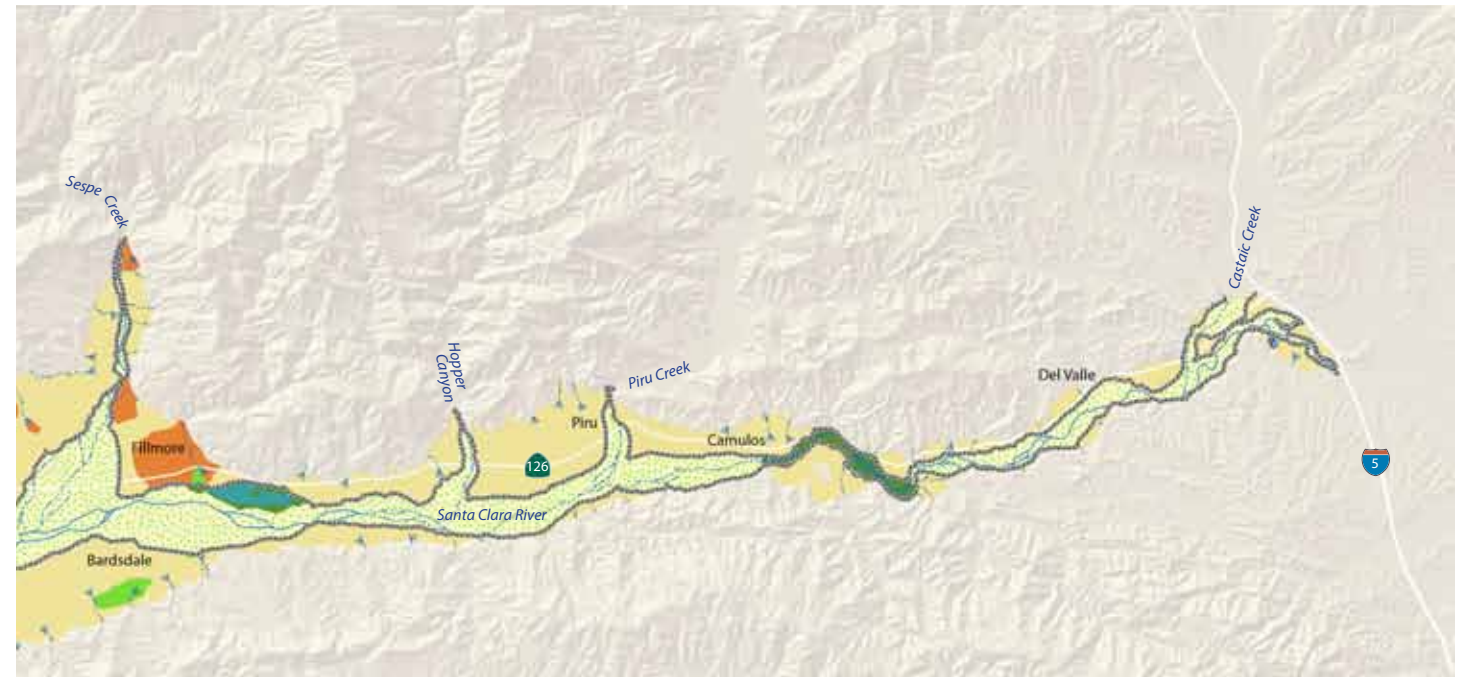
HISTORICAL CONDITIONS, EARLY 1800s

This map reconstructs the habitat characteristics of lowland Ventura County prior to significant Euro-American modification (early 1800s). More detailed views are provided in the map sections shown to the right. Some habitat classifications combined here (e.g., beach/dune) are separated in finer-scale maps (see pages at right).

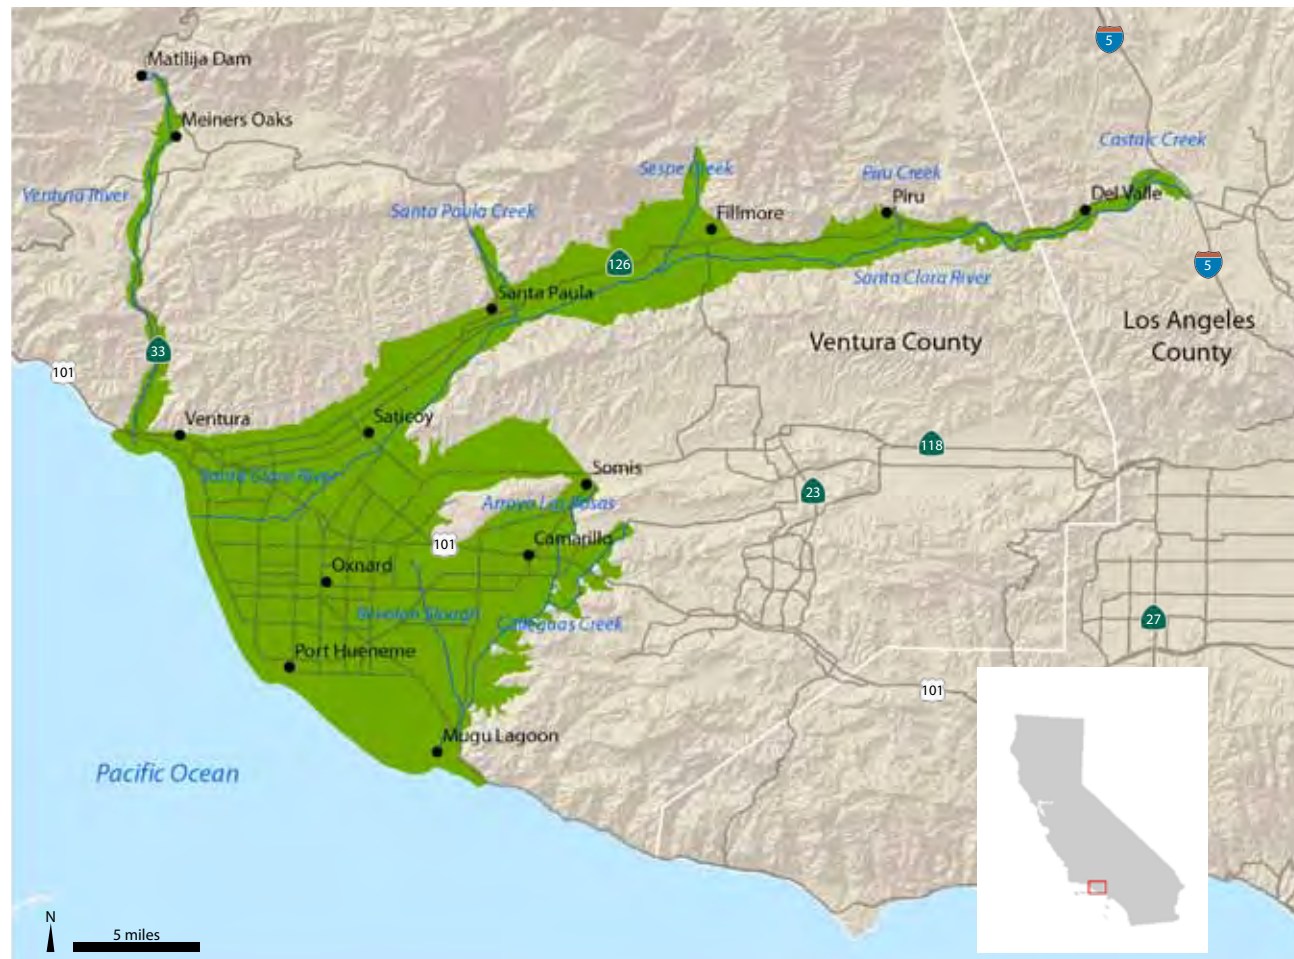
Fig. 1.2. Study area and regional geographic context. The project area included the Ventura River to Matilija Dam, the Santa Clara River to Interstate 5 in Los Angeles County, and the Oxnard Plain.

This study focuses on the habitat and drainage patterns of the region's lowlands, where change has been most pronounced. The study area encompasses three major contiguous areas: the Ventura River, the lower Santa Clara River, and the Oxnard Plain (fig. 1.2). Specifically, the geographic scope is the Ventura River and valley from its mouth to the Matilija Dam (exclusive of the Ojai Valley), and the Santa Clara River and adjacent valley floor from its mouth to its intersection with Interstate 5 in Los Angeles County (including only the lowest reaches of major tributaries, and focused on the Ventura County portion of the valley). It also includes the lowlands and coastal margins south of the lower Santa Clara River, including the Oxnard Plain and lower Calleguas Creek watershed west of Somis and the edge of the Santa Monica Mountains and south of South Mountain.

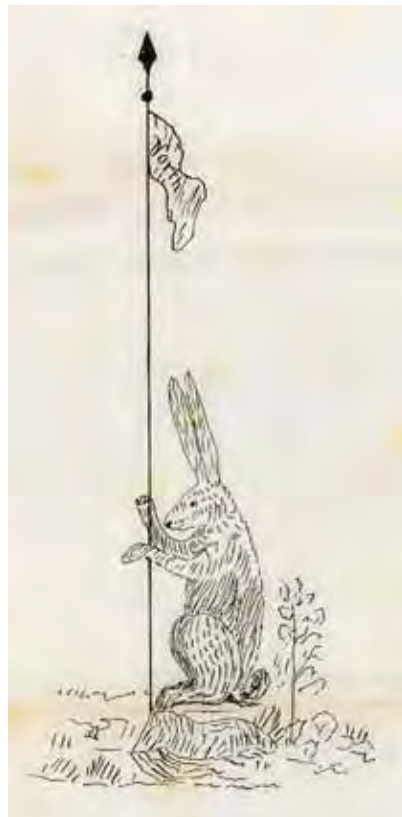
Fig. 1.3. Detail from a map of Rancho San Miguelito and the lower Ventura River, 1897. A jackrabbit serves as the compass, pointing north. (Barry 1897, courtesy of the Museum of Ventura County)

To acquire these sources, we visited local historical archives, public libraries, county offices, and regional archives. In total, we visited twenty-seven source institutions across California to collect data (table 1.1). We also reviewed material available online and conducted searches of over twenty electronic sites and databases. We acquired scans, copies, or photographs of a diverse array of primary and secondary sources pertaining to the historical landscape of Ventura County (fig. 1.3; also see “Historical data for Ventura County” spread, pages 6-7).

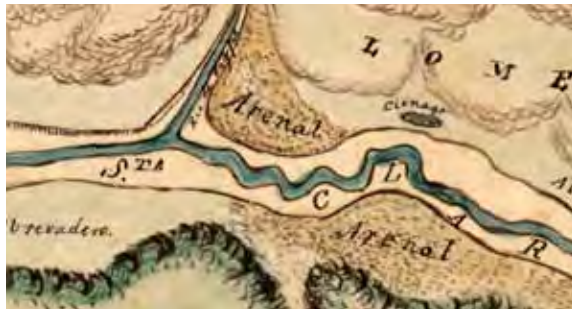
Mexican land grant sketches (1840s-1850s). As the Mission system disintegrated, influential Mexican citizens submitted claims to the government for land grants. A *diseño*, or rough sketch of the solicited property, was included with each claim. *Diseños* often show notable physical landmarks which would have served as boundaries or natural resources, such as creeks, wetlands, springs, and forests. While *diseños* are not as spatially accurate as subsequent surveys, they provide extremely early glimpses of former landscape features and patterns. (U.S. District Court ca. 1840d, courtesy of The Bancroft Library, UC Berkeley)

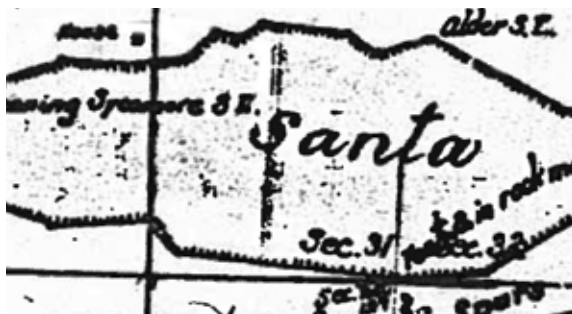
General Land Office Public Land Surveys (1853-1900). In areas not claimed through the land grant system, the U.S. Public Land Survey imposed a grid of straight lines on the landscape, dividing property into six-mile square townships. Each township was further subdivided into 36 one-mile sections, each section containing 640 acres. Surveyors methodically surveyed section lines along these transects, noting cultural and natural features they encountered along the way. Survey notes and plat maps from these surveys are useful for their ecological information. (Hoffman 1868d, courtesy of the Bureau of Land Management)

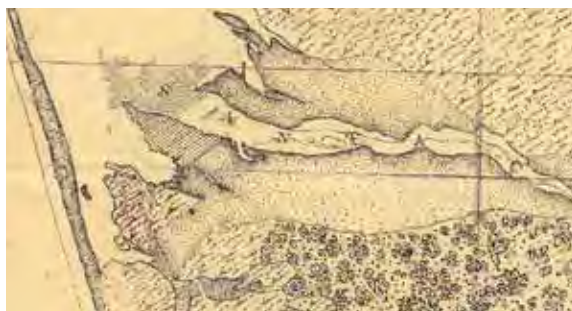
U.S. Coast and Geodetic Survey maps (1855-1934). The U.S. Coast and Geodetic Survey was established in 1807 by Thomas Jefferson to create navigation maps. Though the maps only cover the coastline and immediately adjacent areas, they are a highly valuable source because of their impressive detail and accuracy, scientific rigor, and relatively early survey dates. (Johnson 1855c, courtesy of the National Oceanographic and Atmospheric Administration)

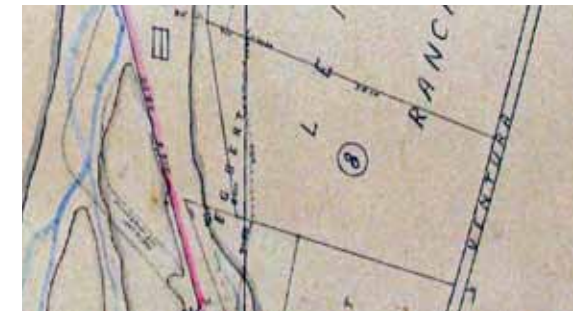
City and county surveys (1860-1930). Local surveyors produced abundant maps, including many surveys of individual parcels. These maps, often surveyed at a large scale, contain details not included in other regional mapping efforts such as sloughs and side channels, smaller ponds and wetlands, or clusters of trees. Though coverage is inconsistent, these maps are invaluable in constructing an understanding of local ecosystem dynamics. (Barry 1894, courtesy of the Ventura County Surveyor's Office)

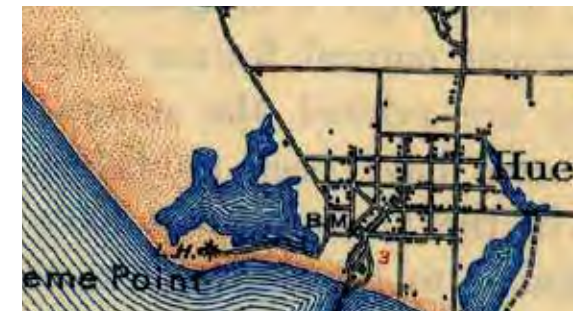
U.S. Geological Survey topographic maps (1903-1943). Shortly after 1900, the USGS (established in 1879) began producing topographic quadrangles at 1:62,500 for the Ventura County region. Though the maps are relatively coarse, they provide some of the earliest consistent, comprehensive coverage for the entire region. (USGS 1904, courtesy of the CSU Northridge Geography Map Library)

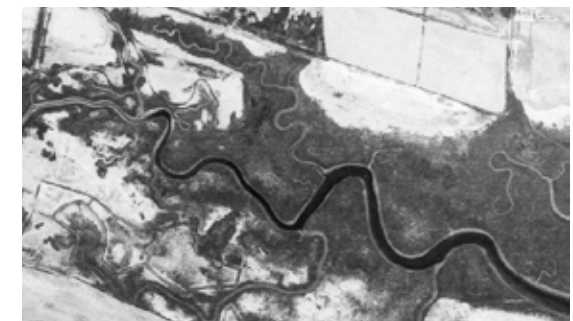
Historical aerial photography (1927-1959). A Depression-era program to ensure crop stability and soil conservation practices resulted in extensive aerial photographic coverage for much of the county. The bulk of historical aerial imagery used in this study is from 1927 and 1938. While the photographs were taken after substantial modification, the photos nevertheless reveal relict ecological features, traces of which are often still present in the landscape. (Fairchild Aerial Surveys 1927, courtesy of Whittier College)

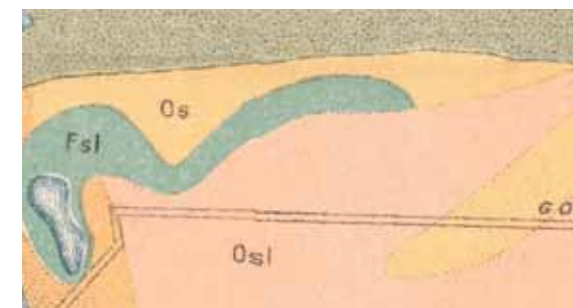
U.S. Department of Agriculture soil surveys (1901-1917). Early soil surveys were developed to describe variability in the agricultural viability of regional soils. These maps, and their accompanying reports, are a key source in the inference of historical habitat extent and location. Descriptions of soil properties and agricultural use can provide insight into former habitats, in particular providing spatially accurate detail on the extent of wet meadows and alkaline habitats. (Holmes and Mesmer 1901b)

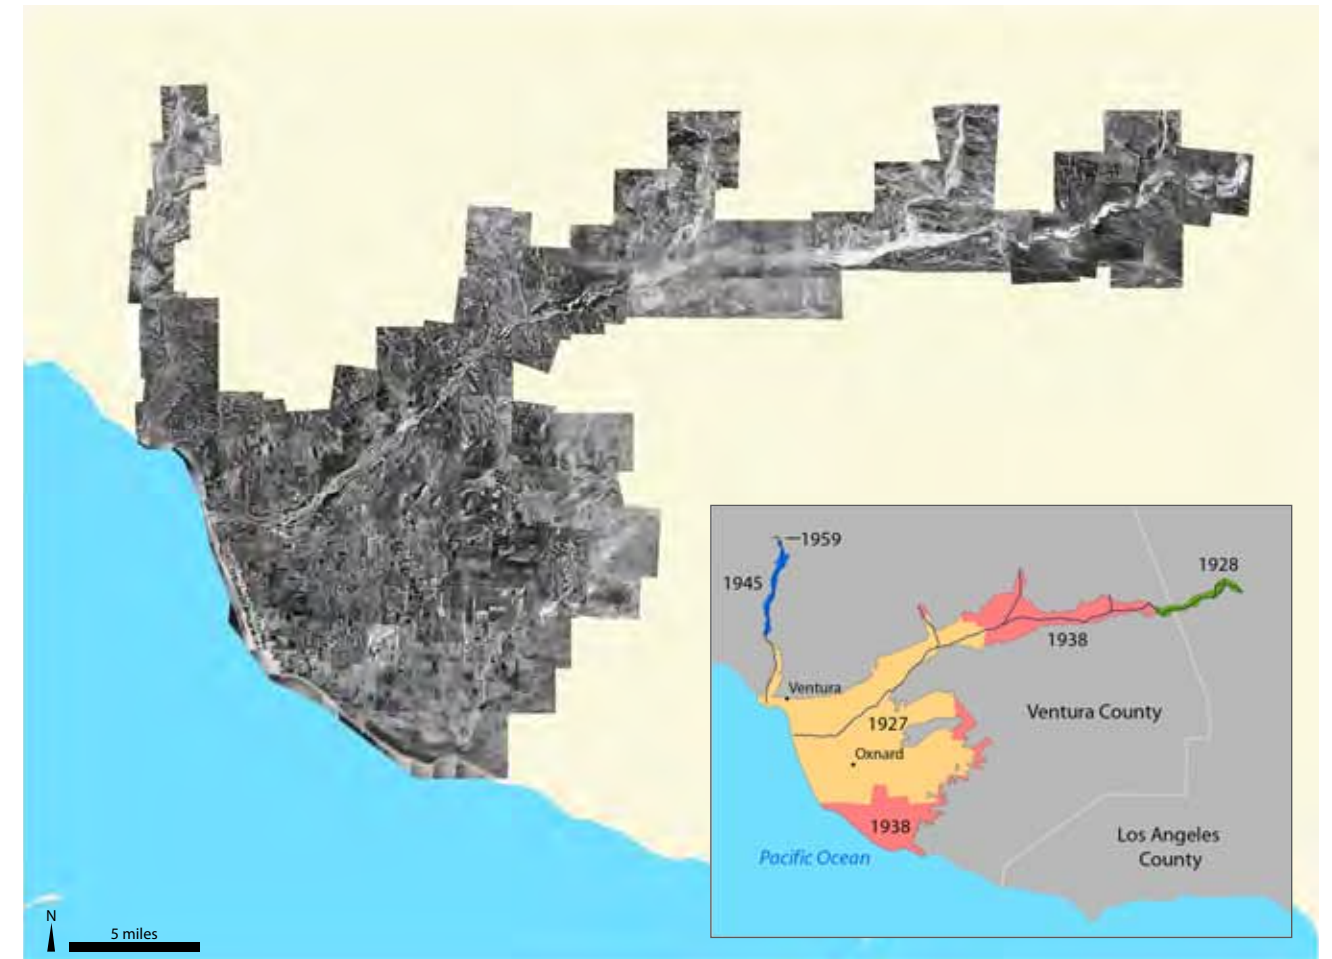
Fig. 1.4. Earliest date of aerial photo coverage. Two hundred and thirty-eight historical aerial photographs were orthorectified and mosaicked to provide continuous coverage of the study area. Aerials spanned from 1927-1959, with the bulk of photos from 1927 and 1938.

One heavily used source was historical aerial photography, which required orthorectification and mosaicking of 238 aerial photographs into a comprehensive, continuous coverage of the entire study area (fig. 1.4). Aerials were acquired from a number of source institutions and spanned a number of different years. The earliest imagery (1927), used where available, makes up about one half of the entire photomosaic. Later imagery (from 1938, 1945, and 1959) was substituted where 1927 imagery was not available. The spatial consistency, accuracy, and high level of detail available made these an invaluable source for the project.

The primary sources used to complete this mapping were the historical aerial photomosaic (which includes 1927, 1938, 1945, and 1959 aerials; see fig. 1.4), historical survey maps, and General Land Office survey data. The bulk of early sources were from 1870-1900; however, relatively few early (pre-1900) sources were available for the river above the Piru Creek confluence. Over 40 historical sources were used to create the outer bank position for the Santa Clara River. Multiple additional sources were also

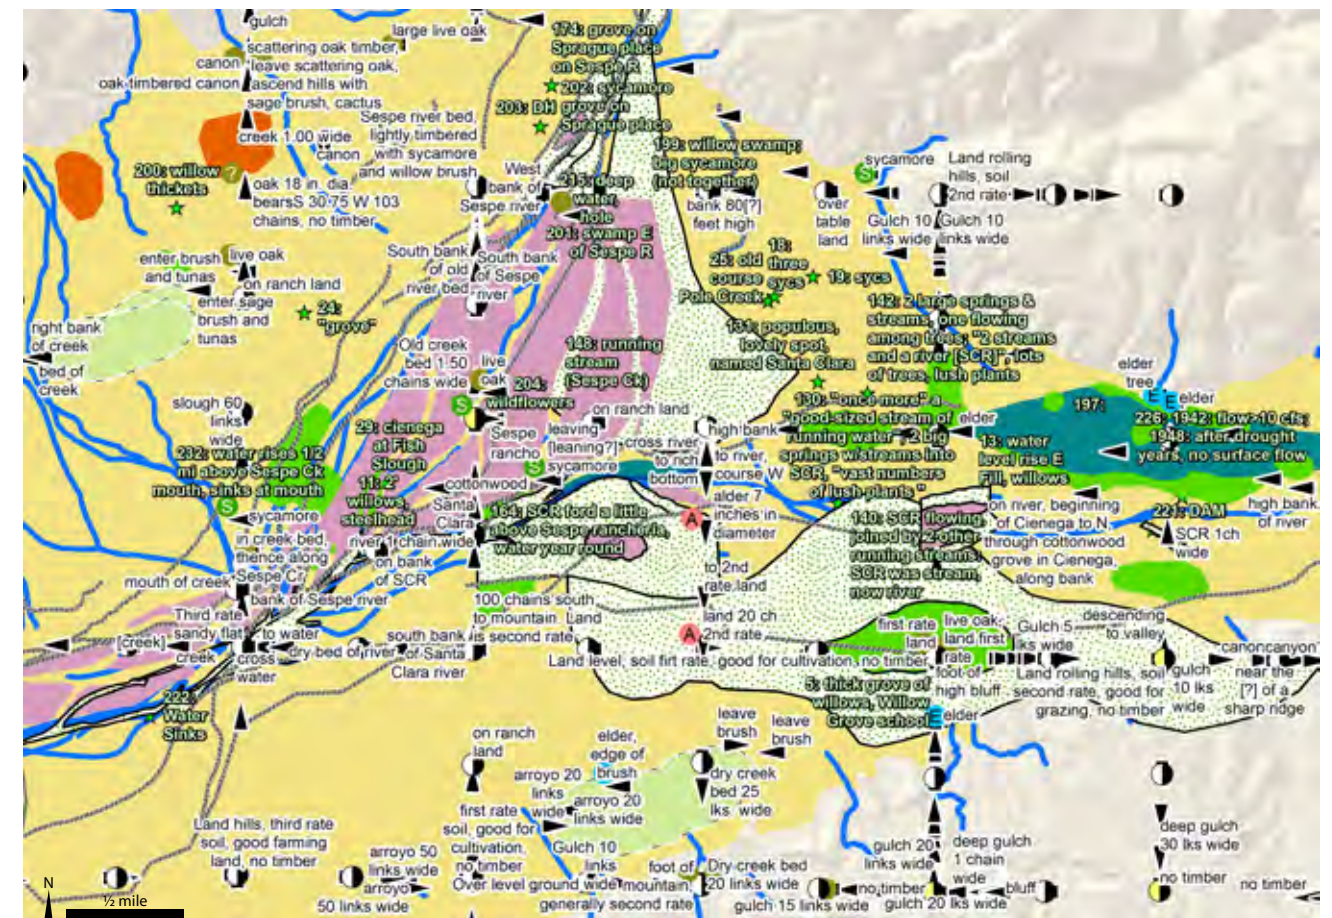
Fig. 1.5. Draft historical habitat and channel mapping at Santa Clara River-Sespe Creek confluence, early 1800s. Features from dozens of historical maps, texts, and photographs were digitized before being synthesized through an intensive process into one integrated map of the region’s historical ecology.

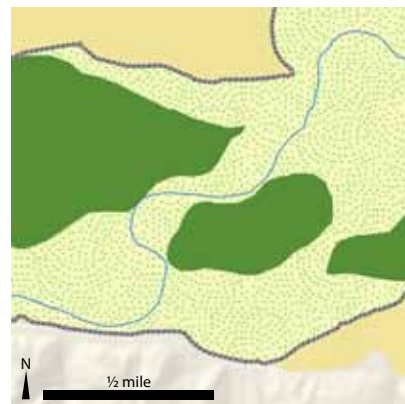
Fig. 1.6. Detail of mapping of outer river banks and river corridor extent. Outer banks were mapped as a broken black line, and river corridor extent with a green and yellow stippled pattern. (The dark green polygons are willow-cottonwood forested wetlands.)

RIVER CORRIDORS AND RIPARIAN HABITATS For the river systems (Santa Clara, Ventura) and major tributaries to the Santa Clara River (Santa Paula, Sespe, Hopper, and Piru), the entire river corridor (from outer bank to outer bank) was mapped as a polygon in the habitat layer (fig. 1.6). (Major tributaries to the Ventura River, such as Coyote, San Antonio, and Matilija creeks, were on the edge of the study area boundary and were not mapped as polygons.) This area includes the predominantly sandy active channel (mainstem; high disturbance) in addition to vegetated areas that show evidence of erosion/deposition (medium disturbance) and more densely vegetated areas that may be subject to flow during flood events, but without evidence of major erosion/deposition (low disturbance). Benches or bottomlands with evidence of flow during at least some flood events are also included. This definition of the river corridor was based on research conducted by Stillwater Sciences (2007b) for 1938-2005. More detailed definitions of riverine terms used in this report is can be found on page 61.

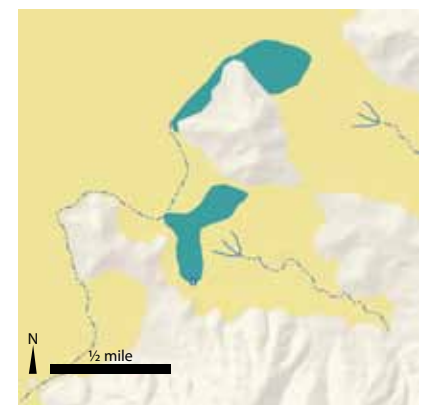
Fig. 1.7. Detail of channel mapping. Small creeks were mapped with a single line, dashed to indicate intermittent/ephemeral conditions. A forked symbol was used to indicate a distributary (that is, the point at which a creek spreads or sinks).

CHANNELS All other watercourses (including Calleguas Creek and tributaries to the rivers and creeks mapped as polygons, as described above) were mapped as line features in ArcGIS (fig. 1.7). The contemporary National Hydrography Dataset (USGS 2004) was used as a basis for mapping the historical channel network. The NHD GIS layer was modified where historical sources (such as historical aerial photos or maps) clearly showed evidence of a historical plan form differing from the contemporary alignment. This process produced a depiction of our best understanding of the historical channel network based on earliest available source.

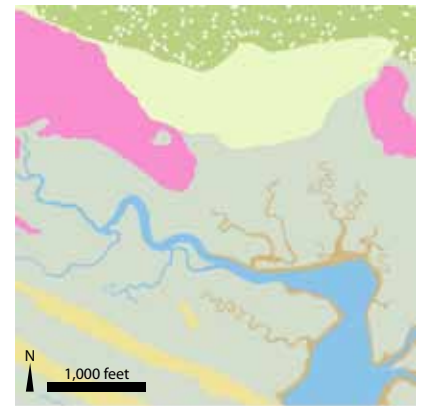
Fig. 1.8. Detail of wetland mapping, northwestern edge of Mugu Lagoon wetland complex. We mapped seasonal wetlands (such as alkali meadows, shown here in green with white stipple) in addition to perennial wetlands (such as the tidal marsh shown in grey-blue).

WETLAND HABITATS We documented the extent and distribution of wetland types prior to significant Euro-American modification based on available historical evidence (fig. 1.8). Wetland types mapped include palustrine habitats (alkali meadow, alkali meadow/flat, wet meadow, valley freshwater marsh, perennial freshwater pond, willow thicket, and willow-cottonwood forested wetland) and also a number of coastal habitat types (see habitat crosswalk, table 1.3).

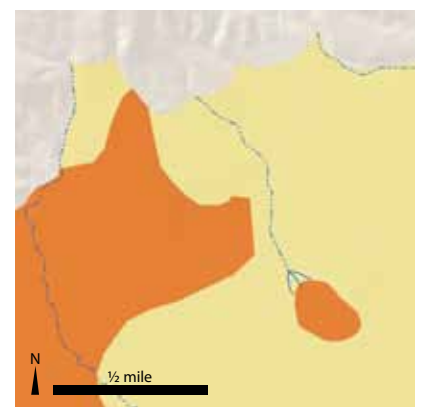
Fig. 1.9. Detail of dryland mapping. We mapped dryland habitats in a generalized fashion, including grassland/coastal scrub (in yellow) and oaks and sycamores (in orange).

DRYLAND HABITATS We documented the extent and distribution of dryland habitat types prior to significant Euro-American modification based on available historical evidence (fig. 1.9). Here we define “dryland” habitats to be well drained terrestrial habitats without regular cycles of flooding. Mapped terrestrial habitat classes include grassland/coastal

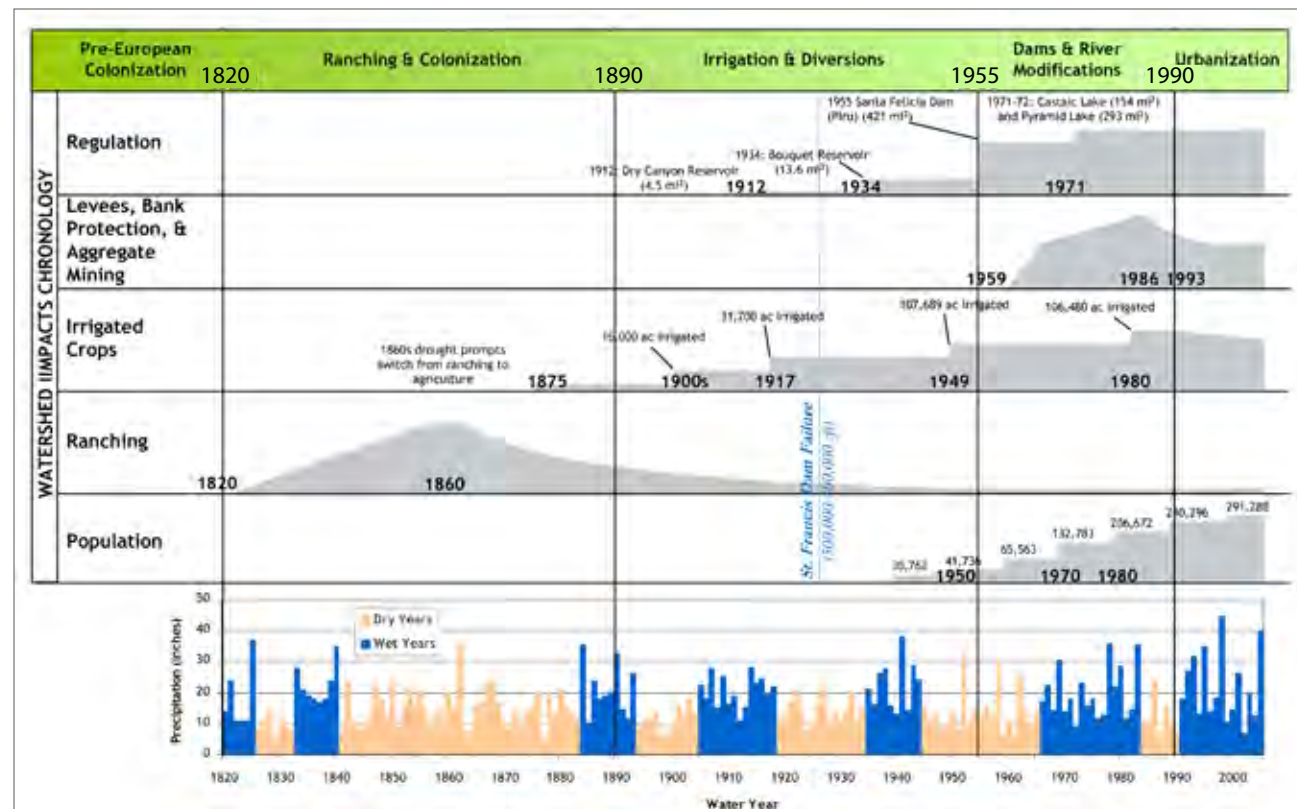
Fig. 2.2. Chronology of land and water use modifications, population, and precipitation on the lower Santa Clara River, 1820-2005. This graphic, produced by Stillwater Sciences (2007b), provides hydrologic and land use modification context useful in the interpretation of historical sources. (Precipitation data extended and adapted from Freeman (1968) by Stillwater Sciences (2007b); graphic courtesy of Stillwater Sciences)

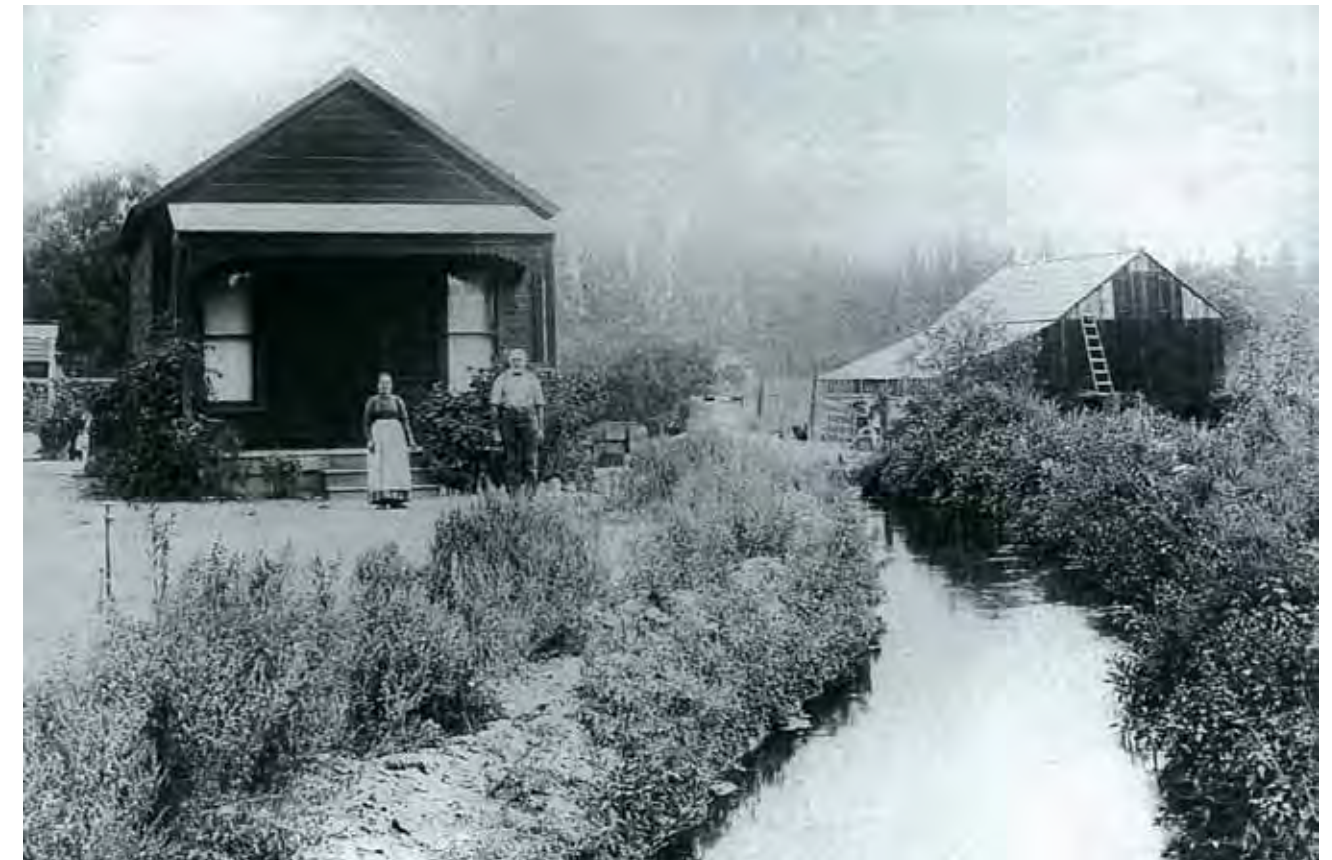
Fig. 2.8. Diversion ditch from Santa Paula Creek, ca. 1900. Surface diversions, such as this ditch taking water from Santa Paula Creek downvalley, brought water from areas with abundant surface flow to drier portions of the valley. (Unknown ca. 1900a, courtesy of the Santa Paula Historical Society)

These ditches brought water often long distances from perennial reaches near Santa Paula and Sespe creeks down to fields and population centers in need of water (fig. 2.8). The Farmers Ditch (1871) was 16 miles long, and brought water along the north side of the Santa Clara River from a branch of the river above Santa Paula Creek down to Prince Barranca (Hall Canyon), just east of Ventura (*Ventura Signal* 1871b, Freeman 1968). (One old-timer recounted to Vern Freeman (1968) that any extra water from the ditch was “disposed of” in the barranca.) The Santa Clara Irrigating Company’s ditch (1871) traveled 12 miles, bringing water to farmers

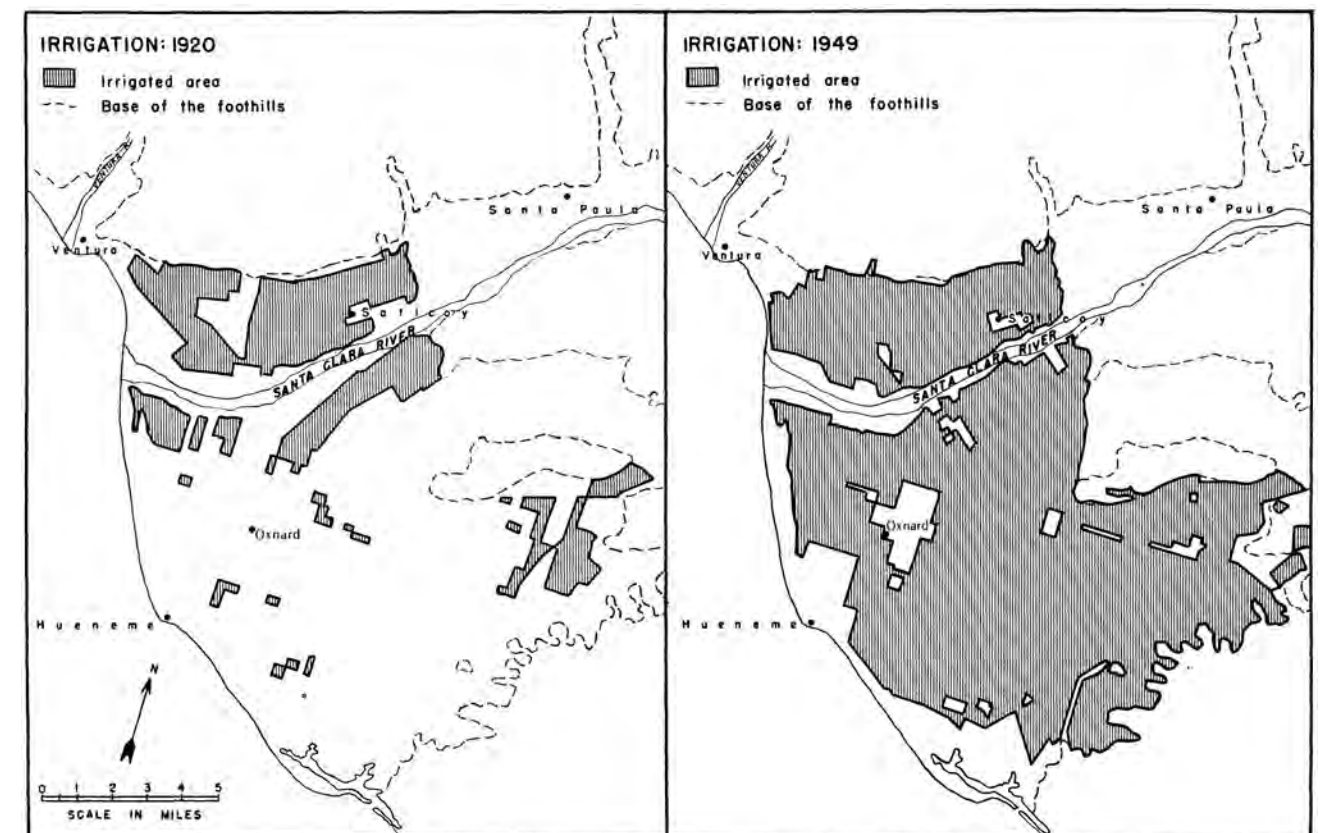
Fig 2.9. Extent of irrigated farms on the Oxnard Plain, 1920 and 1949. Irrigated acreage on the Oxnard Plain expanded rapidly from the 1920s through the 1940s. By 1947, over 93% of the Oxnard Plain's irrigable area was irrigated. (Gregor 1952)

The transition to irrigation occurred gradually over the 1920s and 1930s as orchards expanded over large sections of the county's cultivatable land. In the decade between 1919 and 1928, irrigated acreage in Ventura nearly tripled, from 31,700 to 86,700 acres. This was largely due to land use shifts on the Oxnard Plain as orchards became more common: by 1947, over 93% of the plain's irrigable area was irrigated (Gregor 1952, fig. 2.9).

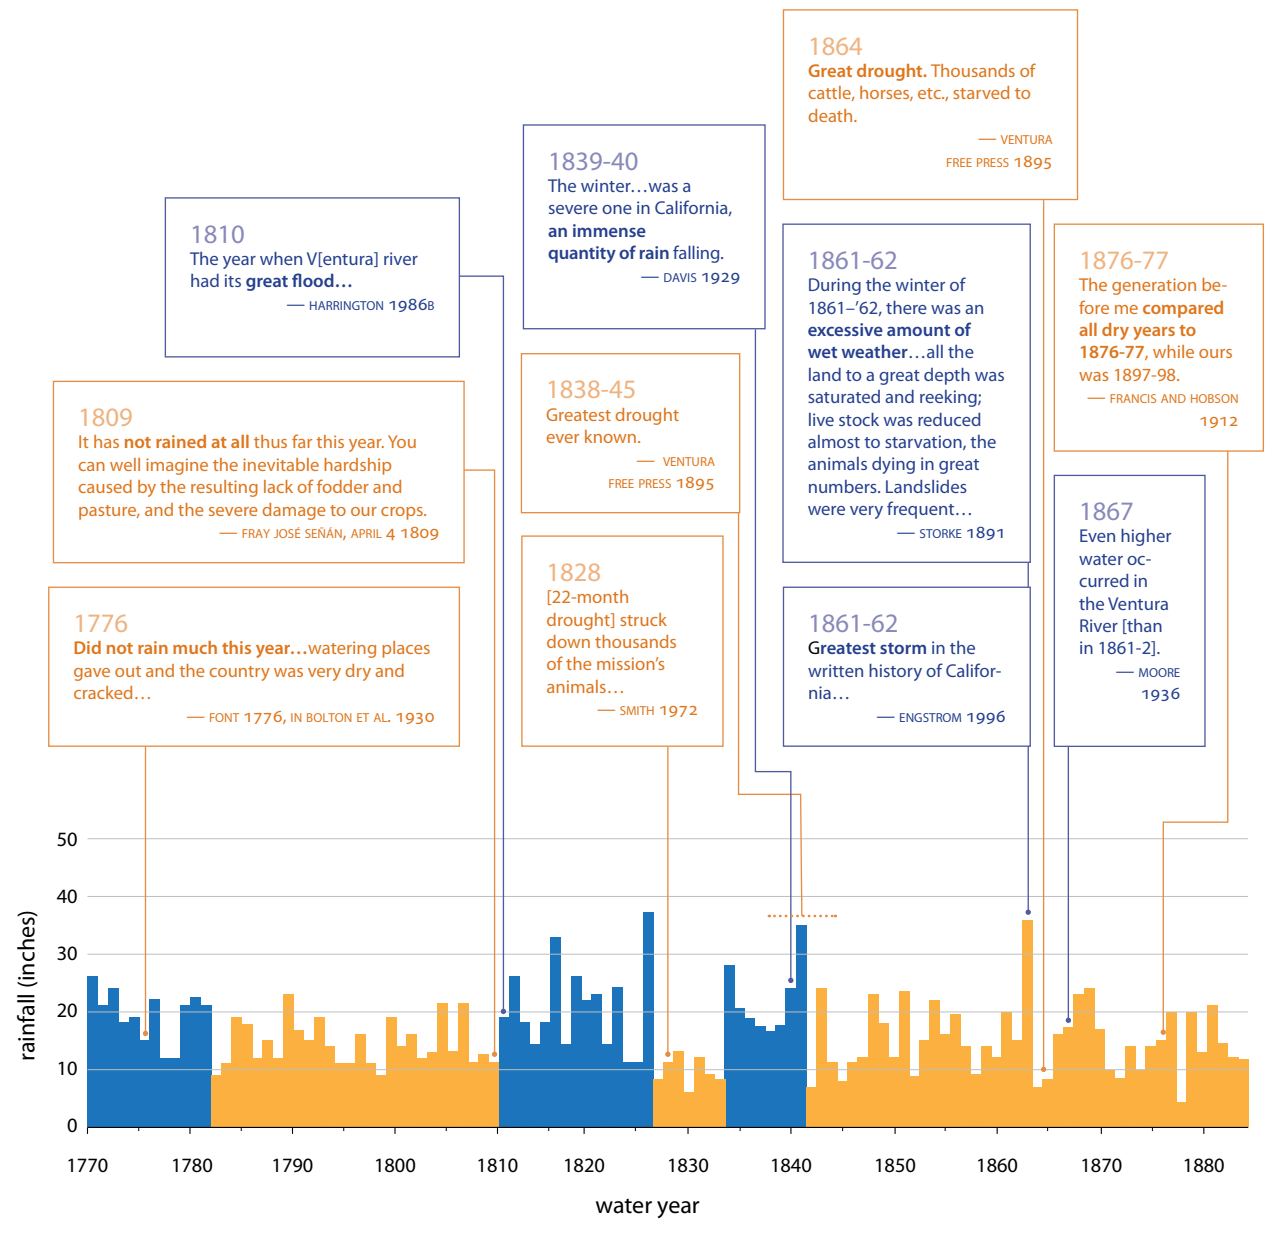
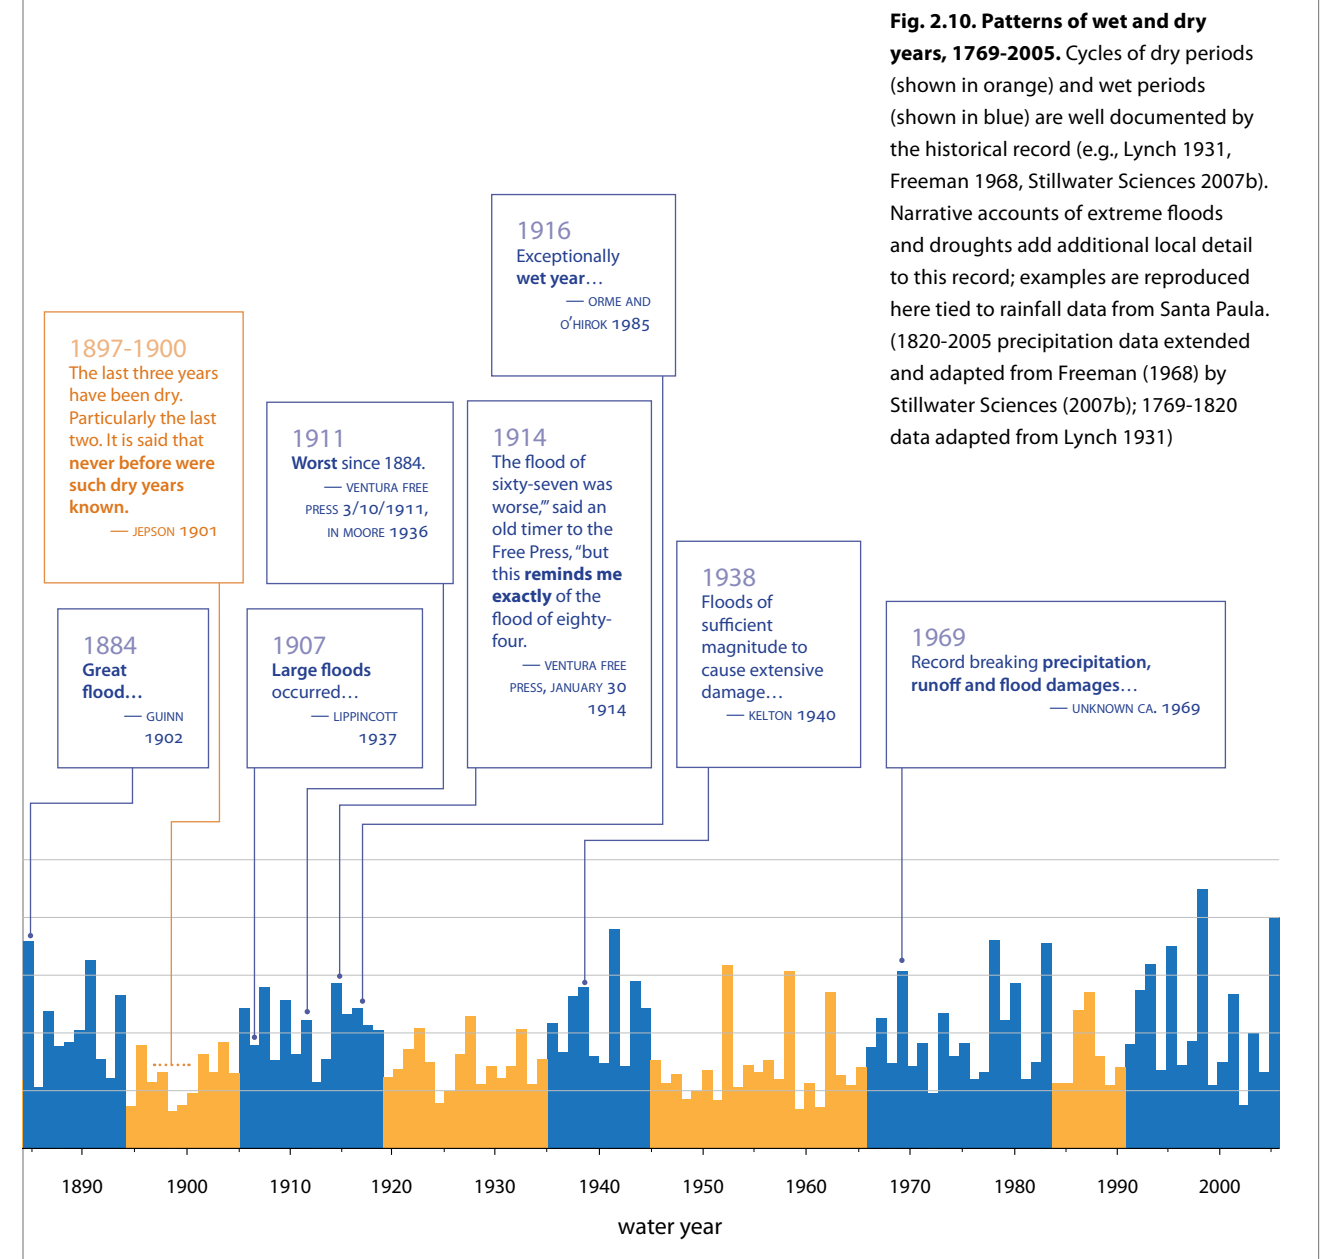
Fig. 2.10. Patterns of wet and dry years, 1769-2005. Cycles of dry periods (shown in orange) and wet periods (shown in blue) are well documented by the historical record (e.g., Lynch 1931, Freeman 1968, Stillwater Sciences 2007b). Narrative accounts of extreme floods and droughts add additional local detail to this record; examples are reproduced here tied to rainfall data from Santa Paula. (1820-2005 precipitation data extended and adapted from Freeman (1968) by Stillwater Sciences (2007b); 1769-1820 data adapted from Lynch 1931)

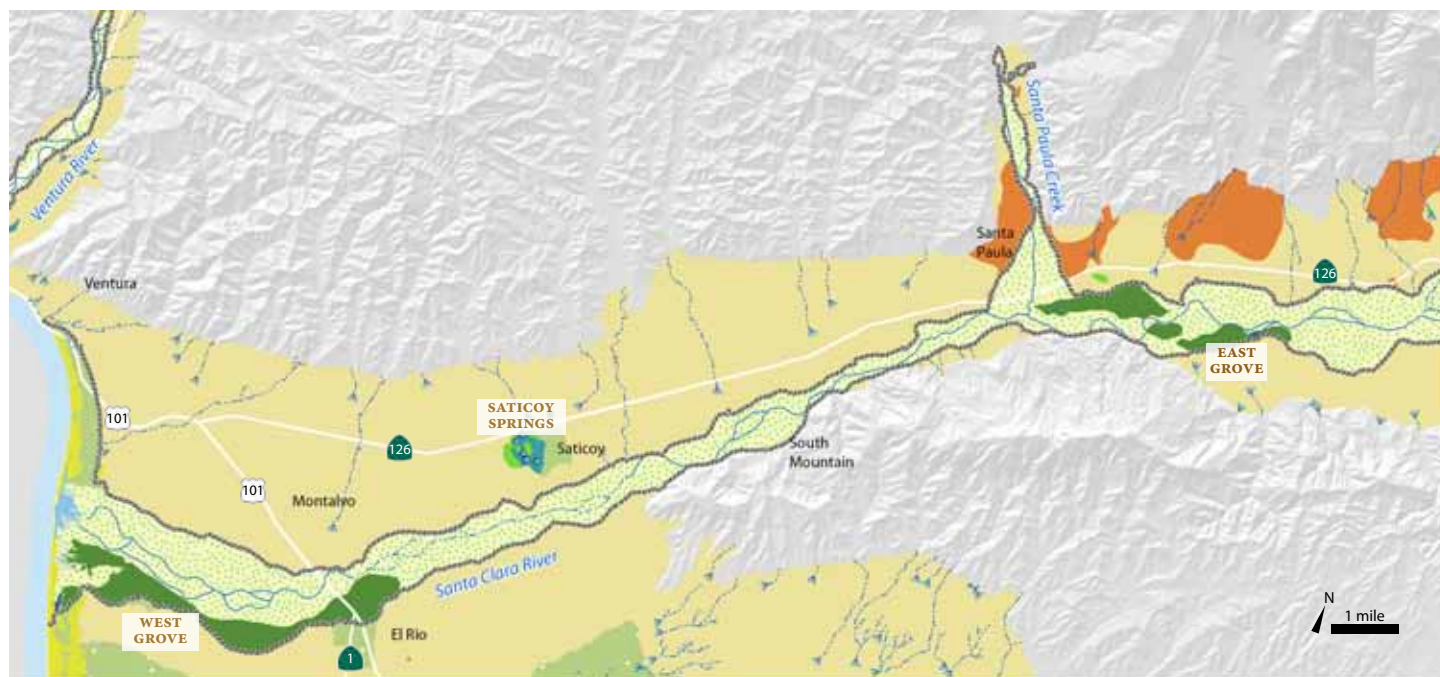
Fig. 3.2. Historical habitats of the Santa Clara River and valley, early 1800s. The Santa Clara River valley was dominated by broad, mostly treeless expanses of grassland and scrub. Trees, such as live oaks and sycamores, occurred on several alluvial fans north of the river and along many of the valley’s tributaries, most of which sank into valley soils before reaching the Santa Clara River. A large wetland complex at Saticoy included willow groves, freshwater marsh, springs, and alkali meadow, and was the only significant wetland complex documented on the plain in the valley. Within the outer river banks, however, large areas of willow-cottonwood forest and freshwater wetlands marked areas of perennial flow and rising groundwater east of Camulos, at Fillmore (near the present-day fish hatchery), Santa Paula, and below the Highway 101 bridge.

This chapter explores the historical characteristics of the Santa Clara River and valley prior to major urban and agricultural modifications (fig. 3.2). In particular, we focus on the pre-modification hydrology, morphology, and ecology of the Santa Clara River, describing each historical attribute at a reach scale.

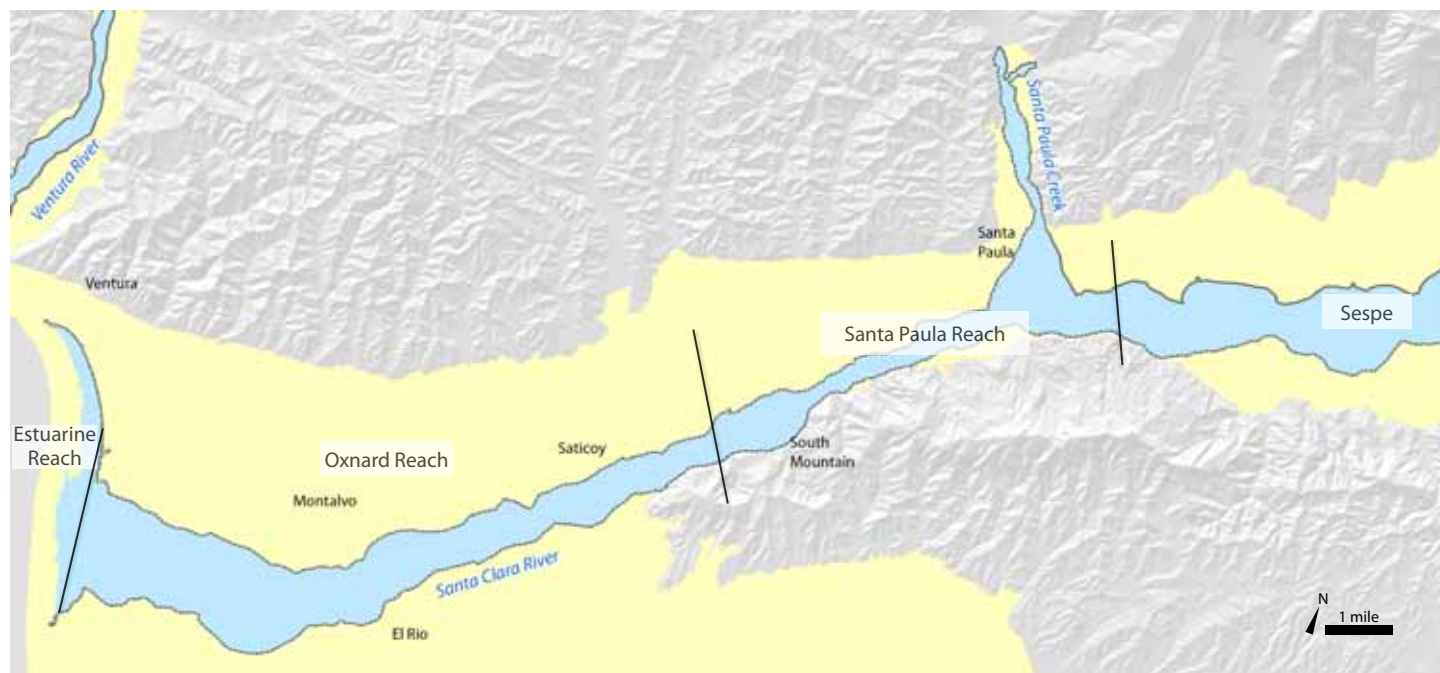
Fig. 3.3. Reaches of the Santa Clara River.

We designated six reaches of the lower Santa Clara River as units of analysis for the following chapter. These reaches are aggregations of Stillwater Sciences’ (2007b) more detailed reach designations for the river, with a few modifications to reflect historical conditions.

From the coast upstream to Interstate 5, the six reaches of the river are designated as the Estuarine reach, the Oxnard reach, the Santa Paula reach, the Sespe reach, the Piru reach, and the Del Valle reach. Through this report, we will refer to these reaches, and use them as a practical scale at which to examine and analyze historical riverine processes and dynamics.

For purposes of comparison, we identified six reaches of the lower Santa Clara River (fig. 3.3). These reaches were broadly defined based on physical characteristics of the system such as topography, flow dynamics, tributary inputs, and geology (Bisson et al. 2006). They are designed to provide meaningful units of analysis for reach-level investigations of channel dynamics and morphology.
