HISTORICAL ECOLOGY of the lower Santa Clara River, Ventura River, and Oxnard Plain: an analysis of terrestrial, riverine, and coastal habitats

HISTORICAL ECOLOGY PROGRAM
CONTRIBUTION NO. 641 • AUGUST 2011

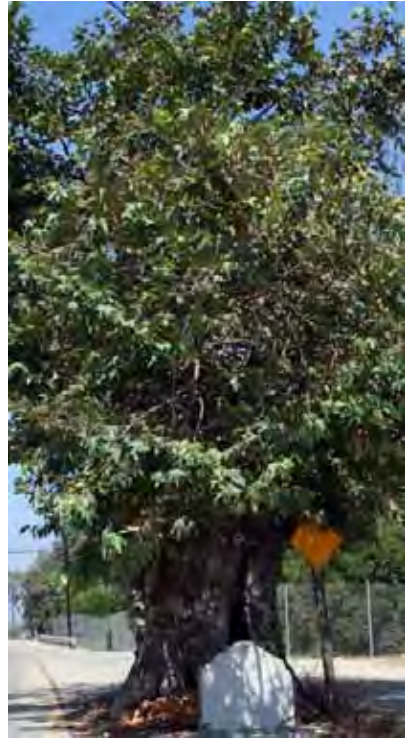
Fig. 3.4. The Fremont sycamore, still standing at the intersection of Highway 126 and Sycamore Road west of Sespe Creek, is a California Historical Landmark. According to the Office of Historic Preservation, the tree “has served as a resting place, a polling place, a temporary post office, and an outdoor chapel” (OHP 2011).

The general absence of trees meant one was able to see long distances over the plain in many places without interruption. The Fremont sycamore, a lone tree north of Highway 126 at Sycamore Road/Hall Road (fig. 3.4), was a landmark tree on the plain; one GLO survey sighted 1.5 miles across the plain to the tree, a remarkable distance away for such a survey (Craven 1874c). (The tree, named after General John C. Frémont, still stands today and is a California Historical Landmark. Modern Sycamore Road follows this line of sight to the tree, and forms the northwestern boundary of the Sespe Ranch.)

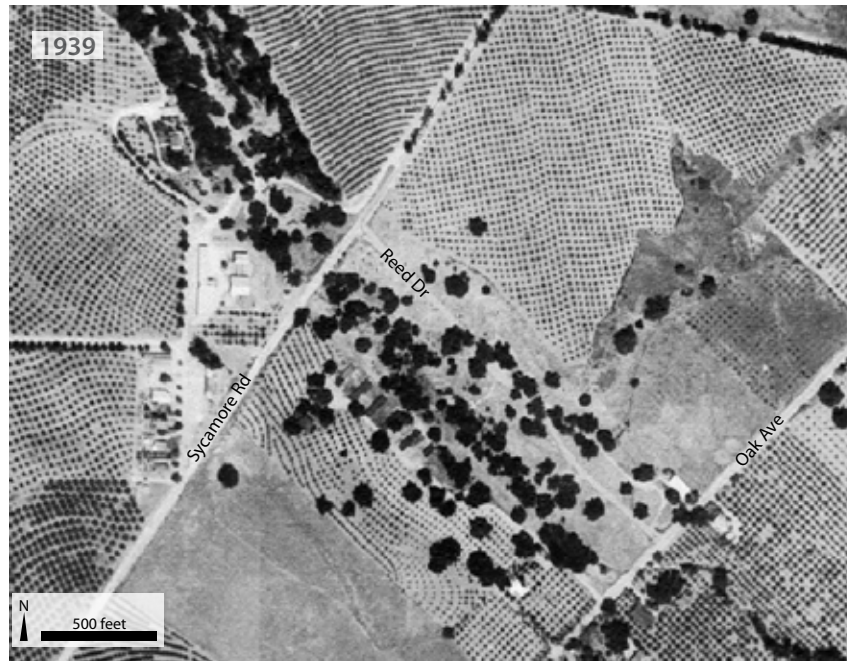
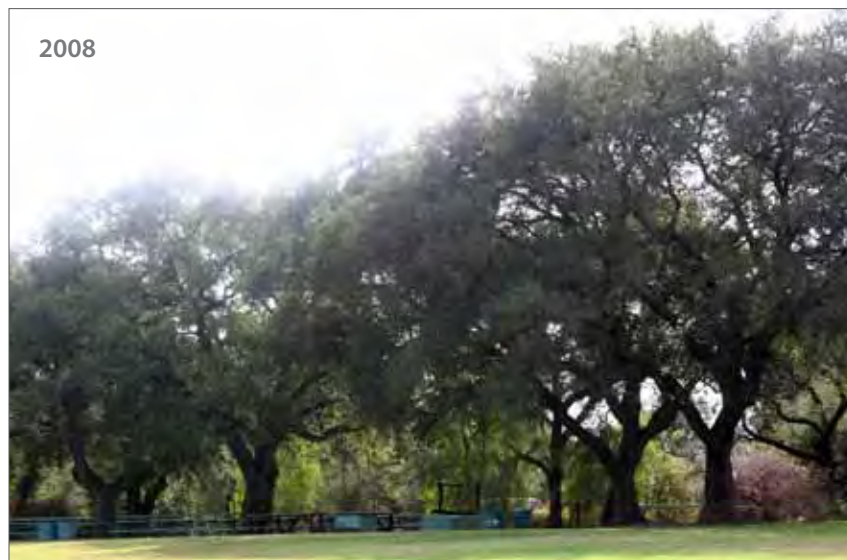
Fig. 3.6. Kenney Grove, 1939-2008. Kenney Grove is situated at the former distributary of a small creek, west of Sespe Creek and above Oak Avenue. Fourth of July picnics were common under these trees in the late 19th century. The trees, still present in 1938 (top), are currently an RV campground shaded by the oaks (bottom). (USDA 1938, courtesy of Ventura County)

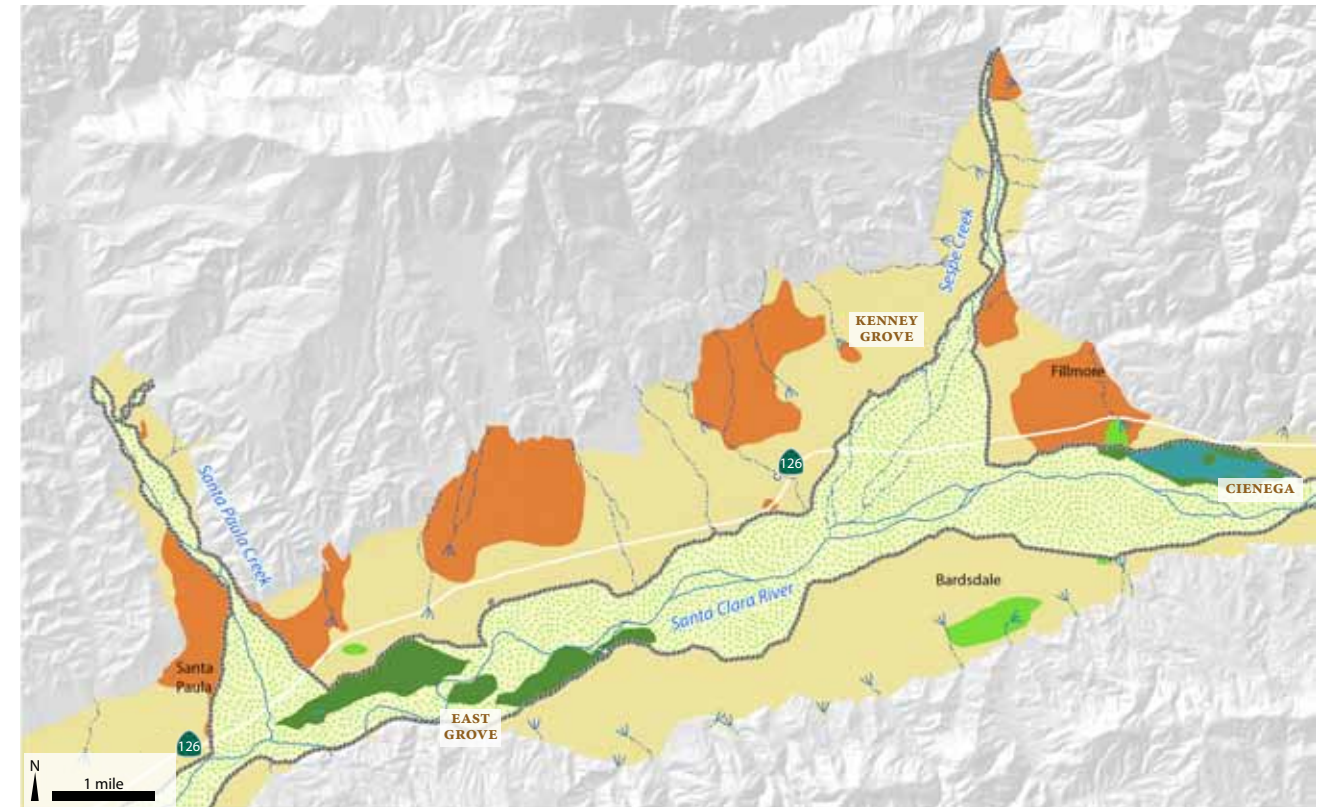
Fig. 3.7. Sycamores and oaks between Santa Paula and Sespe creeks. Scattered oaks and sycamores, documented by GLO, historical soils surveys, and early aerial photography, occupied coarse alluvial fans north of the Santa Clara River.

In addition to these isolated trees and groves, there were a few areas of denser tree cover on the valley floor. These timbered areas were documented exclusively on alluvial fans north of the Santa Clara River between Santa Paula and Sespe canyons (fig. 3.7). Using both GLO survey notes and historical aerial photography, we found that the gravelly fine sandy loam with stones (Yg) soil type from the historical soil survey (Nelson et al. 1917), prevalent on these alluvial fans, was well correlated with the documentation of historical oaks and sycamores. We subsequently used this soil type to delineate probable timbered areas (see page 15). GLO field notes for these areas describe “oak timber,” “scattering oak timber,” and “scattering live oak and sycamore with undergrowth sage brush” (Hoffman 1868c, Orcutt 1900).

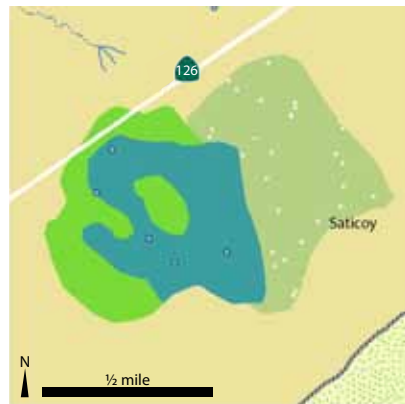
Fig. 3.10 Detail of Saticoy Springs, early 1800s. This 330 acre wetland complex was composed of springs, seasonal alkali meadows, and extensive willow groves and freshwater marsh.

SATICOY SPRINGS In contrast to the Oxnard Plain on the southern side of the Santa Clara River, the lowlands just to the north, on the opposite side of the river, contained few wetlands. This area was naturally steeper and more well drained than the south side of the river, as a result of alluvial fans emanating from the mouths of the series of canyons to the north. However, one distinctive wetland complex was found on the plain on the north side of lower Santa Clara River: Saticoy Springs. Groundwater emerged in an array of springs here, associated with a fault trace of the Country Club fault (Mann 1958), creating a series of springs, wetlands, willow thickets, and alkali meadows that were a noted source of water and wood through much of Ventura history (fig. 3.10).

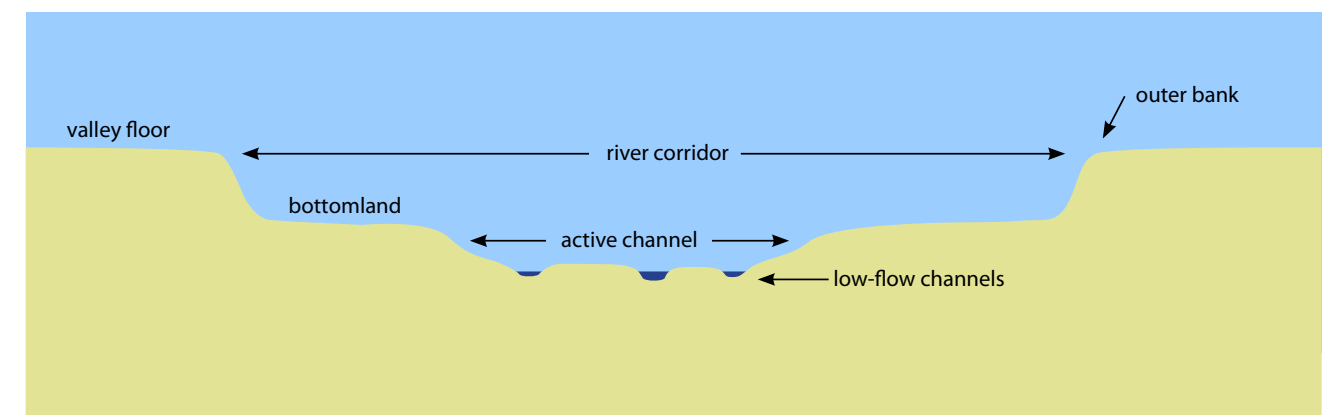
Fig. 3.13. Generalized cross-section, showing riverine terminology used in this report. The active channel consists of the low-flow channels and sparsely vegetated riverwash. In many reaches the active channel is flanked by bottomland (floodplain) surfaces supporting riparian grassland, scrub, and trees. The entire river, from outer bank to outer bank, is referred to as the "river corridor."

A wide variety of geomorphic features are found within the outer banks of the Santa Clara River, each characterized by different hydrology (flooding frequency, depth to groundwater) and ecology (vegetation and habitat types). Concepts of bankfull discharge as defined for streams in more humid climates (i.e., formed by floods with a 1.5 to 2 year recurrence interval; Wolman and Leopold 1957) are not appropriate for this system, which is characterized by considerable extremes of flow and sediment discharge (Stillwater Sciences 2007b). To address this discrepancy, here we use terminology better suited to Santa Clara River geomorphology. For clarity and consistency, we define the terms below that will be used throughout the report. (For a visual representation of riverine terminology, see fig. 3.13.)

The *active channel* consists of the network of all low-flow channels and the sparsely vegetated or non-vegetated, often sandy bed of the river (Richard et al. 2005). This portion of the river is dynamic, and experiences significant water and sediment transport in most floods; Graf (2000) termed it the "high flow channel." It includes high disturbance areas that are scoured during high flows and have little to no vegetation, in addition to medium disturbance areas that support sparse, poorly established vegetation such as sand bars and islands (Stillwater Sciences 2007b). This is consistent with Stillwater Sciences' classification of active channel width. Nineteenth-century surveyors referred to the active channel area as the "sandy bottom" (Terrell 1861b, Thompson 1867), "sandy bed" (Hoffman 1868b, Norway 1878b, Barry 1892a), or "wash of river" (Norway 1878b).

Above the active channel, within the outer banks of the river, *bottomland* surfaces supported scrubby to dense stands of vegetation. Though still subject to flows, these areas would have experienced minimal scour or deposition during most flood events. These areas correspond with Stillwater Sciences’ low disturbance surfaces. “Bottomland” is not a common contemporary ecological term on the West Coast, though it is still widely used in the eastern United States to refer to a periodically flooded forested area (NRCS 2008). Some biogeomorphic literature also uses the term to refer to riverine surfaces above the active channel, though in a broader sense than is meant here (e.g., Scott et al. 1996, Hupp and Osterkamp 1996, Friedman and Lee 2002, Hupp and Bornette 2003, Osterkamp and Hupp 2010). In addition, the Department of Fish and Game’s list of terrestrial natural communities in California recognizes “Riparian and Bottomland Habitat” as one of the primary categories of terrestrial vegetation (CDFG 2003). Early surveyors and residents commonly referred to these surfaces as “bottom” (e.g., Norris 1853, Thompson 1867, Craven 1874e), “river bottom” (*Ventura Free Press* 1876, Van Dyke 1890), or “bottom land” (Norway 1877, Hampton 2002, King 1883). (The active channel was also sometimes referred to as a bottom—though never bottomland—but was distinguished as the “sandy bottom”; e.g., Terrell 1861b, Thompson 1867, Thompson 1874.)

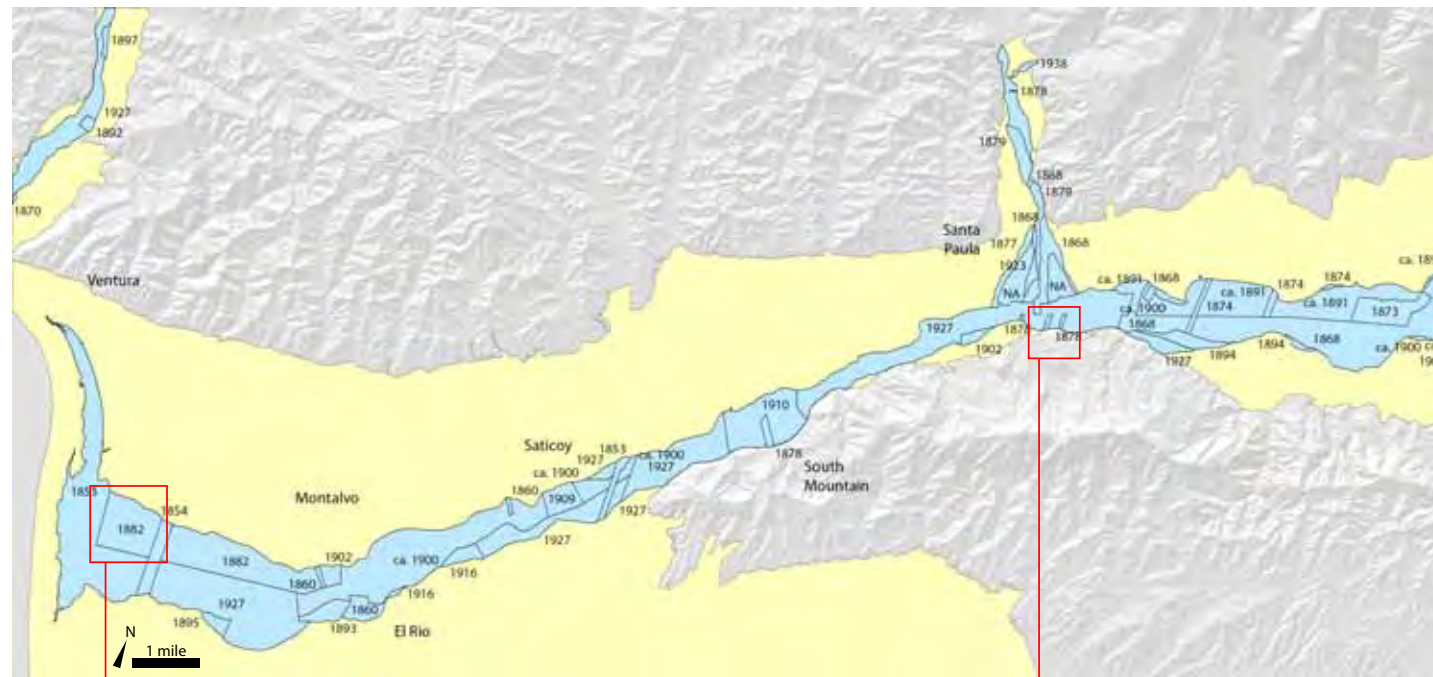
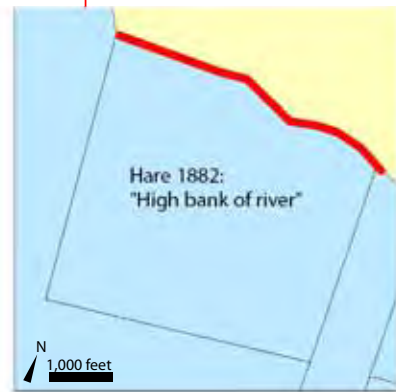
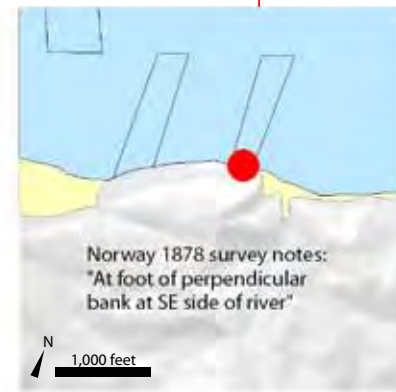
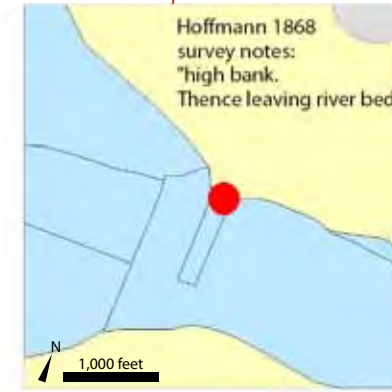
Fig. 3.14. Location of the Santa Clara River corridor by earliest available source, 1853-1938. We mapped the historical position of the outer bank, using the earliest data found for each stretch of the river. We found that while large flood events caused locally significant adjustments in outer bank position and total river corridor width, these changes were relatively small at a regional scale. Pull-out quotes provide examples of the types of sources used to map the historical river corridor.

The river corridor polygon included in our historical mapping represents the earliest reliable source available for each length of stream (fig. 3.14). For the lower Santa Clara River, previous mapping of high, medium, and low disturbance areas from 1938 aerial imagery (Stillwater Sciences 2007b) was used as a starting point. This layer was then compared to earlier historical sources where available. Where earlier sources confirmed 1938 mapping, bank position was left unchanged. Where they showed a substantial change (greater than 150 feet) in bank position, the 1938 layer was modified to reflect the earlier source. In places where Stillwater Sciences was missing 1938 aerial coverage (and in Los Angeles County), we extended their mapping of the active channel. We also mapped the outer banks of the Ventura River and major tributaries of the Santa Clara River from historical aerials and other spatially accurate historical sources.

The primary sources used to complete this mapping were the historical aerial photomosaic (which includes 1927, 1938, 1945, and 1959 aerials; see fig. 1.4), historical survey maps, and General Land Office survey data. The bulk of early sources were from 1870-1900; however, relatively few early (pre-1900) sources were available for the river above the Piru Creek confluence. Over 40 historical sources were used to create the outer bank position for the Santa Clara River. Multiple additional sources were also

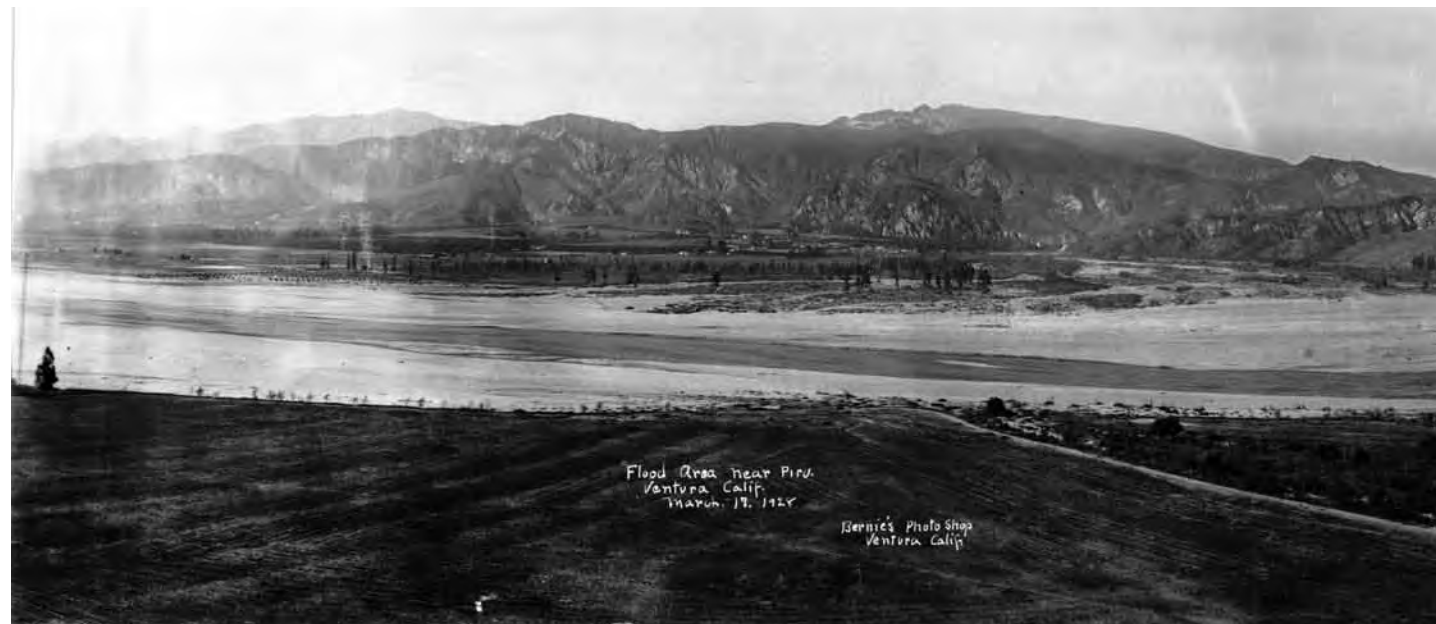
Fig. 3.15. Santa Clara River after the St. Francis dam break, 1928. This photograph was taken near Piru only five days after the failure of the St. Francis dam. (Isensee 1928a, courtesy of the Museum of Ventura County)

Even the St. Francis Dam break appears to have had minimal long-term impact on the river's overall plan form configuration (fig. 3.15), despite noteworthy scour and extensive deposition at various locations along the river valley and the possibility that the gradient of the channel between the county line and Sespe Creek has been recovering ever since (Stillwater Sciences 2007b). Many riparian features persisted, as did the general width and appearance of the channel.

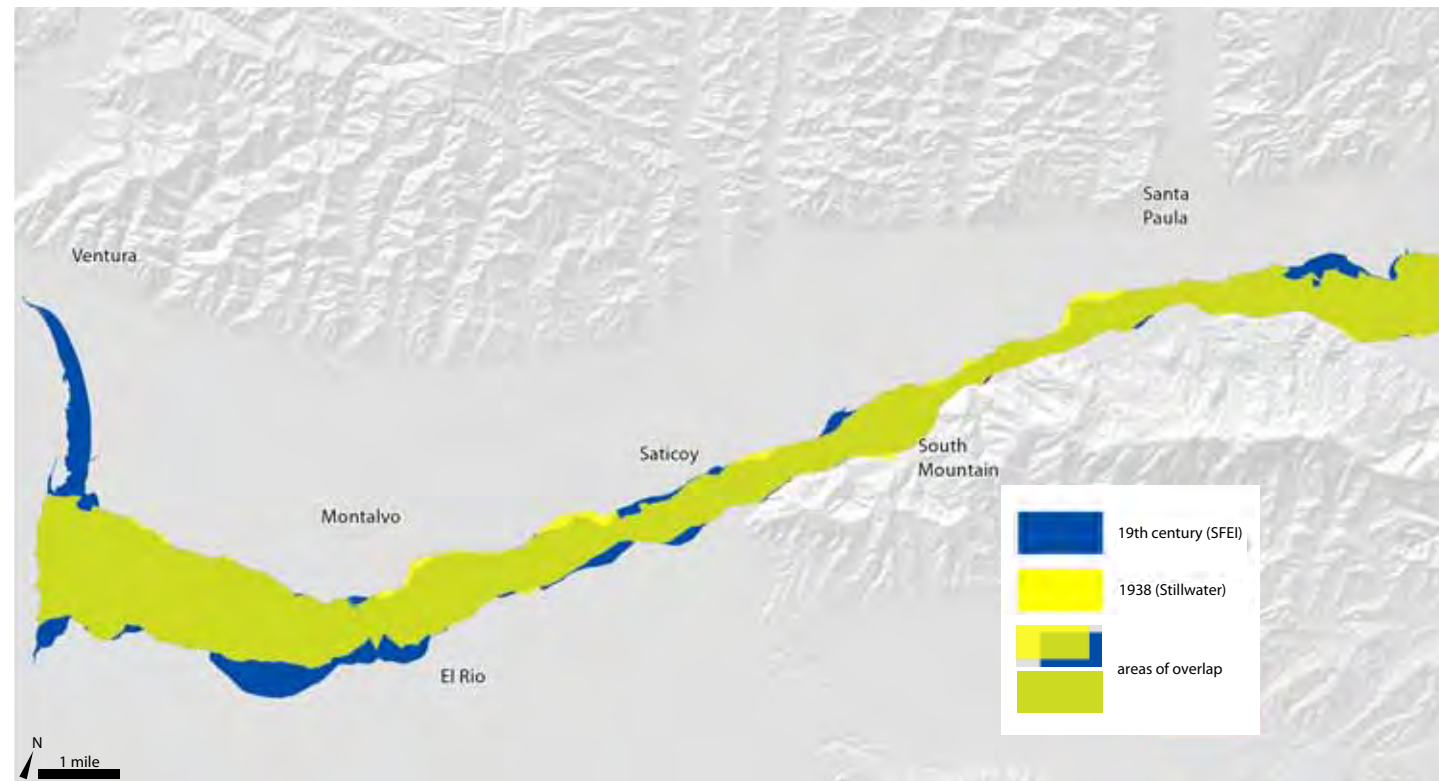
Fig. 3.16. River corridor extent and outer bank position, 19th century and 1938. By 1938, 13% (2,000 acres) of the river's former extent had been removed from the river's influence. Much of this lost river corridor was bottomland habitat near the river mouth and Sespe Creek. (1938 mapping from Stillwater Sciences 2007b)

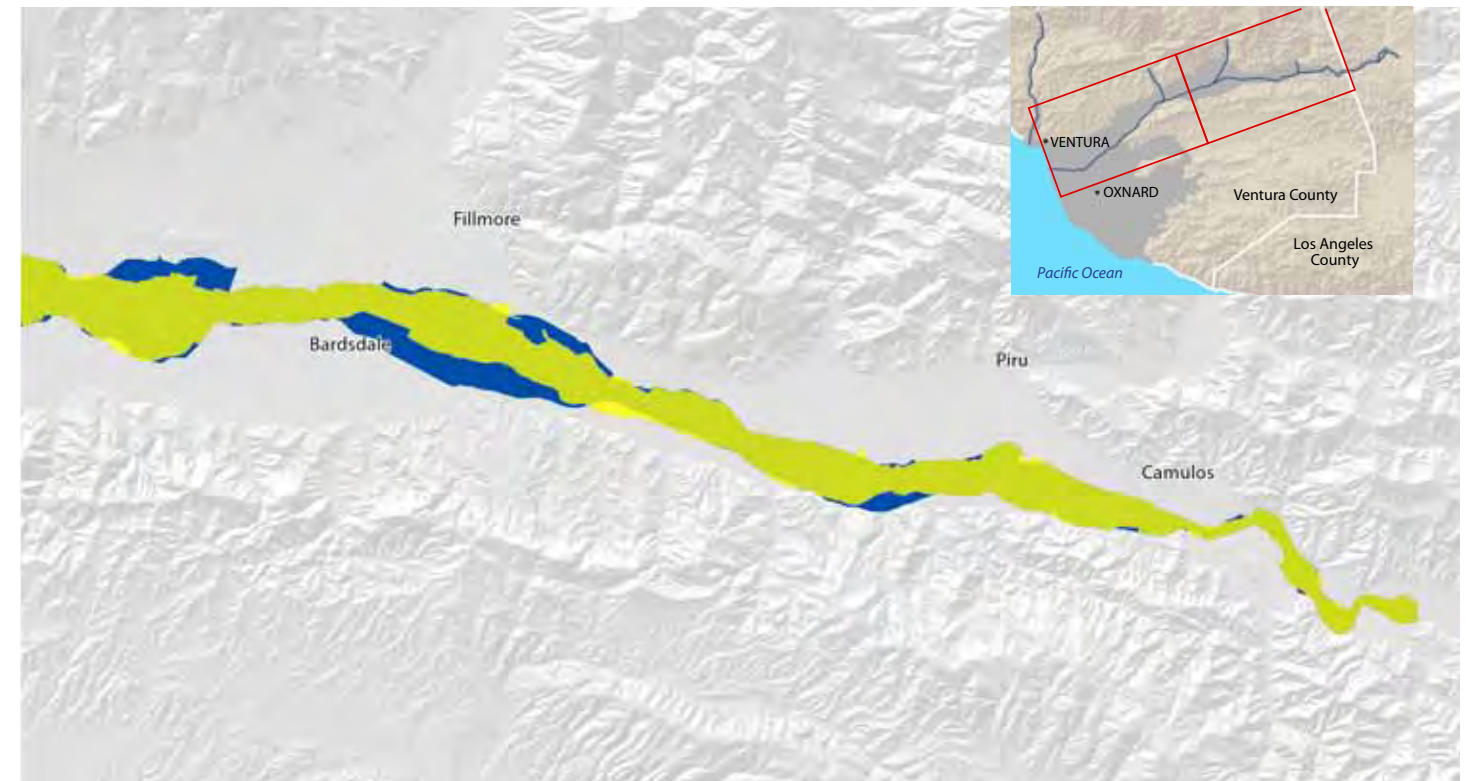
Fig. 3.17. Examples of historical persistence in bank location. In many locations along the river, the position of the outer bank remained quite stable over decades, despite intervening major floods (including the St. Francis Dam break of 1928). This is illustrated here in three reaches: south of the Sespe Creek confluence (left), at South Mountain (middle), and at the Olivas Adobe near the river mouth (right). In each case, early (1854-1882) evidence also confirms the early 20th century (1927-1938) bank position. In each instance, by 2005 bank position has shifted somewhat. (USDA 2009)

channel narrowing by 1938, the bulk of this channel loss is from human encroachment on the river through cultivation, levee construction, etc.) While the data resolution is not sufficient to make reach-scale generalizations about stability, in many locations pre-1900s channel form coincides almost exactly with 1938 form (fig. 3.17).

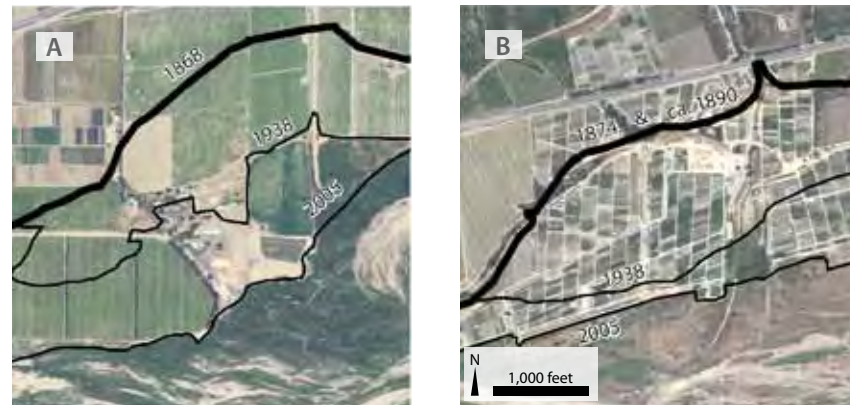
Fig. 3.18. Examples of historical change in bank location (top). In some places, bank position as documented by 19th century surveyors differed substantially from 1938 conditions, as shown here on the river west of the Sespe Creek confluence (left) and east of the Santa Paula Creek confluence (right). In each case, the river corridor had narrowed even further due to reclamation by 2009. (USDA 2009)

In other reaches, however, comparisons between 19th century and 1938 mapping show substantial areas of channel change, on a scale of over 1,000 feet (fig. 3.18). The vegetated area south of the river in the Oxnard reach represents more than 2,300 feet of channel loss at its widest extent. The Sespe reach has been greatly constricted, especially the north bank just downstream of the Sespe confluence and in the Cienega (Fillmore Fish Hatchery) area. By 1938, bottomland areas in many portions of the Sespe reach extended 300-2,300 feet less far than they had in the 19th century.

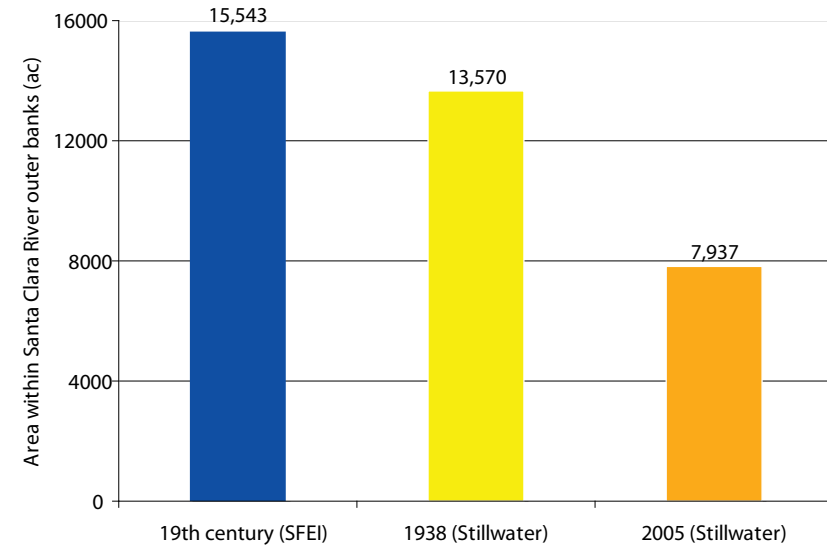
Fig. 3.19. (middle) From the 19th century to 1938, total river corridor area dropped only a little under 2,000 acres (13% loss), largely as a result of levee construction and agricultural encroachment on the channel. By 2005, over 7,600 acres had been lost, 49% of the original river corridor area. (1938 and 2005 data from Stillwater Sciences 2007b.)

By 2005, 7,600 acres of bottomland had been lost from the river corridor, nearly half of the 19th century area of about 15,500 acres (fig. 3.19). These areas had been converted to agricultural or urban uses, and were no longer regularly flooded or considered part of the river (fig. 3.20). Development

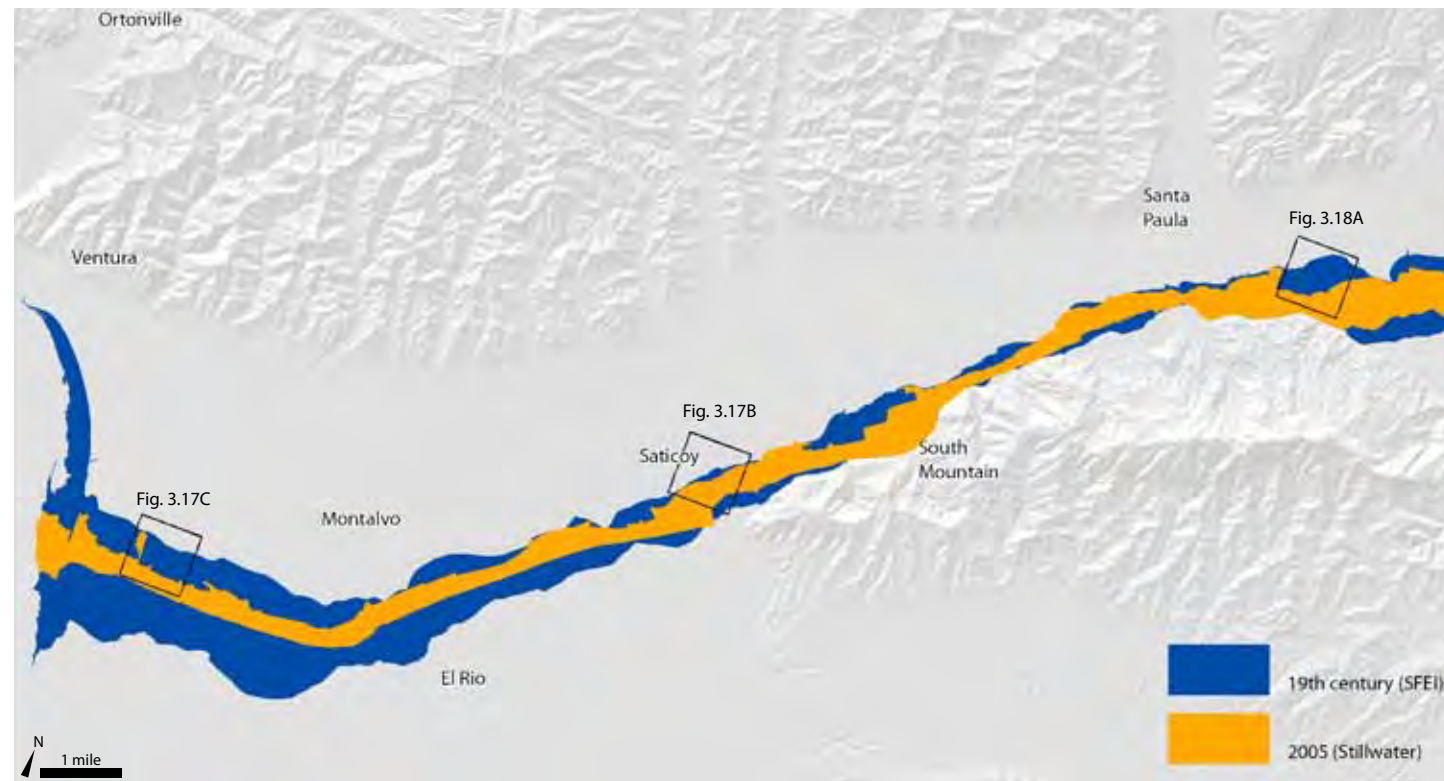
Fig. 3.20. (bottom) River corridor extent and outer bank position, 19th century and 2005. By 2005, over 7,600 acres had been lost, 49 % of the original river corridor area. Much of the lost area was bottomland habitats, leveed and reclaimed for farming and other land uses. Documented change is concentrated particularly in the Oxnard and Estuarine reaches (below Saticoy) and between Santa Paula and Sespe creeks. (2005 mapping from Stillwater Sciences 2007b)

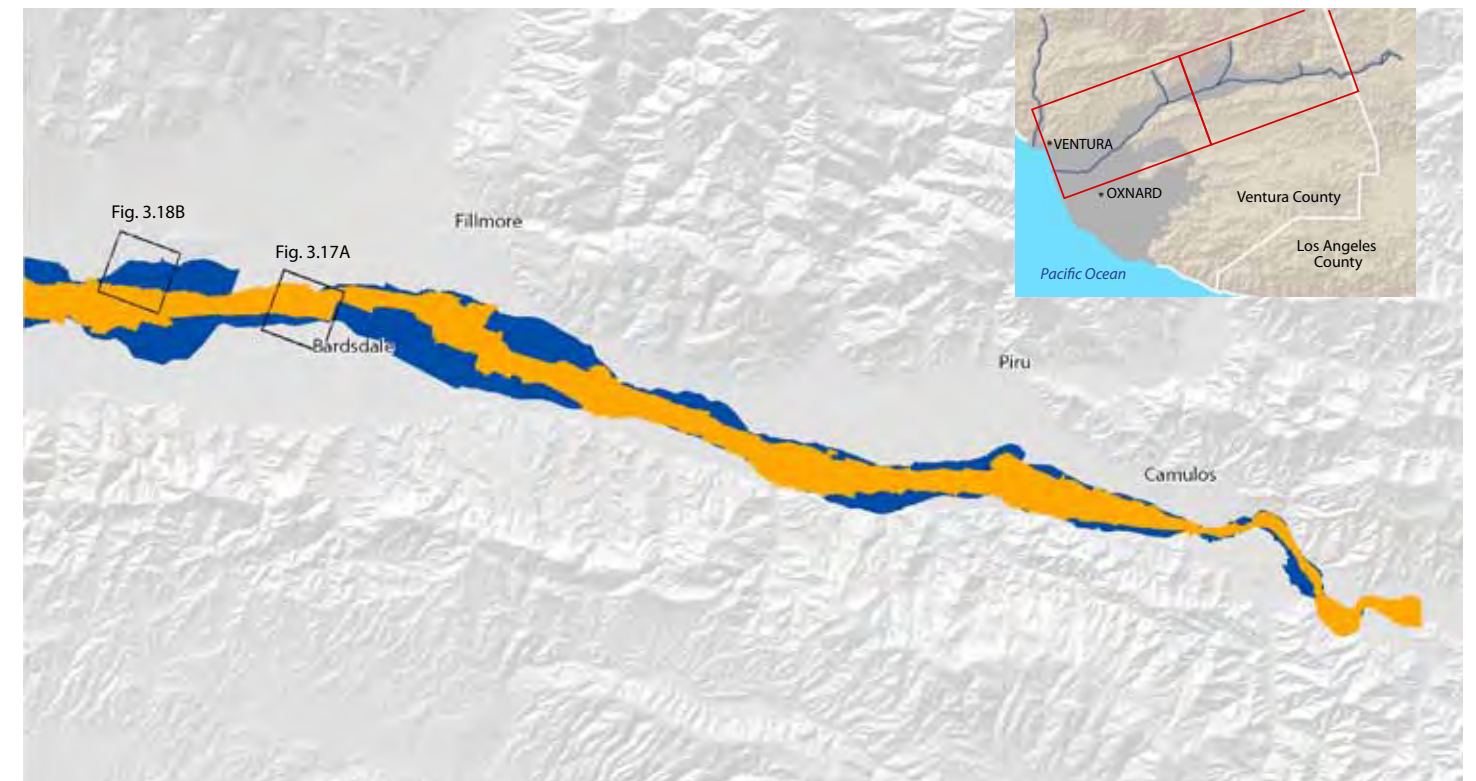
Fig. 3.21. Large-scale changes in the lower Santa Clara River course on the Oxnard Plain. Geologic, archaeological, historical, and edaphic data all support the migration of the Santa Clara River over the Oxnard Plain over geologic time. Extreme floods coupled with sediment deposition triggered channel migration on the Santa Clara River delta (Oxnard Plain) and subsequent large-scale changes in river corridor location. The dashed black lines represent paleochannels; the most recently occupied former course of the river (Saviers paleochannel, labeled **a**) may have been active as recently as 1812. It can also be seen here how ecological patterns of the Oxnard Plain are dictated by the channel migration history, with grassland/sage scrub on higher surfaces marking natural levees along more recently occupied routes of the river. (Nelson et al. 1917, Fairchild Aerial Surveys 1927, Clahan 2003, Parsons 2004)

LARGE-SCALE CHANNEL CHANGE A notable exception to the overall trend of channel stability is the migration of the Santa Clara River mouth from Point Hueneme to its present location, a shift of over six miles upcoast. Geologic maps and early aerial photography of the Oxnard Plain clearly show a former course of the Santa Clara River flowing through El Rio and Oxnard before entering the ocean just south of Hueneme, about six miles south of the current mouth of the river (fig 3.21; Fairchild Aerial Surveys 1927, Clahan 2003). This inactive, meandering channel was mapped by Parsons (2004); he termed it the Saviers paleochannel and identified it as the former course of the Santa Clara River.

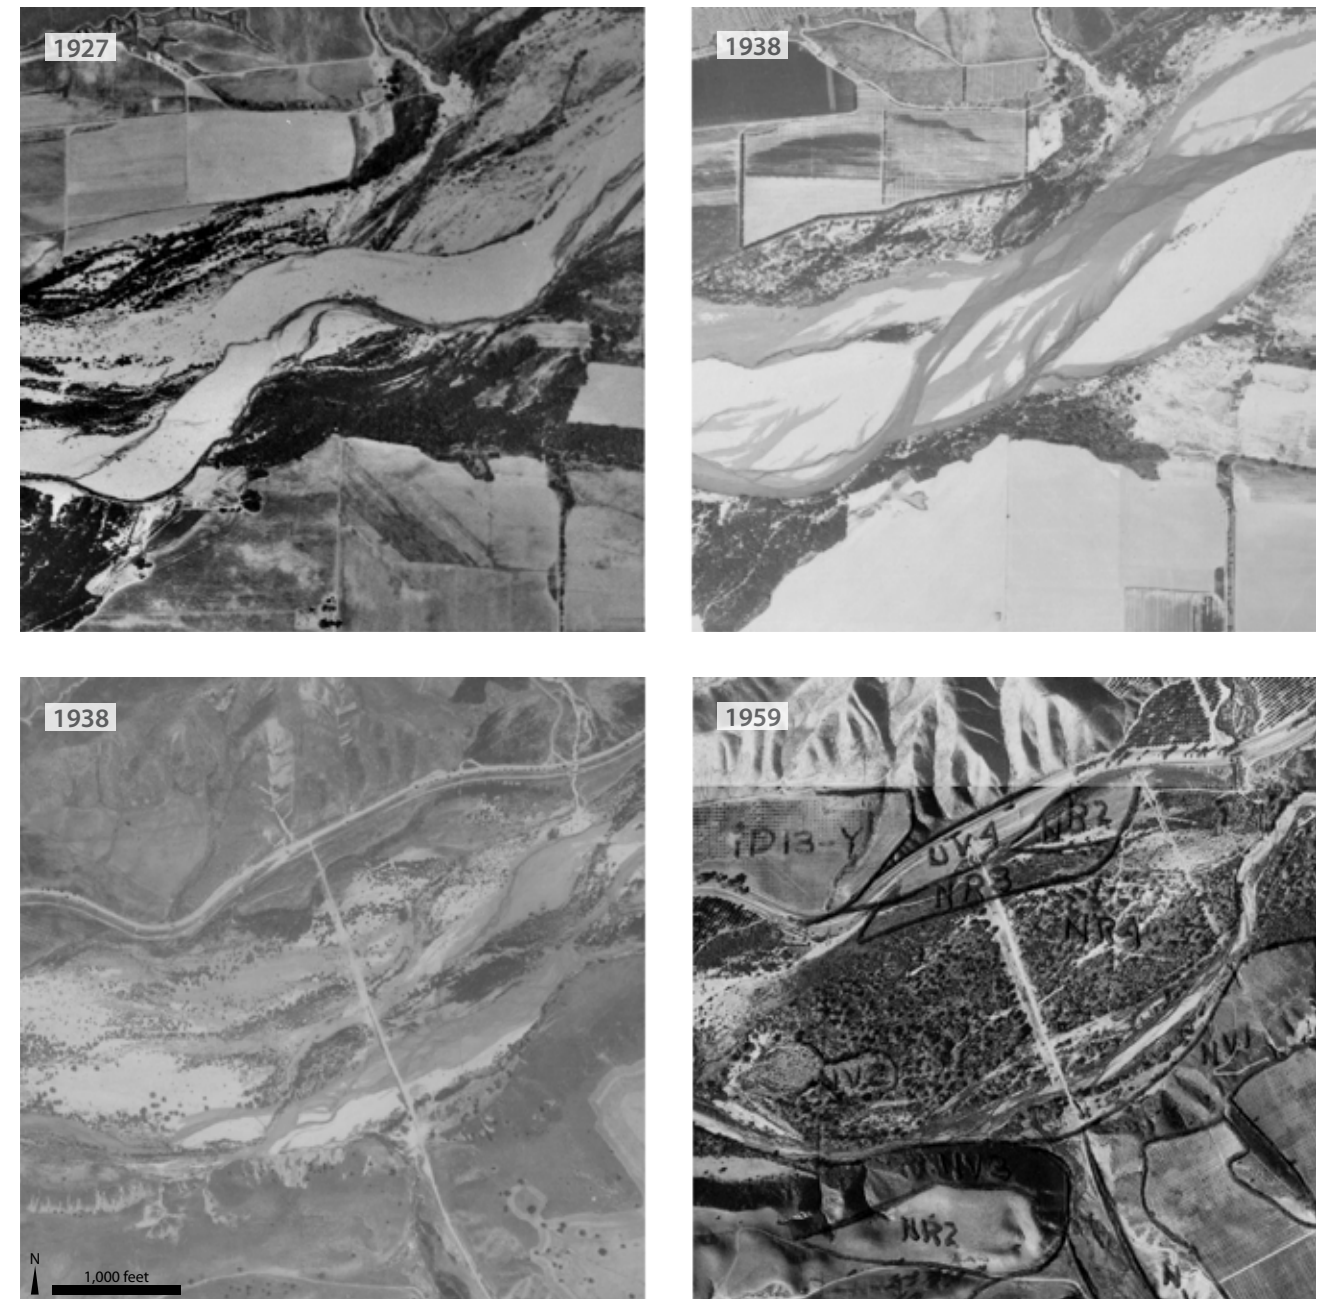
Fig. 3.22. Decadal-scale shifts in in-channel riparian vegetation and channel form. Major floods reworked the active channel and floodplain, creating new channel and vegetation patterns. Top images: Santa Clara River east of Santa Paula, 1927 and 1938. Bottom images: The river east of the Los Angeles County line, 1938 and 1959. (Fairchild Aerial Surveys 1927, courtesy of Whittier College; USDA 1938, courtesy of Ventura County; USDA 1959, California State University Northridge, Map Library)

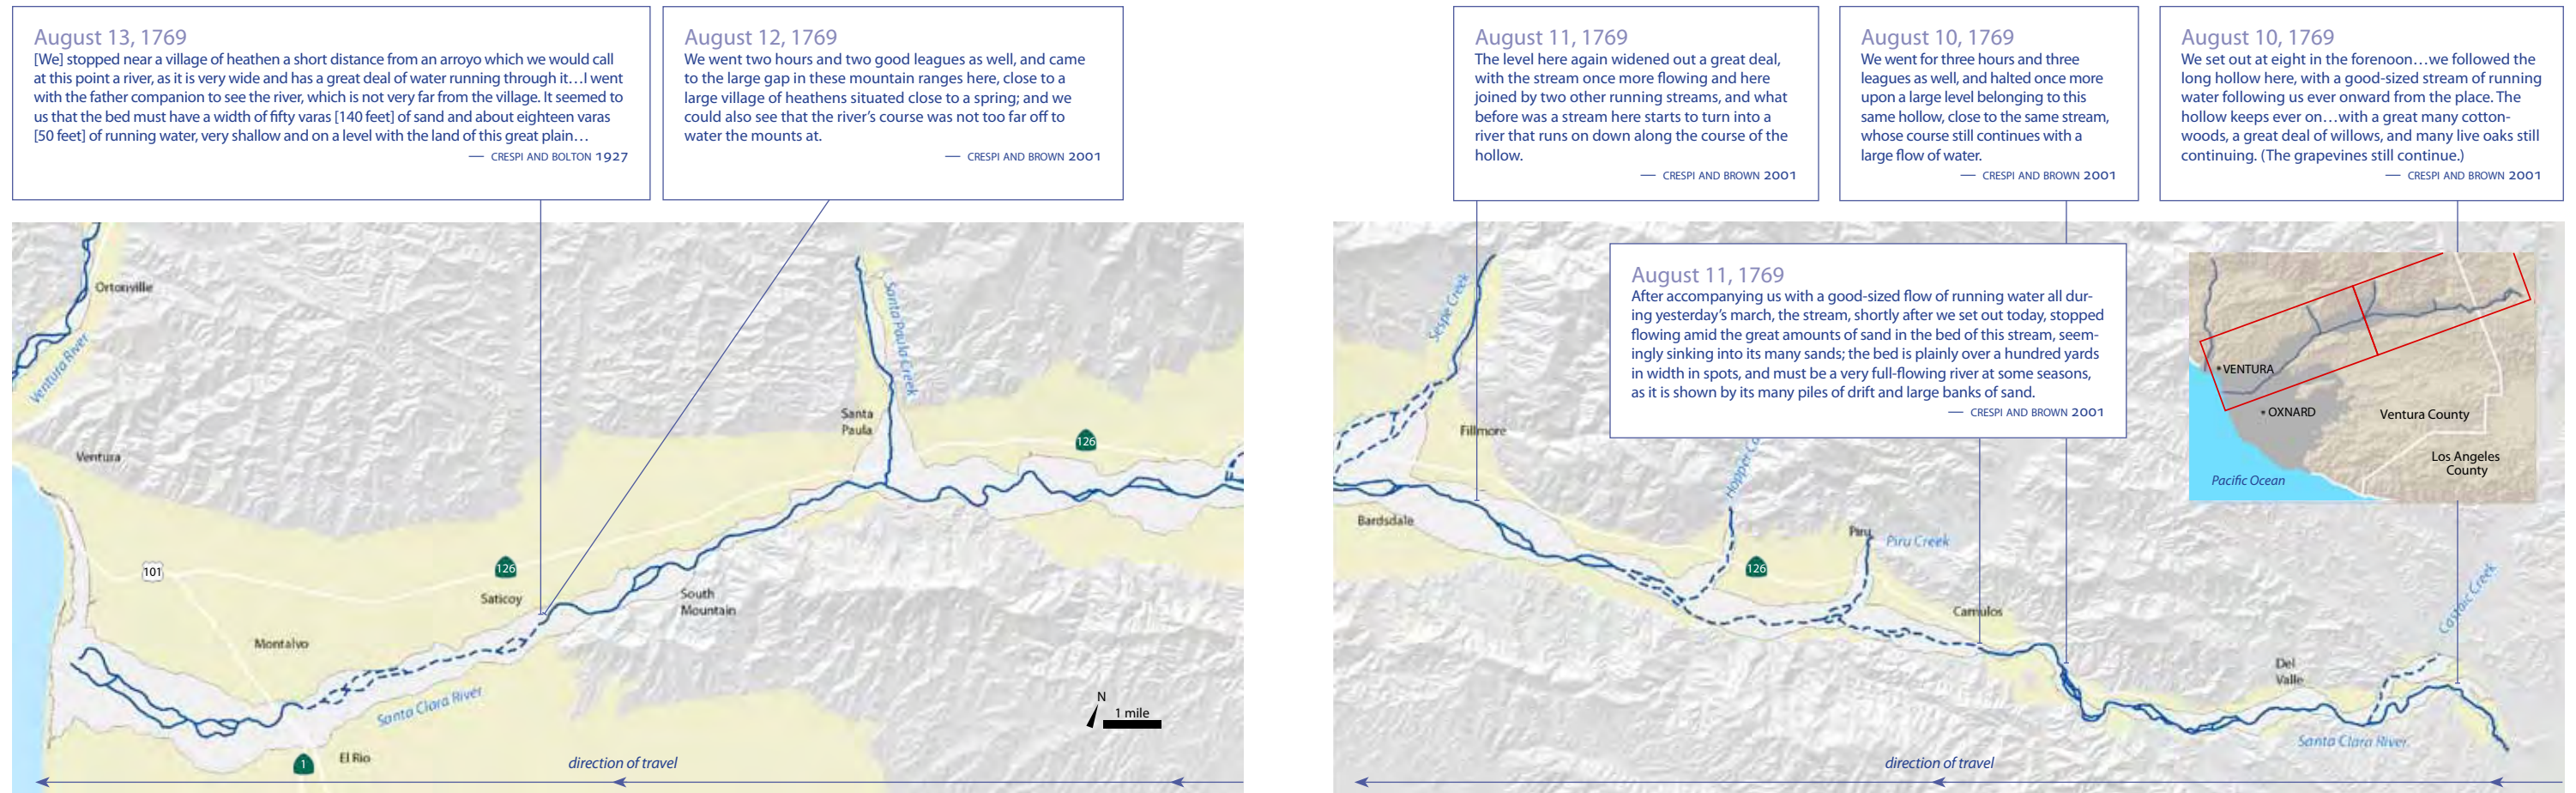
Fig. 3.23. Crespi’s River, August 1769. The Santa Clara River exhibited a pattern of alternating reaches of perennial and intermittent summer flow, as depicted below (dashed reaches are intermittent). These patterns were recorded in the observations of Spanish explorer Juan Crespi, travelling downstream along the river from August 10-13, 1769. Though Crespi’s observations cannot all be placed precisely, they provide detailed, early observations of flow patterns on the river.

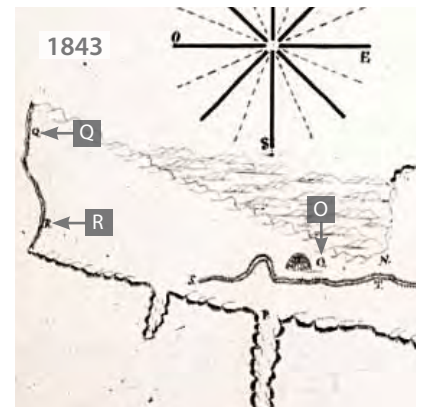
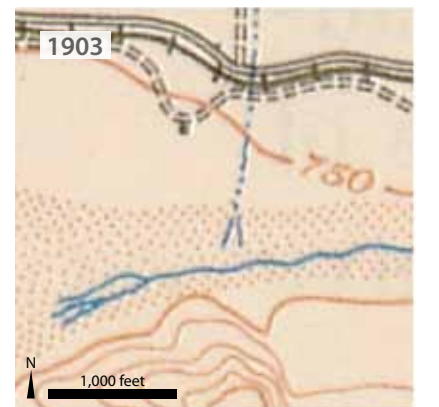
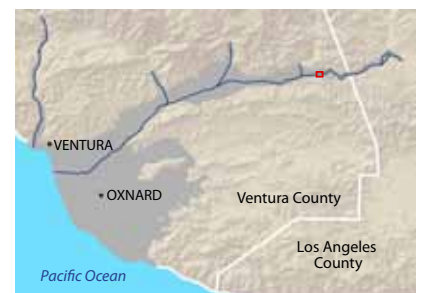
Fig. 3.24. An early diseño (top) shows the Santa Clara River—which it calls the "Arroyo de la Soledad"—stopping abruptly before reaching Piru Creek (labeled on the diseño as "Q-R"). This corresponds to the well documented location of the loss of summer surface flow in this reach, near Camulos (which is labeled with a small hut and "O" on the diseño). A historical USGS quad (bottom) shows the loss of flow in the same location, around sixty years later. (Unknown ca. 1843, courtesy of John Johnson and Santa Clarita Valley History; USGS 1903b, courtesy of the CSU Northridge Map Library)

USGS topographic quad from 1903 [Santa Susana], which shows a solid blue line in the sandy bed of the Santa Clara River (the conventional USGS symbol for a permanent stream) from west of Saugus to ½ mile east of Camulos, where a forked distributary represents the stream sinking into its sandy bed (fig. 3.24).

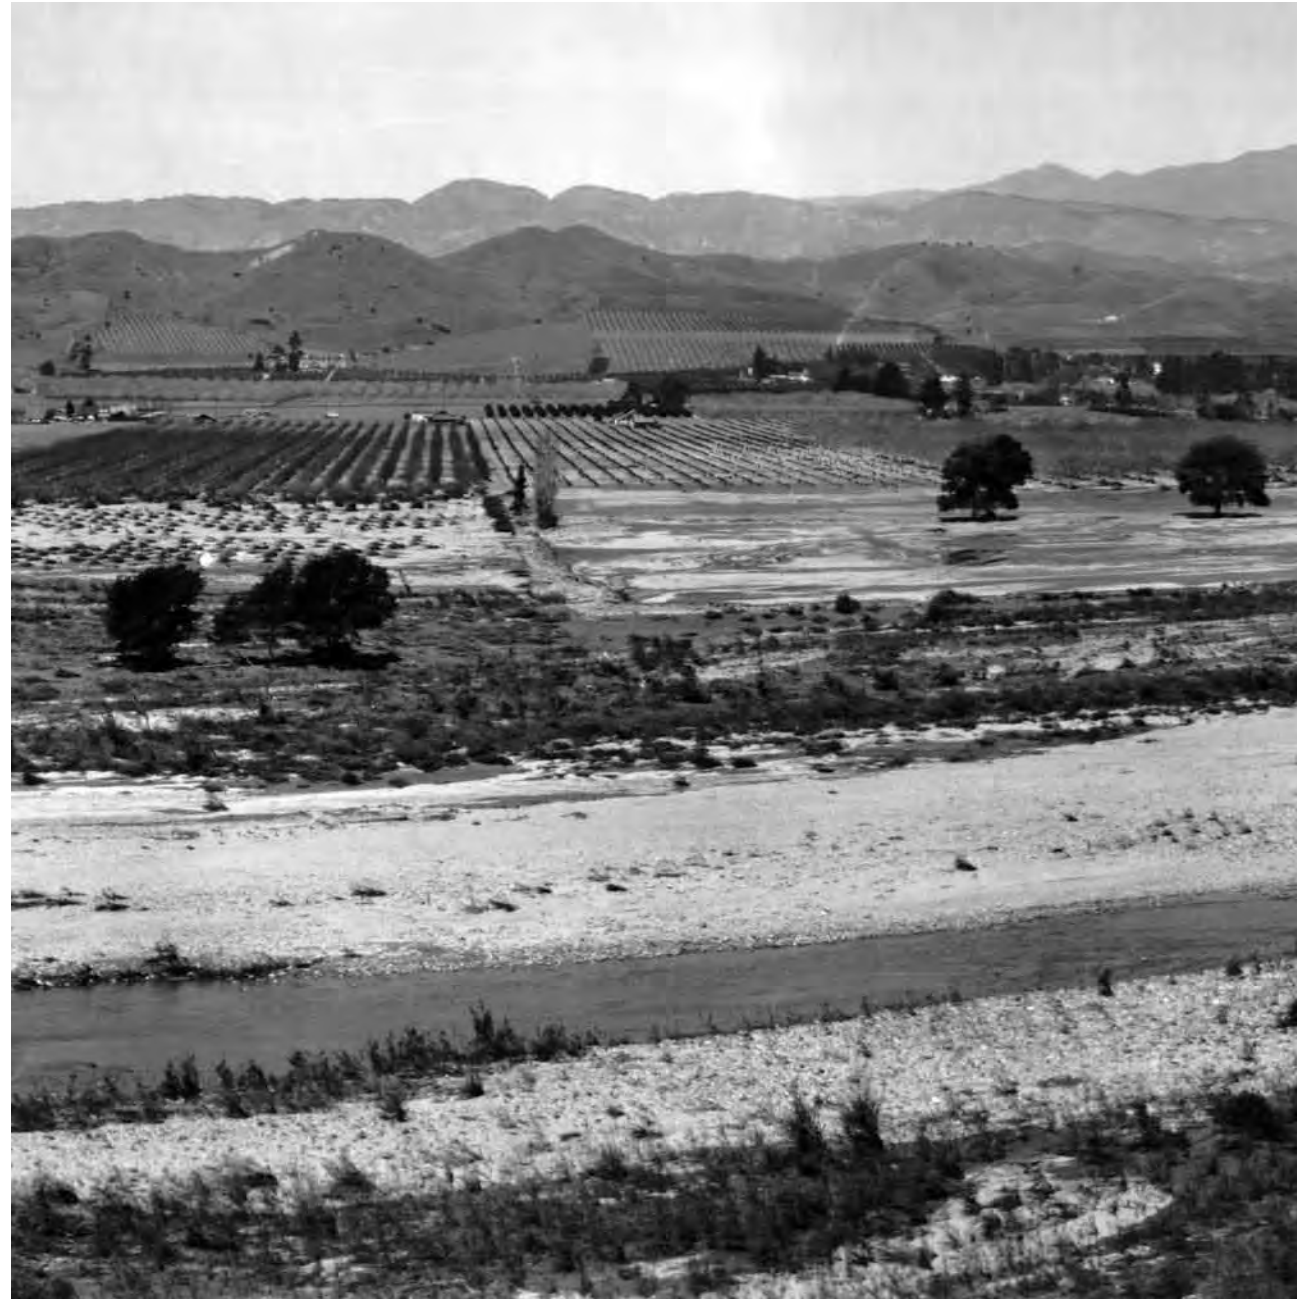
Fig. 3.25. This image of the Santa Clara River west of Santa Paula was taken on March 17, 1928—only five days after the St. Francis Dam break swept through the Santa Clara River valley. The recent presence of high flows is evident in the low vegetation along the river, which is bent downstream in the direction of flow. Even after such a large event, riparian patterns are evident: live oaks are seen bordering the river, while the bottomland surfaces are dominated by low scrub. The active channel is largely unvegetated, having been recently scoured by the flood. (Isensee 1928b, courtesy of the Museum of Ventura County)
