HISTORICAL ECOLOGY of the lower Santa Clara River, Ventura River, and Oxnard Plain: an analysis of terrestrial, riverine, and coastal habitats

HISTORICAL ECOLOGY PROGRAM
CONTRIBUTION NO. 641 • AUGUST 2011

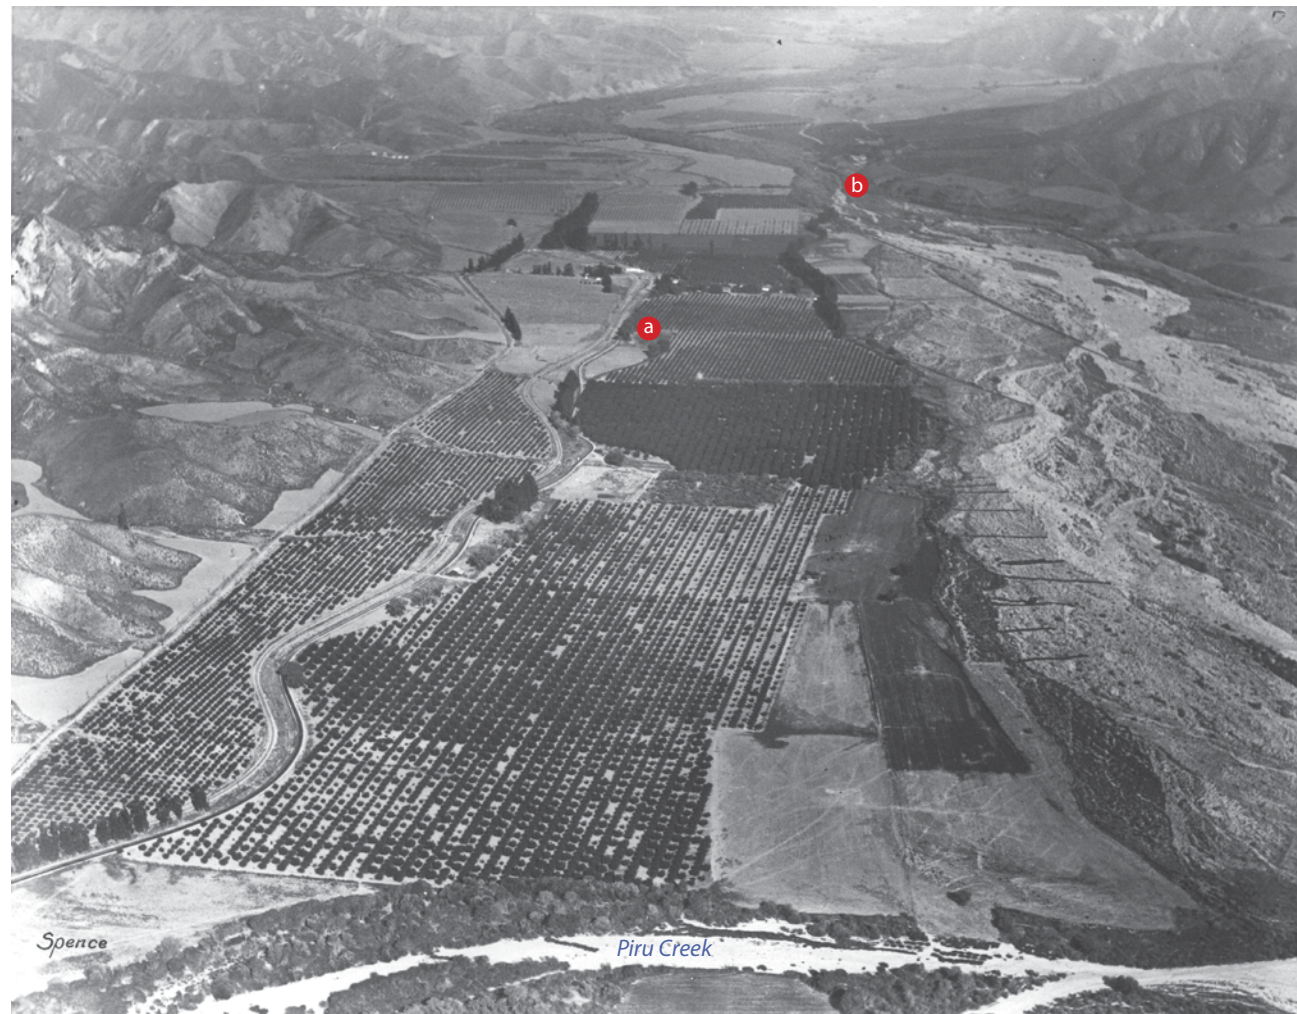
Fig. 3.26. Camulos Ranch in Piru, September 1924. Upstream of Camulos Ranch (marked **a** in the photograph), a continuous belt of riparian trees flanked the Santa Clara River. Downstream of the ranch, the river widened considerably; forest disappeared and was replaced by alluvial scrub and riverwash **b**. This ecological transition also marked a hydrologic one: the location of disappearance of summer surface water on the river. Piru Creek can be seen in the foreground. (Spence 1924, courtesy of Benjamin and Gladys Thomas Air Photo Archives, Spence and Fairchild Collections, UCLA, Department of Geography)

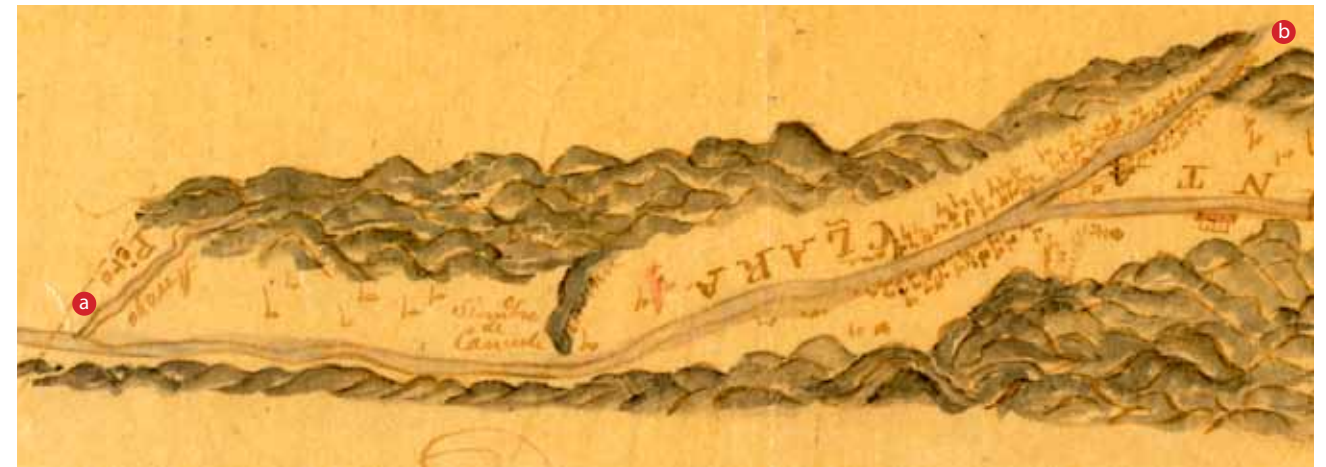
Fig. 3.27. This diseño captures a similar pattern of discontinuous riparian forest (shown here as closely spaced, small, circular trees) east of Piru Creek at **a**. Though the location of this transition is highly generalized, it is shown here east of Camulos and extending up what is likely Castaic Creek **b** in Los Angeles County. (U.S. District Court ca. 1840c, courtesy of The Bancroft Library, UC Berkeley)

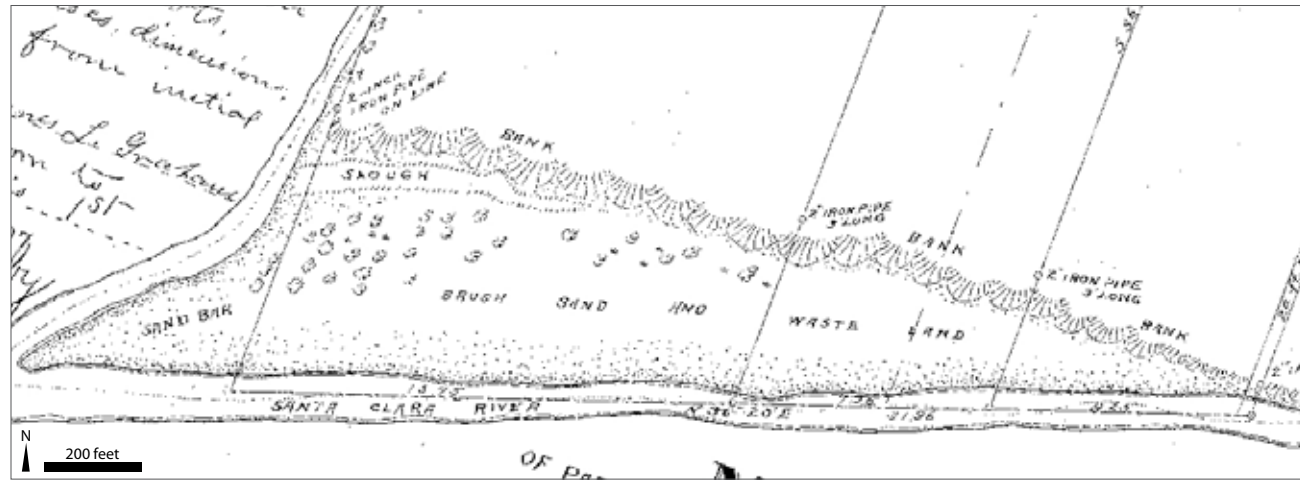
Figure 3.28. This 1897 map shows the variety of habitats found within the clearly delineated banks of the Santa Clara River, including a slough, “brush sand and waste land” with scattered willows, and a sand bar. Adams Barranca can be seen joining the river at left. (Orcutt 1897, courtesy of the Ventura County Surveyor’s Office)

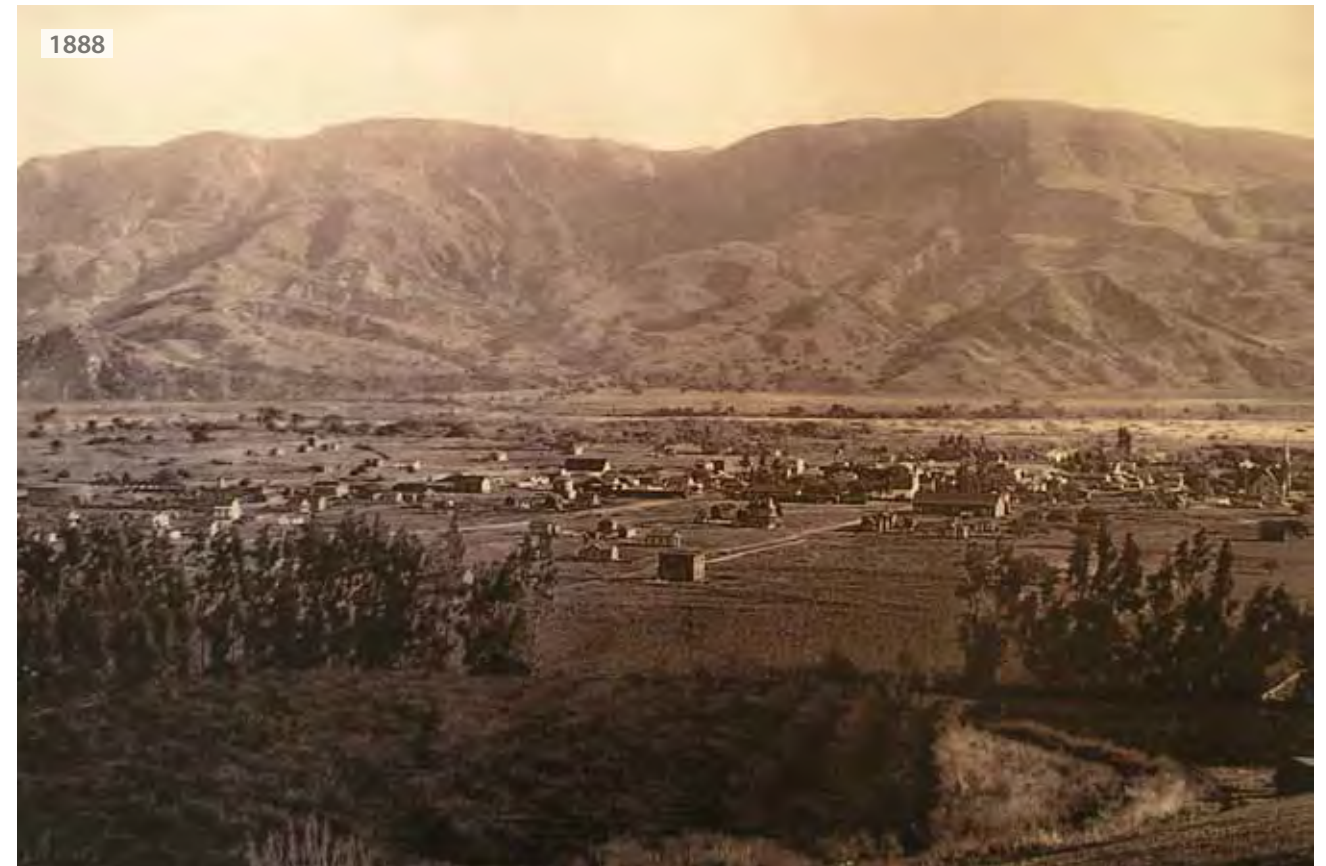
Fig. 3.29. A view of the river corridor south of Santa Paula (top) looking south toward South Mountain, 1888. The sparsely vegetated active channel can be seen behind the town of Santa Paula, with strips of dense riparian vegetation on bottomlands along both sides of the river. (Unknown 1888; courtesy of the Santa Paula Historical Society)

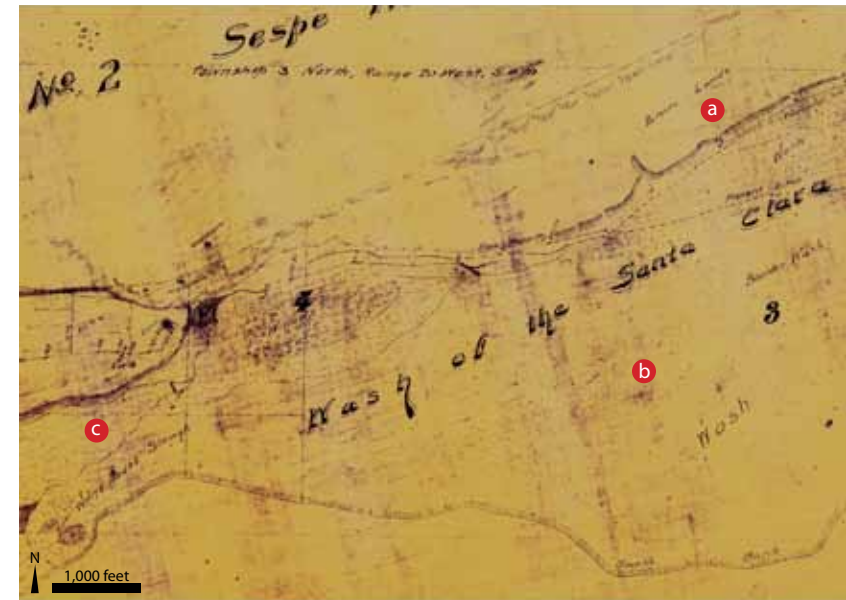
Fig. 3.31. This portion of a map showing the river immediately downstream of the confluence with the Sespe shows “Bottom Lands” **a** sitting above a break in slope, at a higher elevation than the “Wash” of the Santa Clara River **b**. Ponds and a slough (the upstream end of East Grove, **c**) and willows are also noted. (Stocker 1894, courtesy of the Museum of Ventura County)

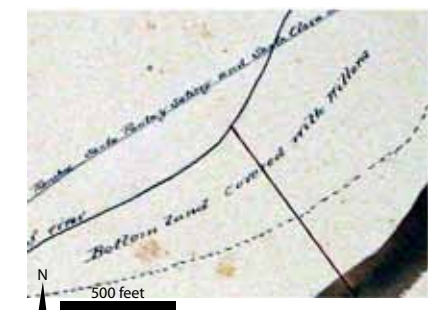
Fig. 3.32. Above the Highway 101 bridge, “bottom land covered with willows” was found on the protected bars at curves in the river. (Barry 1893, courtesy of the Ventura County Surveyor’s Office)

Willow trees and scrub were historically widespread along the Santa Clara River. Many maps show willows growing on what are apparently islands, side bars on the margin of the active channel, or higher benches within the banks of the river (e.g., Craven 1874h, Barry 1892b, Barry 1893, Stocker 1894, Barry 1898, Everett 1907, Unknown 1911). On these maps, willows are labeled as “heavy willow and cottonwood brush,” “willow brush,” “willow land,” and simply as “willows” (Barry 1892b, Barry 1893, Stocker 1894, Waud ca. 1899, Waud 1916; fig. 3.32).

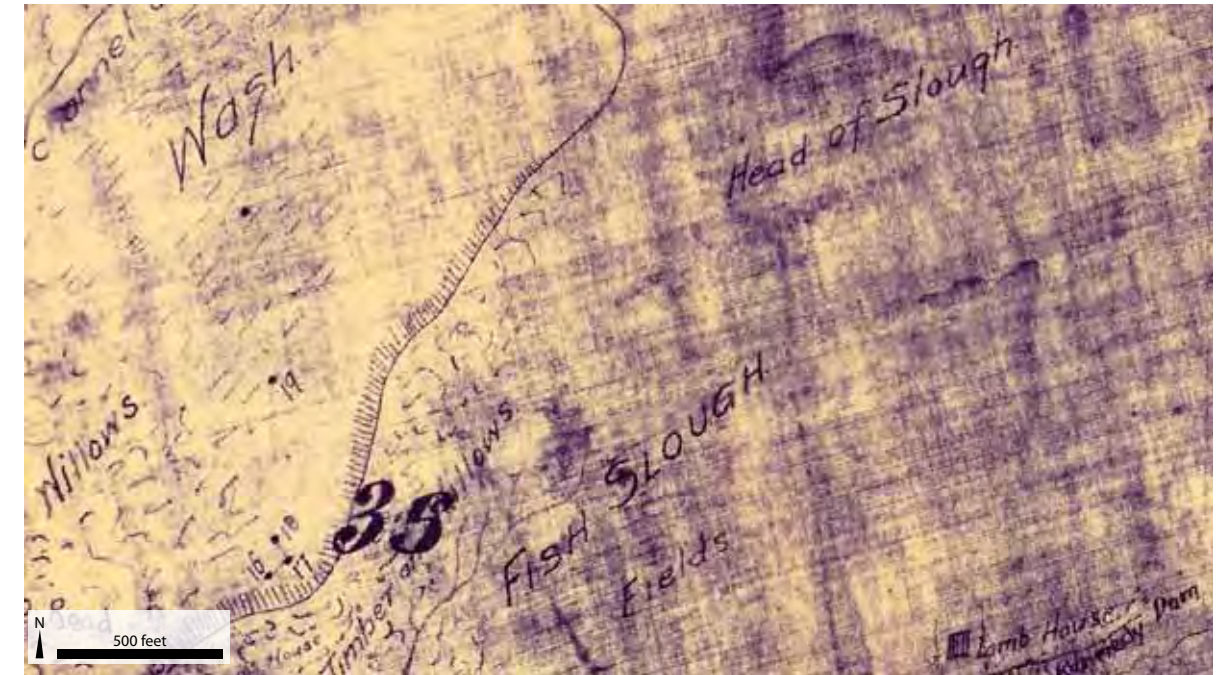
Fig. 3.33. Fish Slough complex, 1894. This map of the Santa Clara River-Sespe confluence shows the whole length of Fish Slough, extending about half a mile upstream on Sespe Creek. (Stocker 1894, courtesy of the Museum of Ventura County)

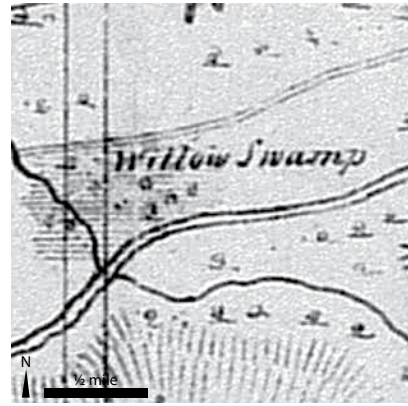
Fig. 3.34. Detail of a “willow swamp” at the confluence of Santa Paula Creek and the Santa Clara River. Though the map is coarse, this appears to be an early representation of East Grove. The cartographer also drew a “swamp” on the Santa Clara River east of Sespe Creek (the Cienega, not shown here). (Unknown ca. 1860, courtesy of The Bancroft Library, UC Berkeley)

In addition to the array of bottomland habitats described above, large areas of freshwater wetland and willow-cottonwood riparian forest were also documented on bottomlands along the river. These habitats, which we call “persistent wetland riparian areas,” were found in perennial reaches of the Santa Clara River and occupied bottomland surfaces that were less frequently disturbed by flooding than other in-channel habitats. Because of the abundance of water and timber, they were often significant cultural areas, and as a result are often well documented in the historical record (fig. 3.34).

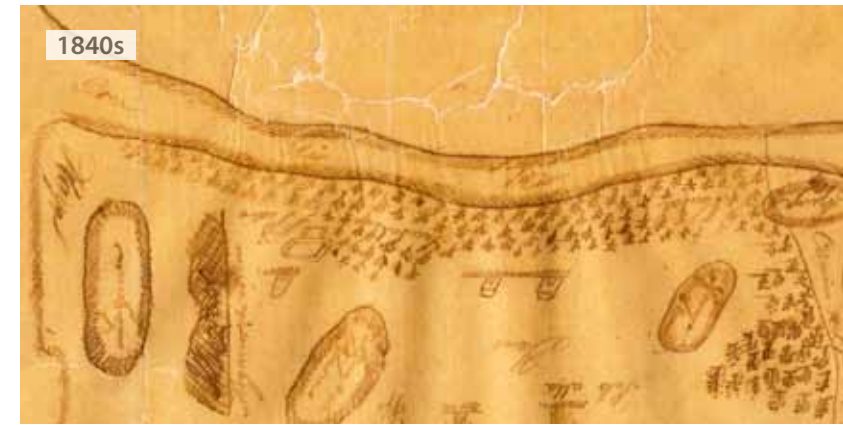
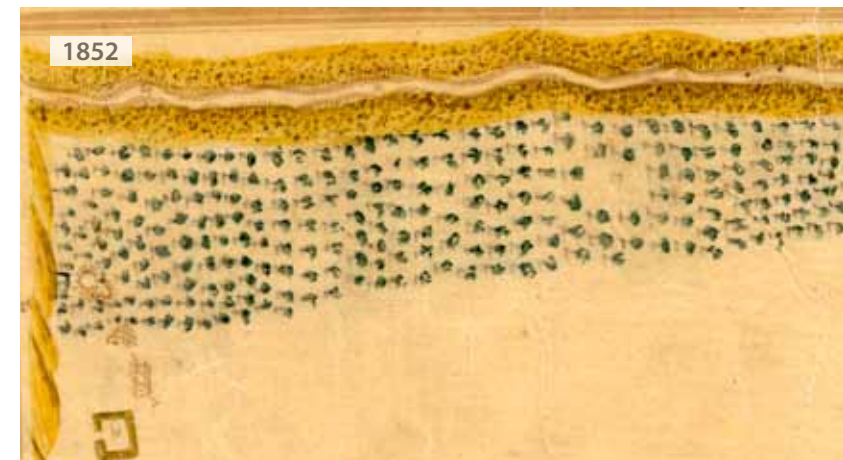
Fig. 3.35. Riparian forest (West Grove) on the lower Santa Clara River, 1840-1852. An early map (top, 1840s) shows extensive riparian willows (labeled *sausal*) along the south side of the river, extending beyond and along the camino (now Highway 101). About a decade later (1852), the grove is still a major landmark on the south side of the river (bottom). (U.S. District Court ca. 1840e, Ardisson 1852; courtesy of The Bancroft Library, UC Berkeley)

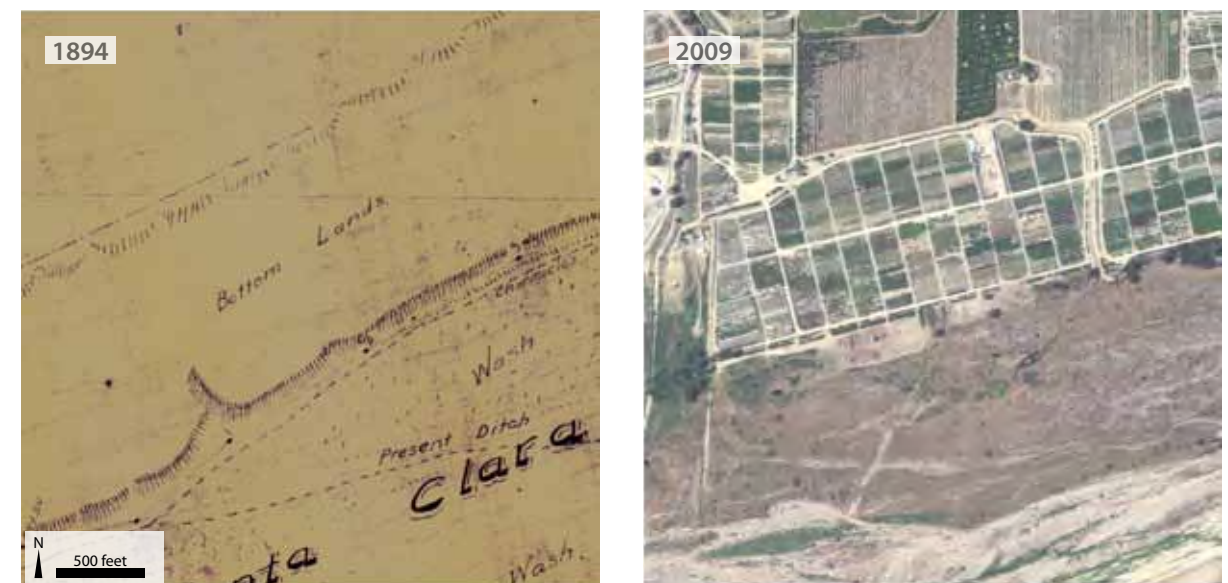
Fig. 3.36. This bottomland surface west of the Sespe Creek confluence remained uncultivated in the late 19th century, as shown here in this 1894 map (left). By 1938, the surface had been converted to mostly walnut, orange, and lemon orchards. The area is still farmed today (right). (Stocker 1894, courtesy of the Museum of Ventura County; USDA 2009)

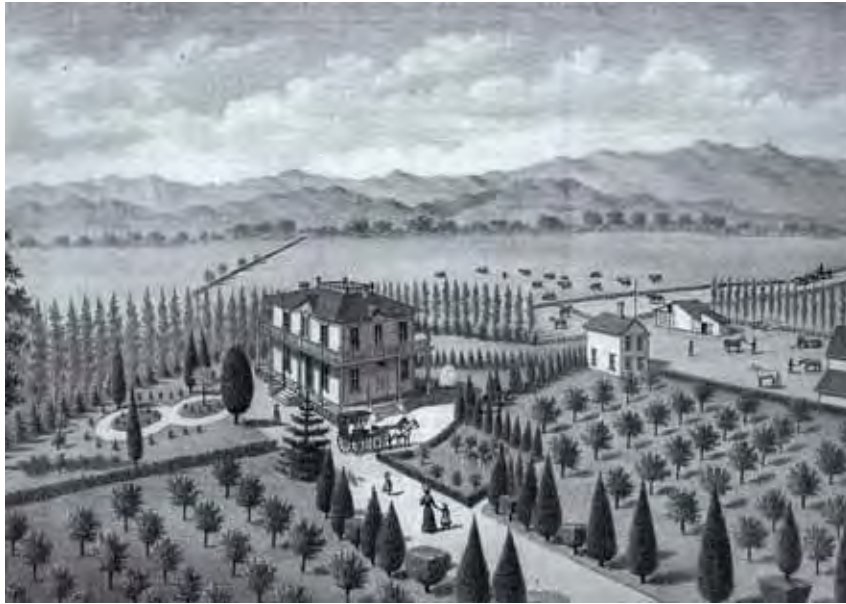
Fig. 3.37. John Scarlett's ranch abutted the south bank of the Santa Clara River, just east of McGrath's oceanfront property. Scarlett's ranch included a large portion of the forested bottomland (West Grove) along the river, as can be seen in the background in this image. The *Ventura Signal* (1879, in Hampton 2002) printed that "the Santa Clara river with its fine timber and rich bottom lands form the northern boundary; in this timber wild blackberries are found in great profusion." (Thompson and West [1883]1961)

trichocarpa; Stillwater Sciences 2007a, Orr et al. 2011). Henry Hancock (1854), surveying a GLO transect across the river and through the grove in 1854, noted discrete cottonwood groves and willow groves within the larger riparian zone (fig. 3.37).

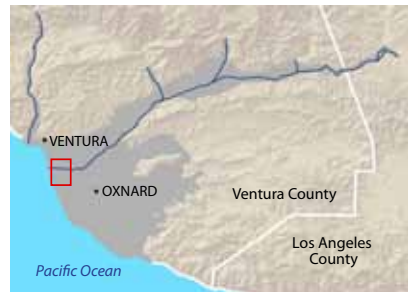
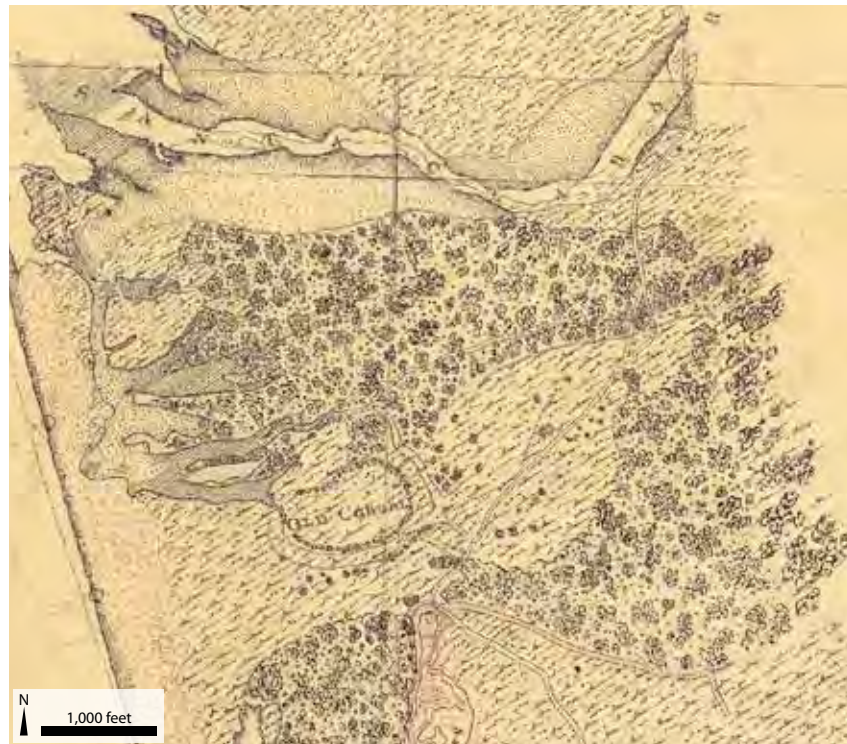
Fig. 3.38. Santa Clara River mouth, 1855. This early USCS survey shows the westernmost end of West Grove as it stood in 1855. Dense stands of trees surround an open area (including an “old corral”). Auxiliary sources describe the grove as a mix of willows, cottonwoods, and sycamores. (Johnson 1855c, courtesy of the National Oceanographic and Atmospheric Administration)

Mapping of West Grove (see page 48) was based on a few detailed sources which depicted the location and width of parts of the grove with spatial accuracy. A USCS T-sheet (Johnson 1855c; fig. 3.38) shows dense thickets approximately 3,700 feet wide at the mouth of the river, and GLO surveyors

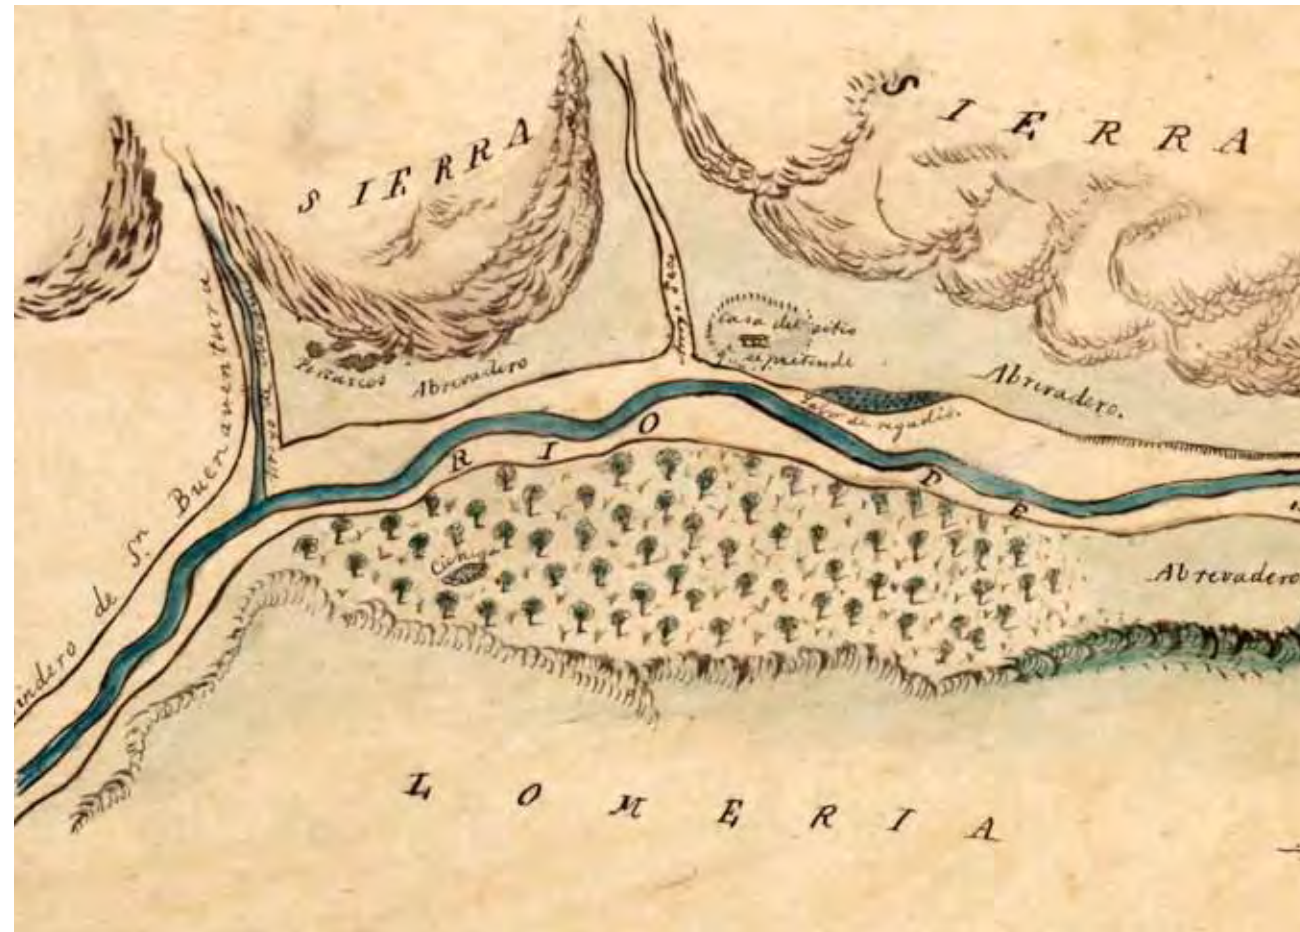
Fig. 3.39. This early map shows a number of in-channel features along the Santa Clara River, including an extensive forest south of the channel with a smaller *ciénega* (marsh) amongst the trees (East Grove, east of Santa Paula Creek/Arroyo de Mupu), and another eponymous *ciénega* (the Cienega) east of Sespe Creek/Río de Sespe. A bottomland field is shown as *labor de regadío* (irrigated field). (U.S. District Court ca. 1840d, courtesy of The Bancroft Library, UC Berkeley)

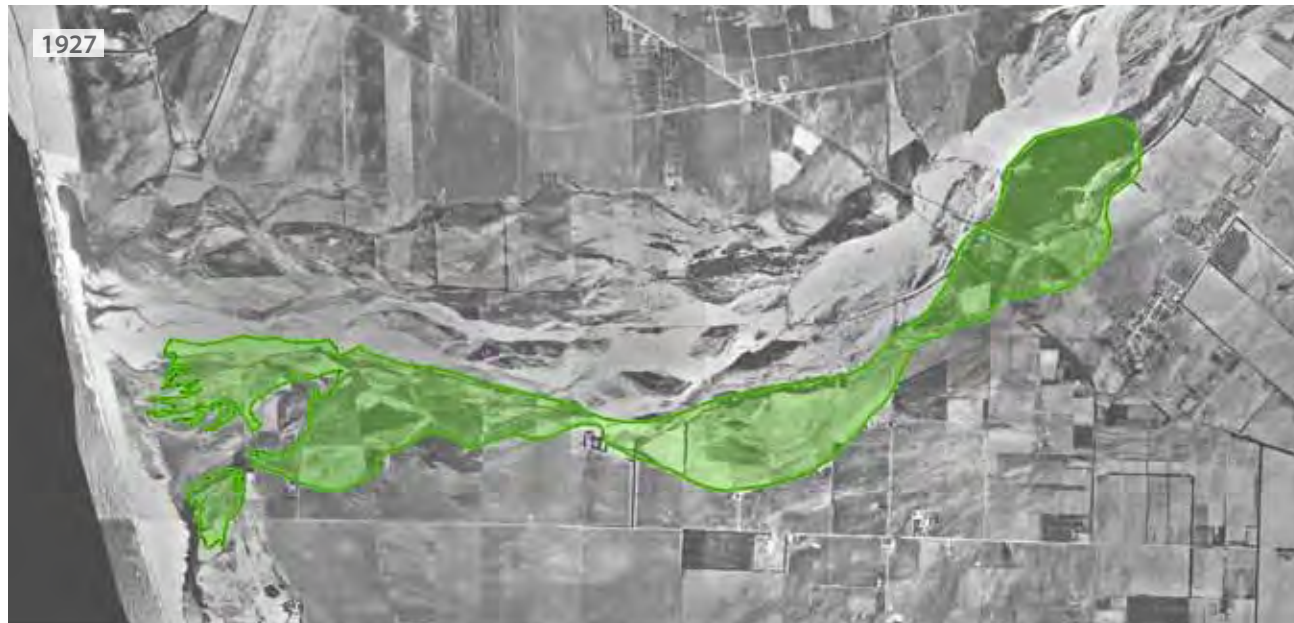
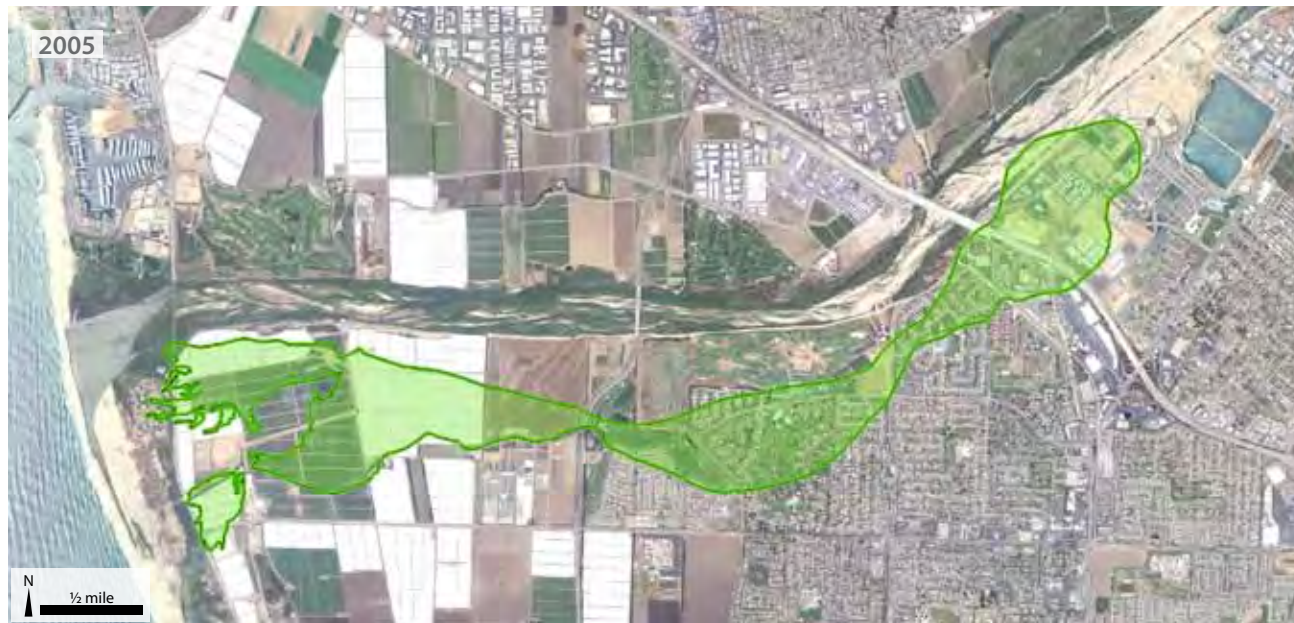
Fig. 3.41. Lower Santa Clara river, 1927 (top) and 2005 (bottom). By the 20th century, the majority of the original 1,200 acres of forest along the southern side of the Santa Clara River had disappeared. (Fairchild Aerial Surveys 1927, courtesy of Whittier College; USDA 2005)

While the forest had mostly disappeared by 1927, the outline of the low-disturbance bottomland is still visible on an aerial image. By 2005, nearly all traces of the forested area had disappeared into farmland, housing, a landfill, and golf course, and the area had been largely cut off from the river by a levee built by the Army Corps of Engineers in 1961 (Stillwater Sciences 2007b; see fig. 3.41).

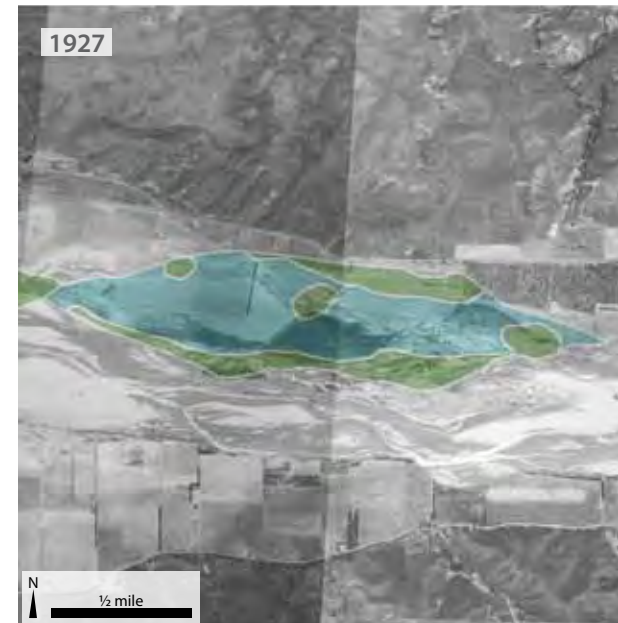
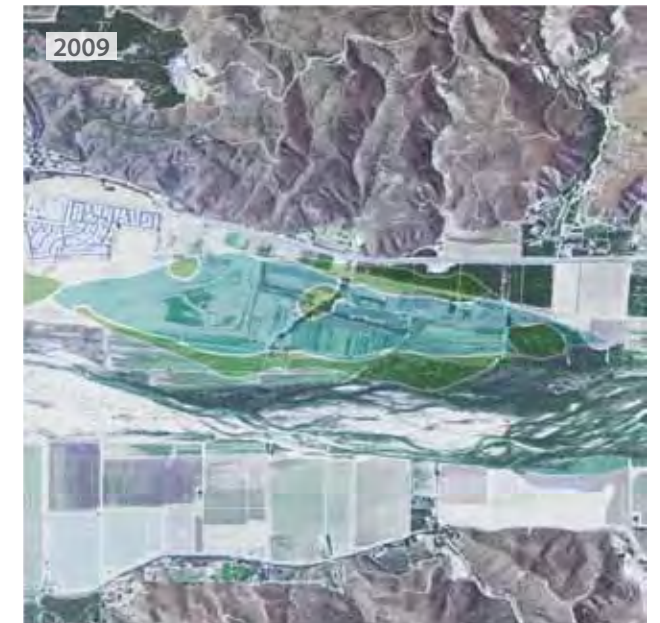
Fig. 3.42. Cienega, 1927 (left) and 2009 (right). As early as 1927, most of the original extent of the Cienega had been cleared. The former Cienega site is now the location of the Fillmore Fish Hatchery and crops tolerant of high groundwater conditions (e.g., watercress). Very little of the original Cienega extent remains, though substantial forest is found in the river corridor to the south. (Fairchild Aerial Surveys 1927, courtesy of Whittier College; USDA 2009)

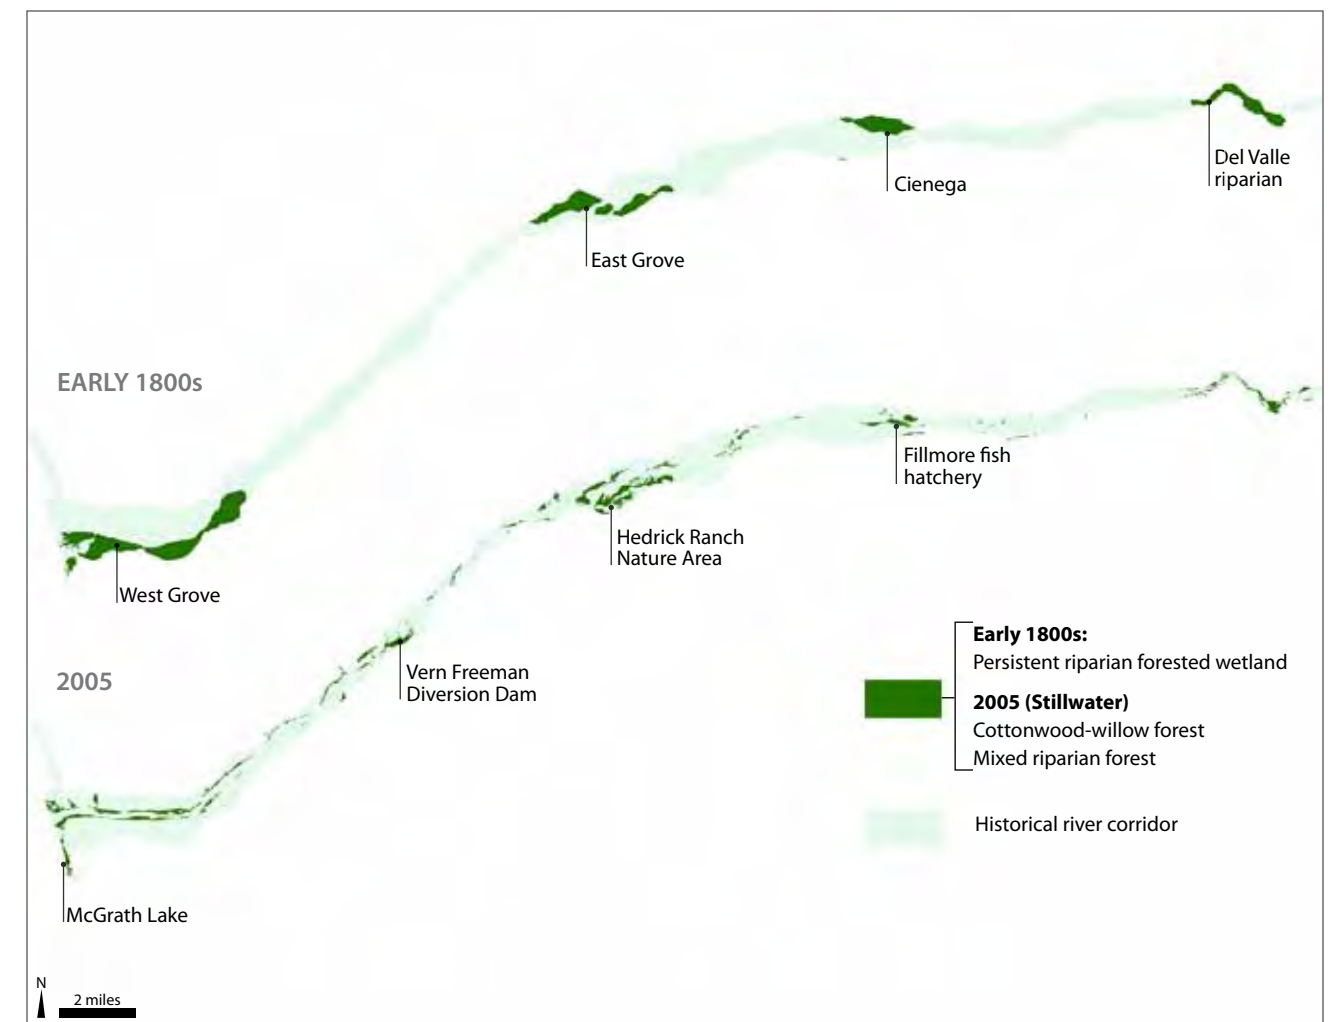
Fig. 3.43. Distribution of riparian forest on the Santa Clara River, early 1800s and 2005. The current (2005) distribution of mixed riparian and cottonwood-willow forest on the Santa Clara River closely mirrors the former distribution patterns of similar habitats in “nodes” along the river. Though the extent of these habitats has been sharply reduced, the persistence of these nodes over the past 200 years suggests relatively intact groundwater patterns and the potential for additional recovery.

Longitudinally across different reaches of a semi-arid river, heterogeneous hydrology (in particular, presence of summer surface flow and depth to groundwater) can drive corresponding patterns of riparian vegetation (Tabacchi et al. 1996, Sandercock et al. 2007, Stillwater Sciences 2007a). This interaction between stream seasonality and vegetation can be clearly seen on the Santa Clara River, where the presence of mature willow-cottonwood riparian forest corresponds with perennial flow. This is what Sandercock et al. call “abrupt changes in patterns of riparian vegetation” along a longitudinal gradient. Similar patterns are still visible on the river today, though the extent of native riparian forest has been drastically reduced (Stillwater Sciences 2007a, Stillwater Sciences and URS Corporation 2007, Orr et al. 2011; see fig. 3.43).

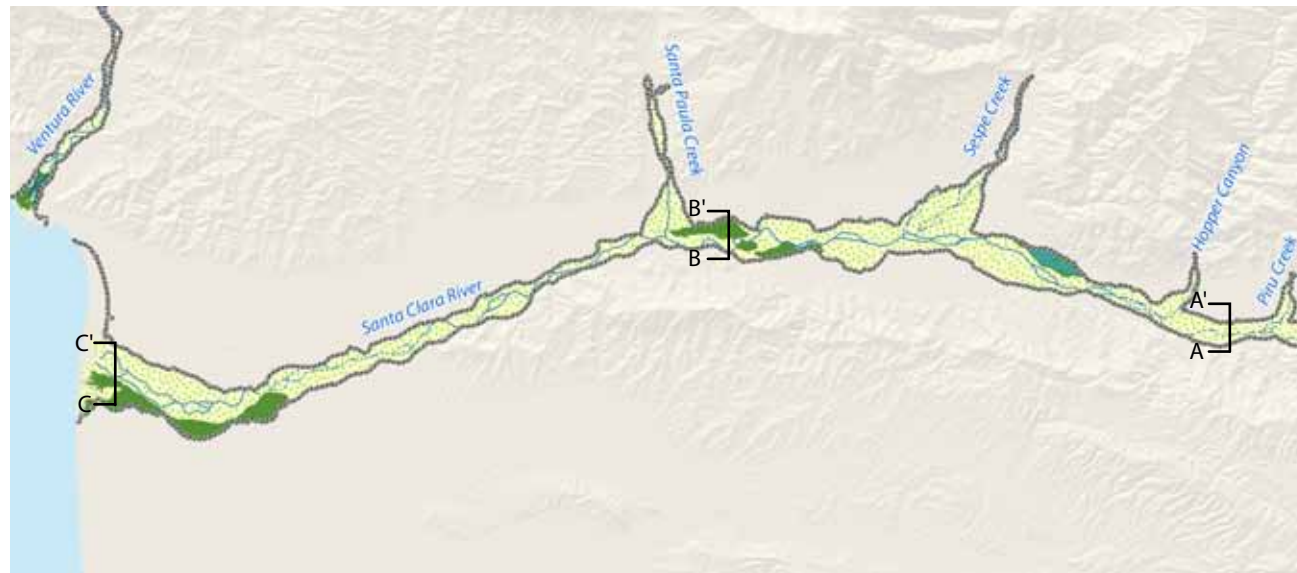
Fig. 3.44. Locations of illustrated cross sections on Santa Clara River. The easternmost reach is just downstream of the Piru confluence, and is characterized by intermittent flow and sparse, scrubby vegetation. The middle reach is just upstream of the town of Santa Paula, an area of rising groundwater historically characterized by multiple channels and marshes bounded by willow-cottonwood forests. The westernmost cross-section depicts the mouth of the river. This area has changed from a broad deltaic formation with seasonal lagoons surrounded by grasses and willow-cottonwood forest to a narrow single-thread channel with levees protecting a golf course on the north bank and agricultural operations on the south.

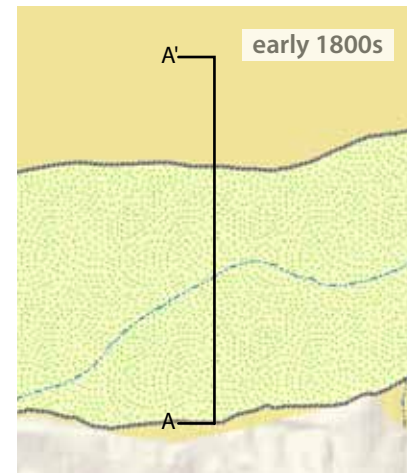
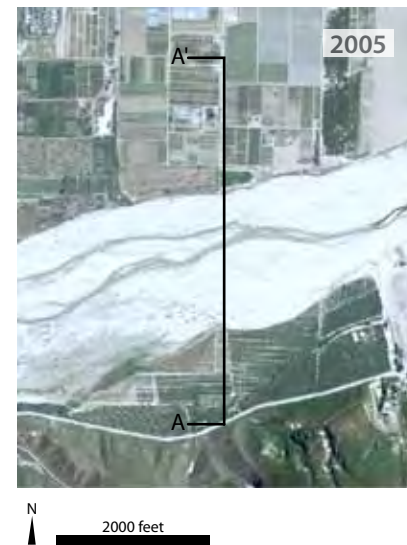
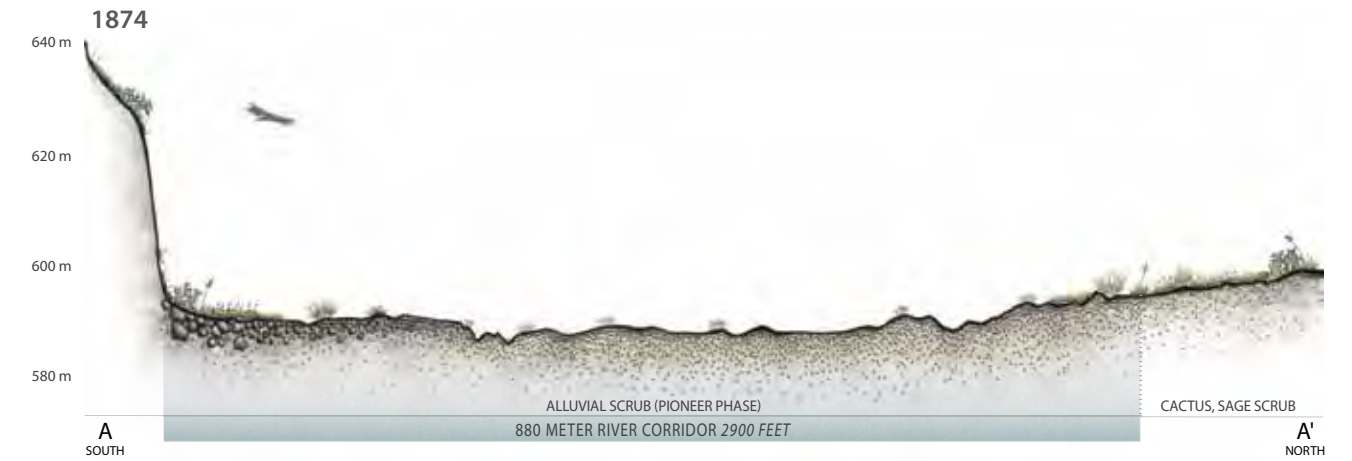
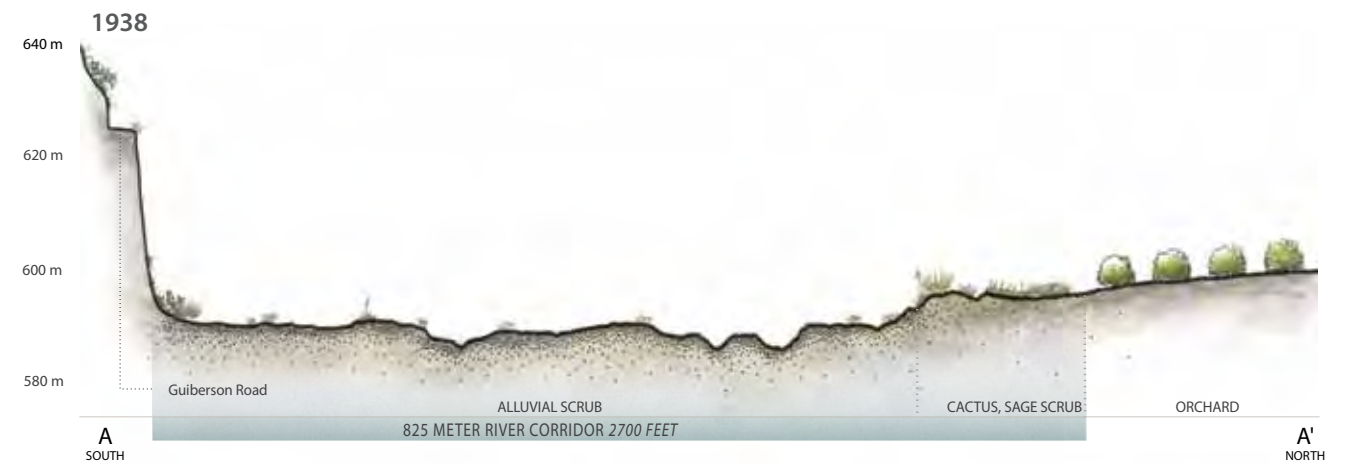
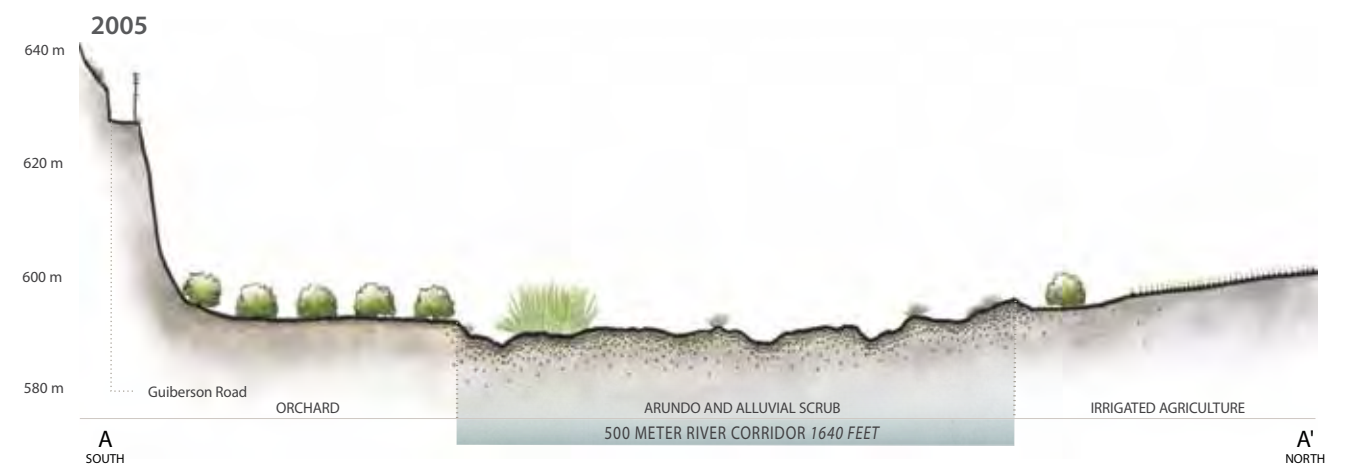
Fig. 3.45. Historical cross-sections at Piru, 1874-2005. This series shows the Santa Clara River west of Piru, between Piru Creek and Hopper Canyon. This intermittent reach was characterized by a broad active channel dominated by sand and scrub vegetation. Similar hydrology and vegetation persist today, though *Arundo* is now present and the river corridor has narrowed due to agricultural development on the floodplain. Cross-sections are drawn with 5x vertical exaggeration. (Craven 1874f; USDA 1938, courtesy of Ventura County; USDA 2005; Stillwater Sciences and URS Corporation 2007. Cross-sections produced by Jen Natali)

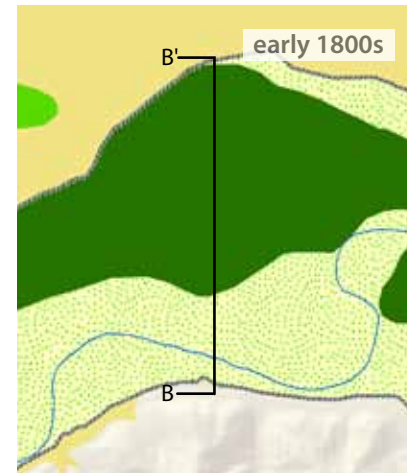
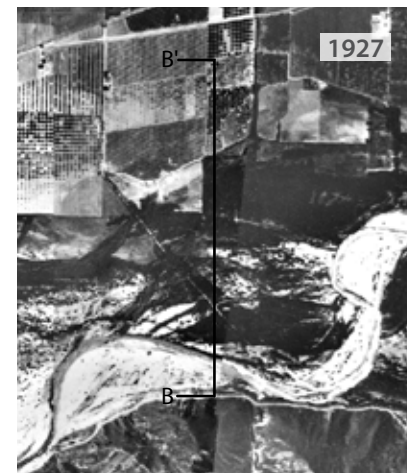
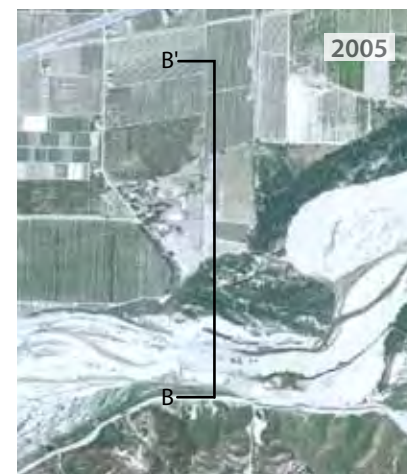
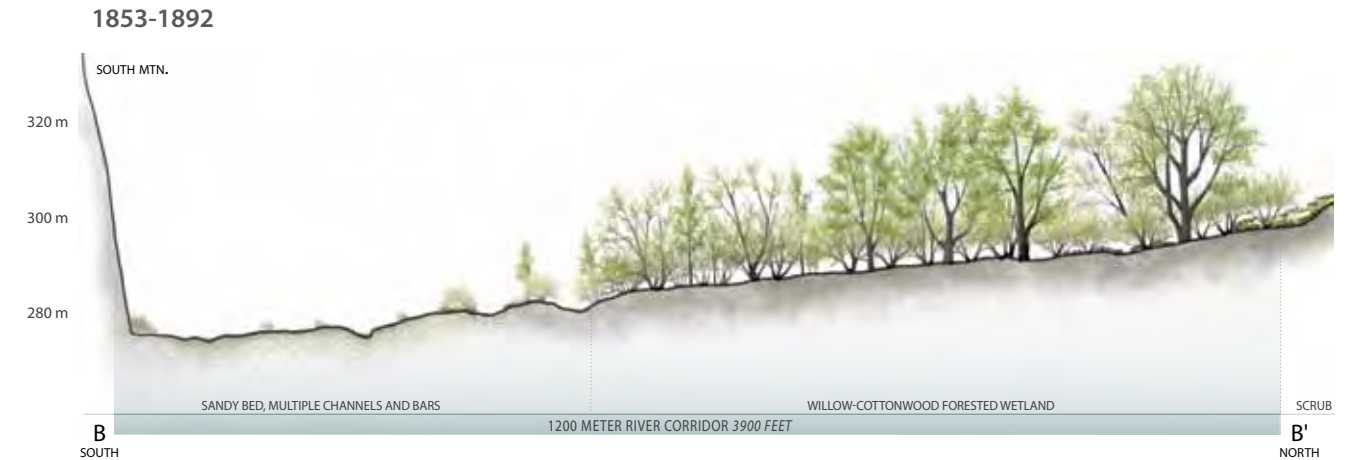
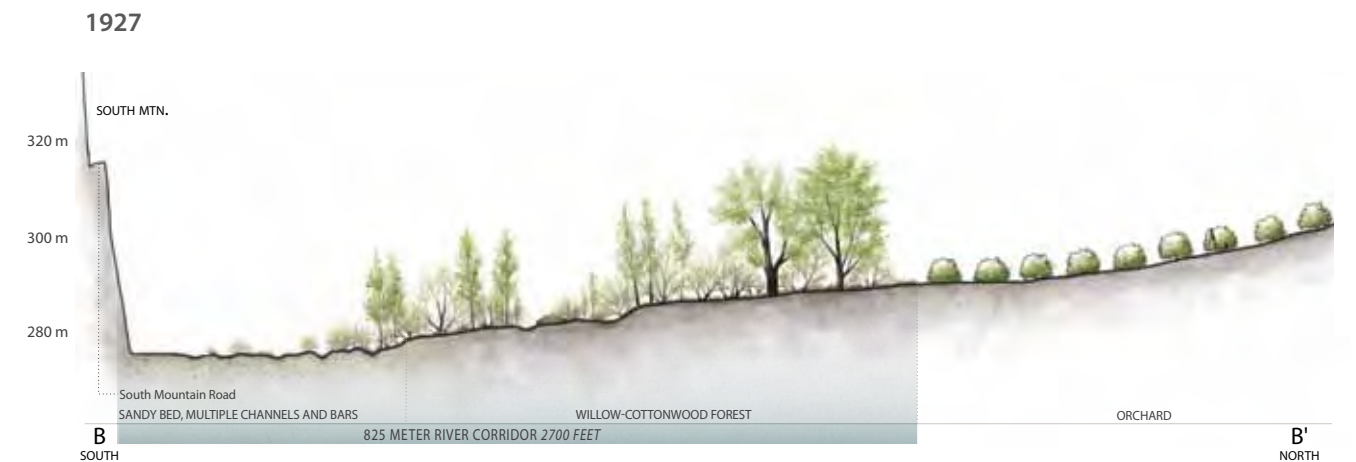
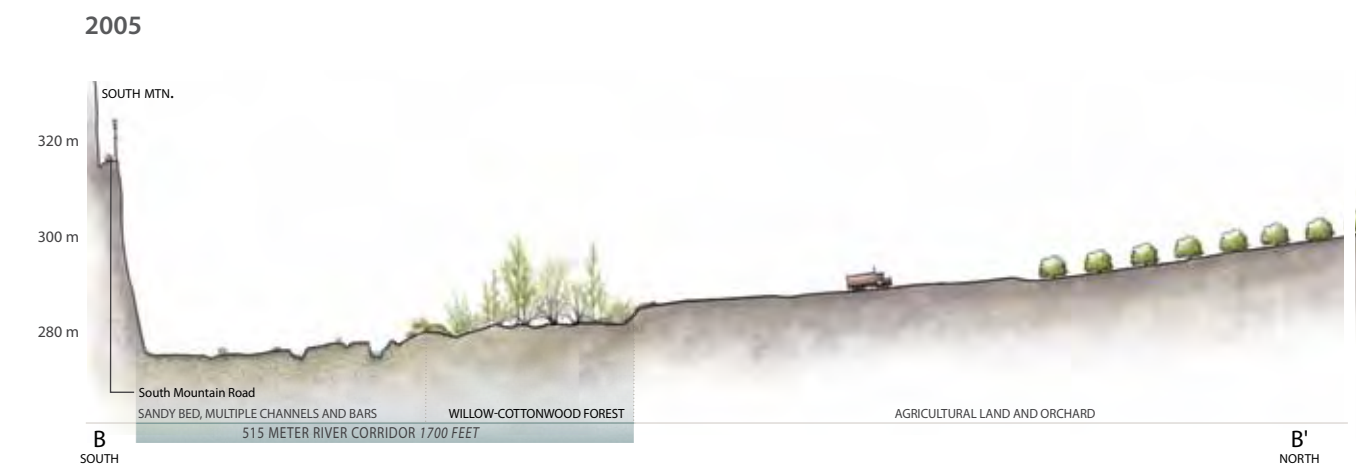
Fig. 3.46. Historical cross-sections at Santa Paula, 1853-2005. This series of cross-sections shows the Santa Clara River east of the Santa Paula Creek confluence, where the south bank of the river abuts South Mountain. The transect is in a perennial reach of rising groundwater, characterized in the 19th century by extensive willow-cottonwood forests and freshwater wetlands. Substantial willow-cottonwood forest remains in the area today, though much diminished from former extent. The earliest cross-section is derived from a composite of GLO surveys spanning the second half of the 19th century. Cross-sections are drawn with 5x vertical exaggeration. (Norris 1853; Hoffman 1868b; Thompson 1869; Barry 1892a; Fairchild Aerial Surveys 1927, courtesy of Whittier College; USDA 2005; Stillwater Sciences and URS Corporation 2007. Cross-sections produced by Jen Natali)
