HISTORICAL ECOLOGY of the lower Santa Clara River, Ventura River, and Oxnard Plain: an analysis of terrestrial, riverine, and coastal habitats

HISTORICAL ECOLOGY PROGRAM
CONTRIBUTION NO. 641 • AUGUST 2011

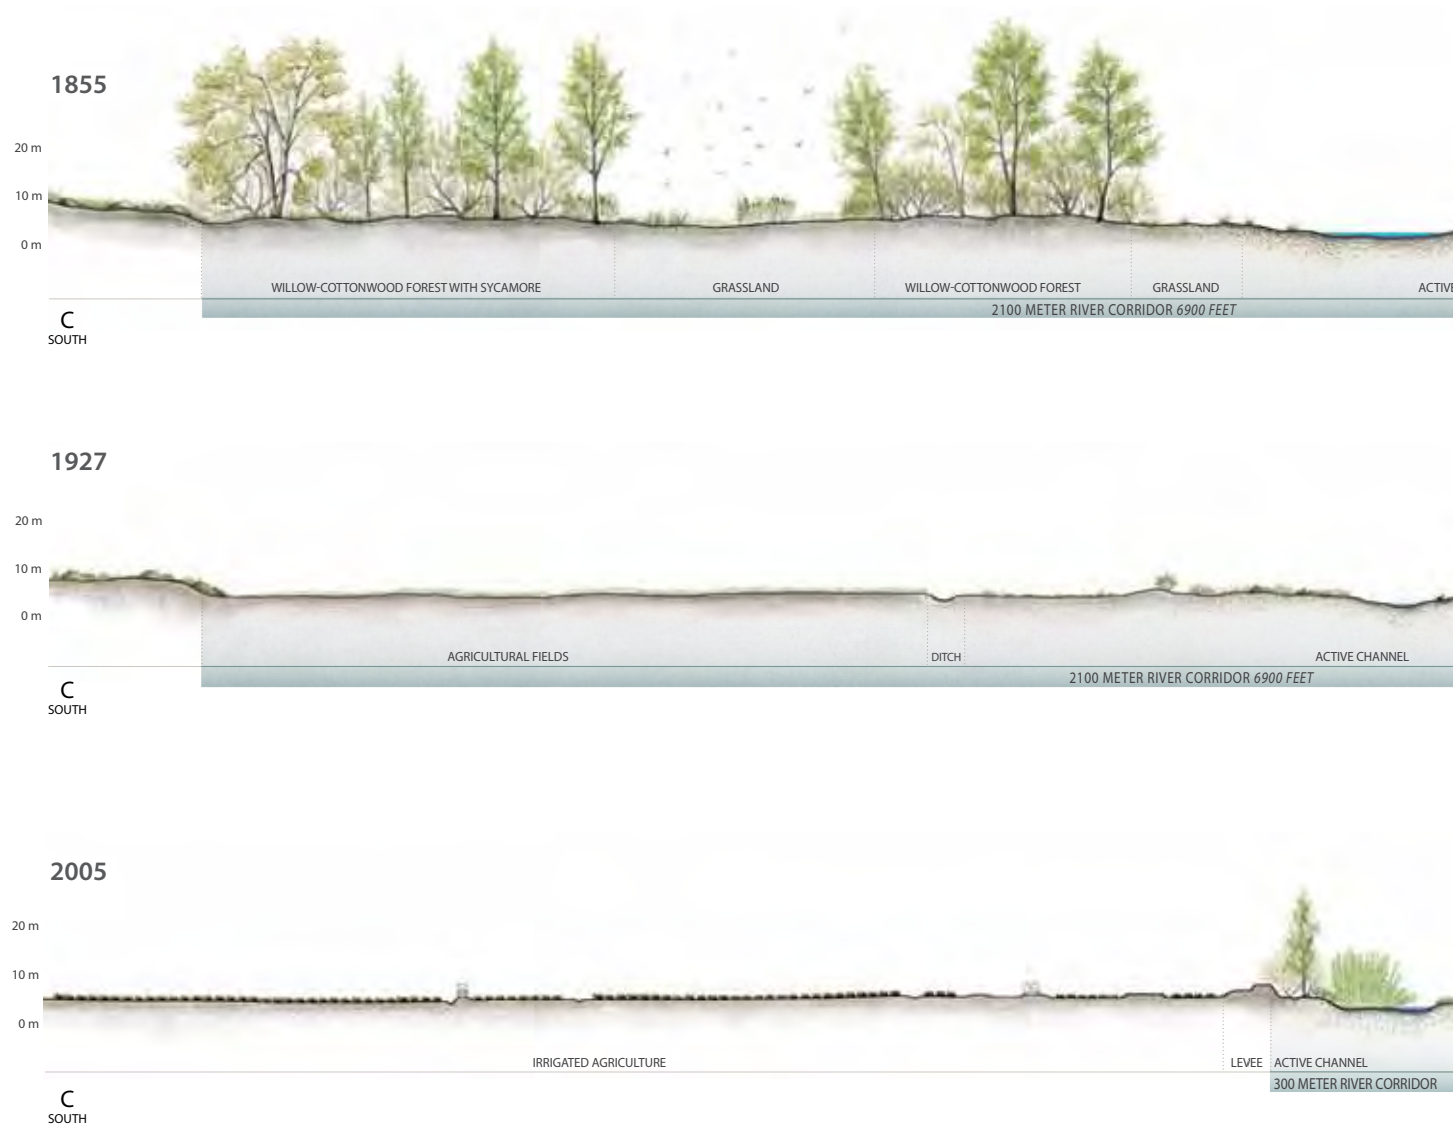
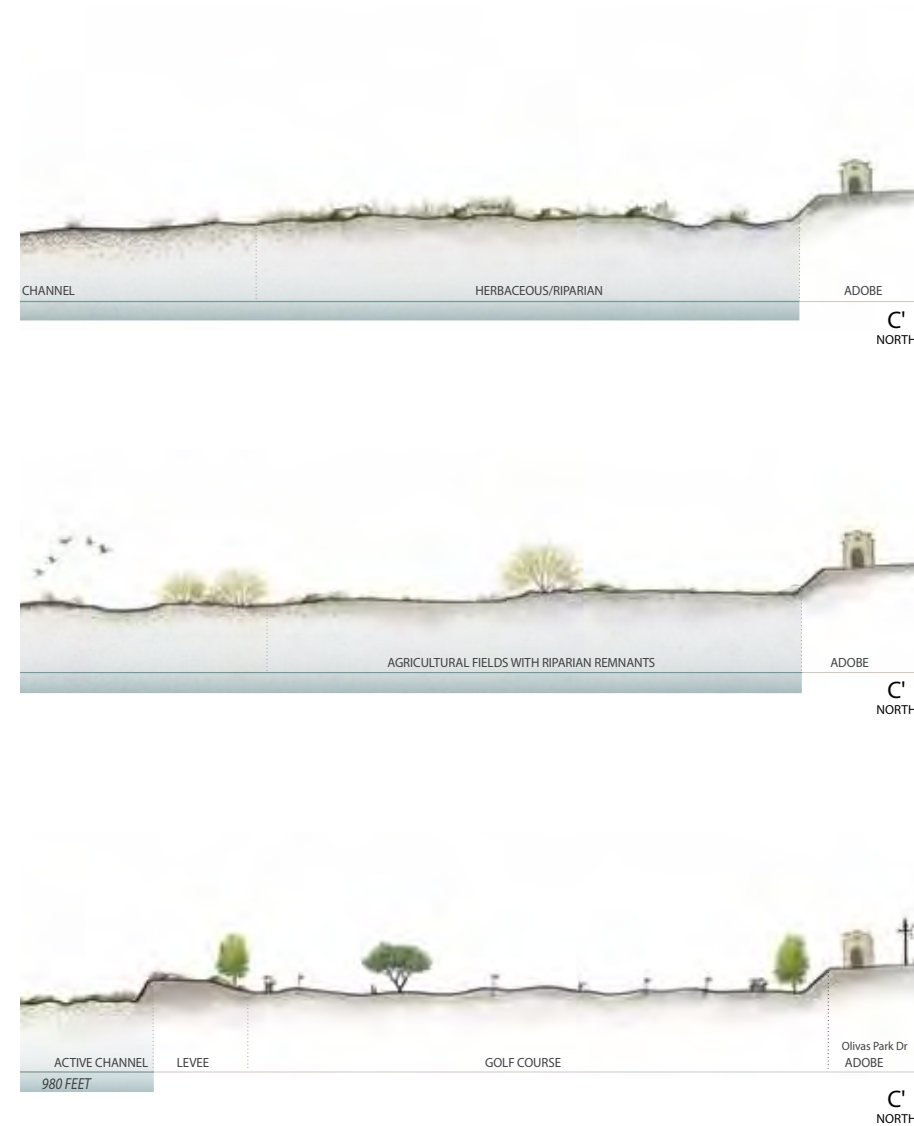
Fig. 3.47. Historical cross-sections at the Santa Clara River mouth, 1855-2005. This time series shows the Santa Clara River at its mouth, about 3.5 miles downstream from the Highway 101 bridge. A large willow-cottonwood forest and wetland complex dominated the left bank (south side) of the river from above the bridge all the way to the river mouth, a distance of over four miles. Very little of this once-expansive forest remains today. The earliest cross-section is derived from GLO notes and the mid-19th century T-sheet drawn for the river mouth by the U.S. Coast Survey. Cross-sections are drawn with 5x vertical exaggeration. (Hancock 1854; Johnson 1855c, courtesy of the National Oceanographic and Atmospheric Administration; Fairchild Aerial Surveys 1927, courtesy of Whittier College; USDA 2005; Stillwater Sciences and URS Corporation 2007. Cross-sections produced by Jen Natali)

Early surveyor's notes describe cottonwood and willow "belts" and "groves" near the mouth (Hancock 1854). These descriptions are corroborated by the 1855 T-sheet, which depicts dense willow-cottonwood forest south of the active channel, and broad distributary channels and grassland to the north. This area maintained shallow summer surface flow due to perched groundwater conditions.

Over 70 years later, in 1927, most of West Grove had been cleared for agriculture. Broad floodplain areas on both sides of the active channel were subdivided into farmland, and irrigation ditches and levees are evident. However, patterns visible on the aerial affirm that much of this area (particularly on the south side) continued to be regularly flooded. By 2005 levees bound the river, including a levee on the south side of the river originally built by the Army Corps in 1961 (Stillwater Sciences 2007b). Levees and land use constrain the formerly 6,900 foot wide river to a 1,000 foot corridor. Intensive agriculture and the Olivas Park golf course inhabit the former floodplain. Herbaceous cover, willow-cottonwood forest, and invasive *Arundo donax* flank the mainstem.

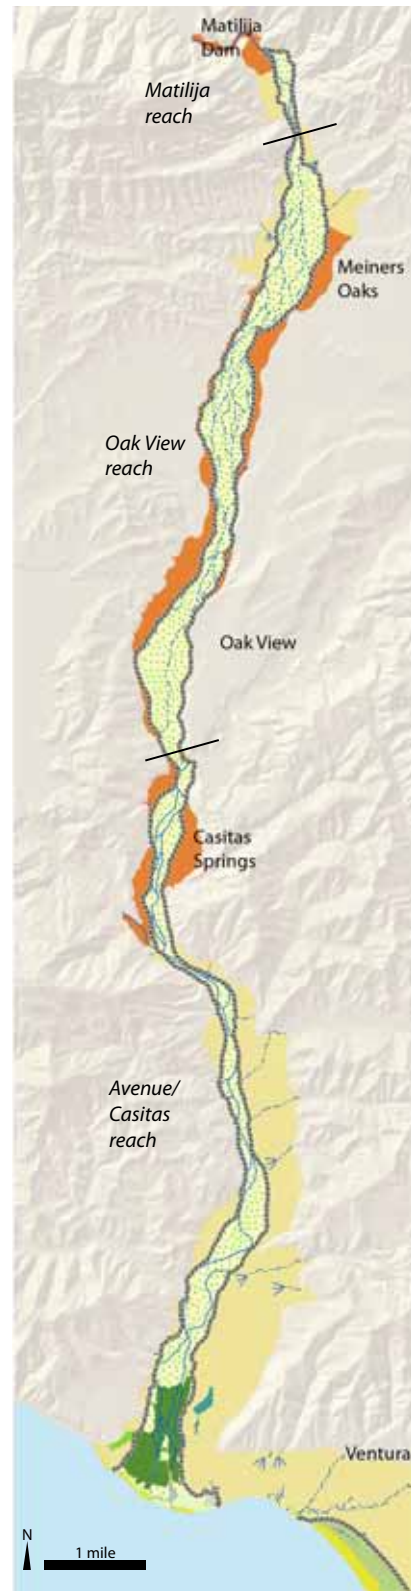
Fig. 4.2. Ventura River reach divisions. We divided the river into three reaches, based on hydrological and ecological characteristics: the uppermost Matilija Reach, the middle Oak View reach, and the lower Avenue/Casitas reach.

We divided the Ventura River into three broadly defined reaches (fig. 4.2 and table 4.1). These reaches were defined based on the hydrology and ecological characteristics of the system. They are designed to provide meaningful units of analysis to facilitate reach-level understanding of channel dynamics and morphology.

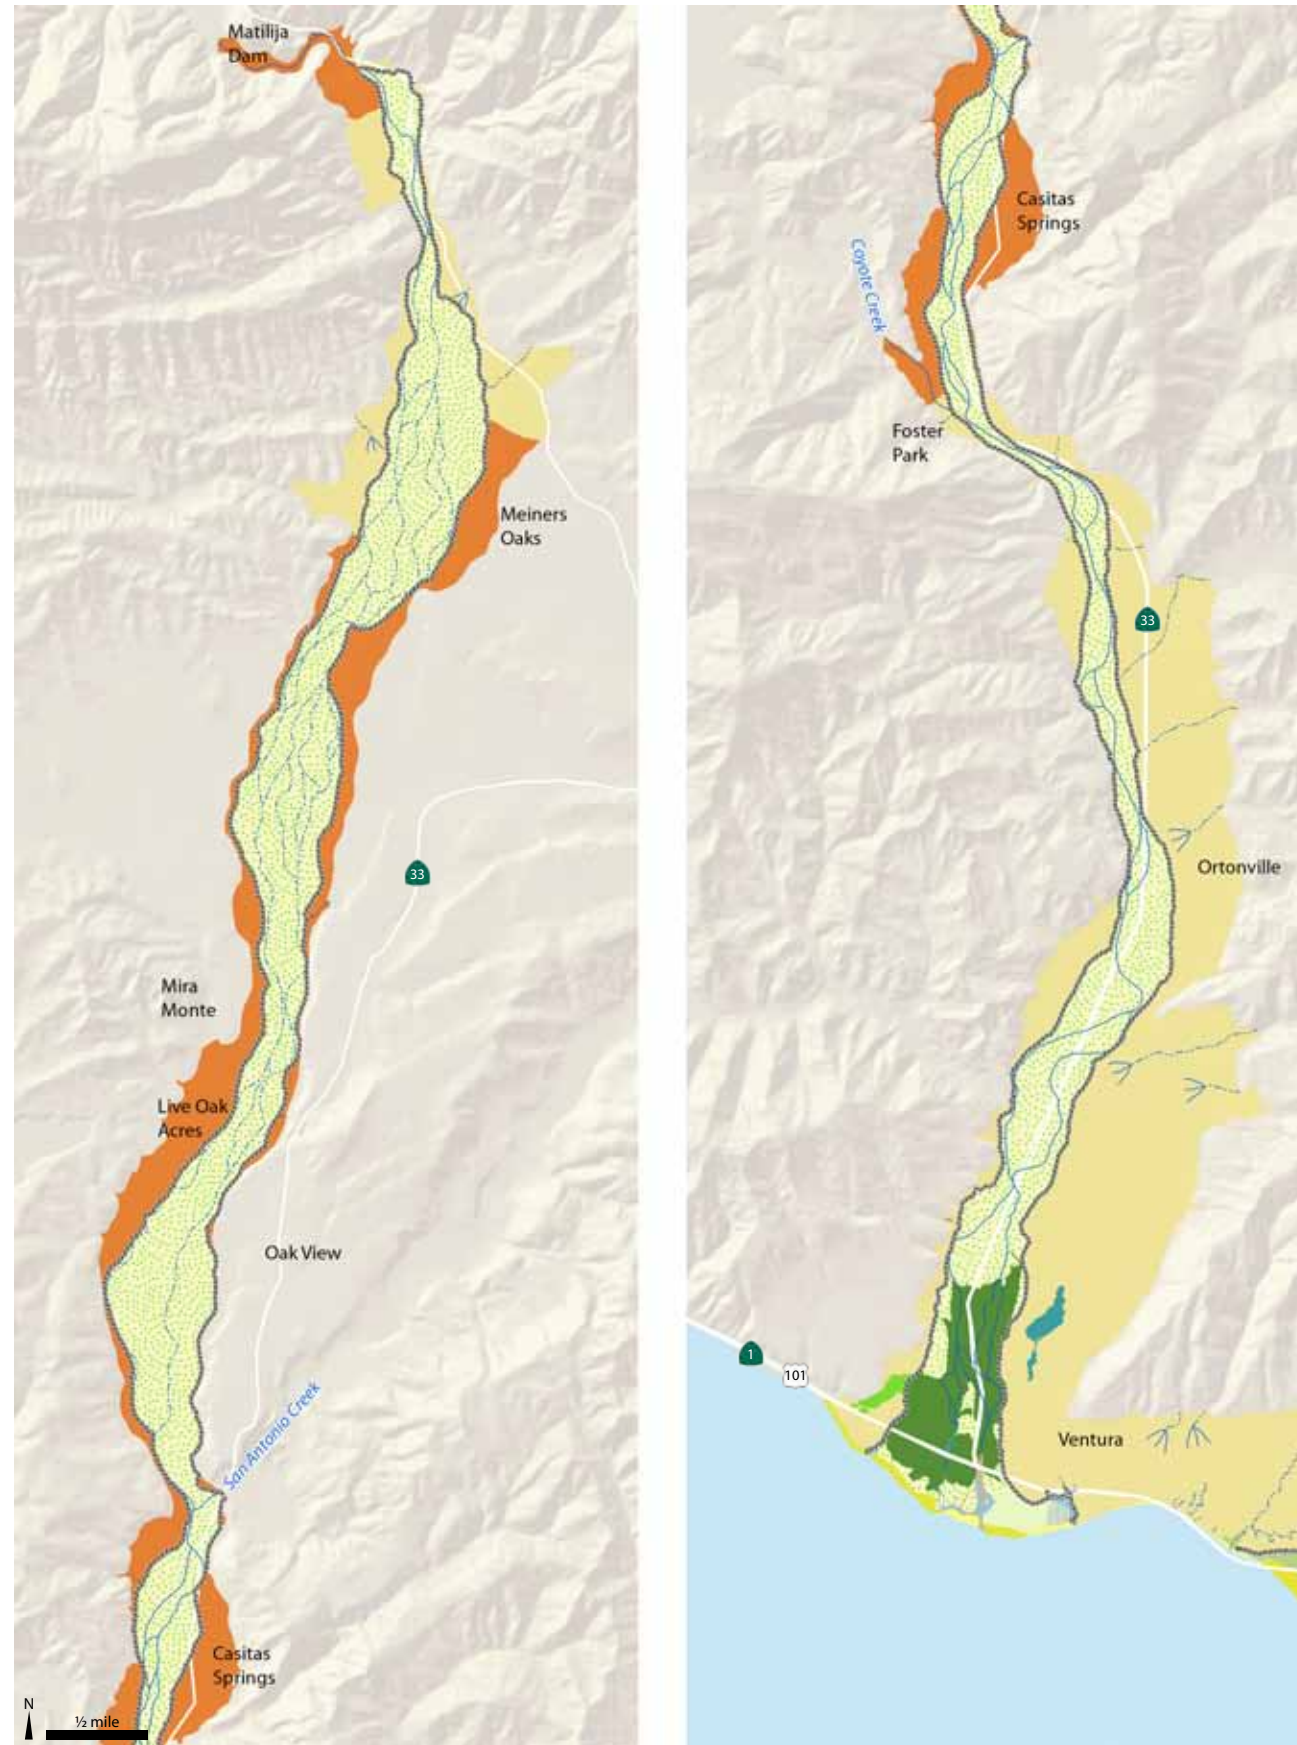
Fig. 4.3. Historical habitats of the Ventura River valley, early 1800s. The Ventura River corridor was broad, in places occupying a large proportion of the valley floor. Live oaks, sycamores, and scrub were prevalent in the upper valley, while grassland was more common in the lower valley.

We mapped three types of habitats on the Ventura valley floor: grassland/coastal sage scrub, oaks and sycamores, and valley freshwater marsh (fig. 4.3). Grassland/coastal sage scrub was the most prevalent habitat type. In contrast to the Santa Clara River valley, which was dominated by grassland/coastal sage scrub, our mapping suggests that oaks and sycamores composed a relatively high proportion of the Ventura River valley floor. Only one freshwater marsh (17 acres) was mapped in the project area, occupying a depression to the east of the Ventura River and demarcating a former route of the river.

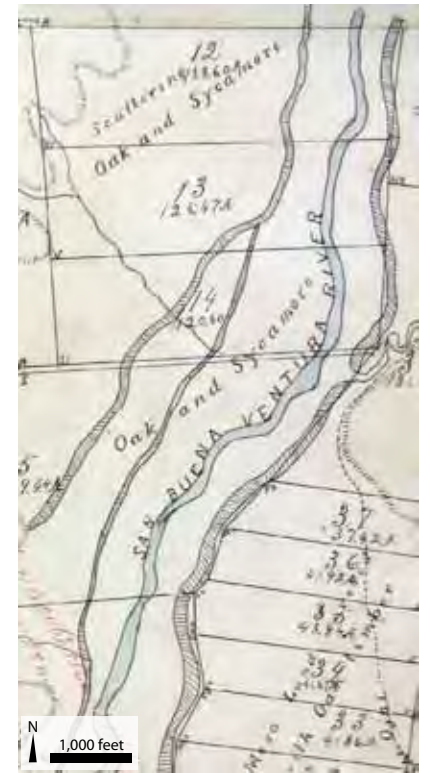
Fig. 4.4. Ventura River in the vicinity of present day Oak View, 1876. This late-1800s map depicts sycamores and oaks occupying the river corridor, as well as "scattering oak and sycamore" on the valley floor between the high bank and the scrub-covered mountains to the west. (Hare 1876, courtesy of the Ventura County Surveyor's Office)

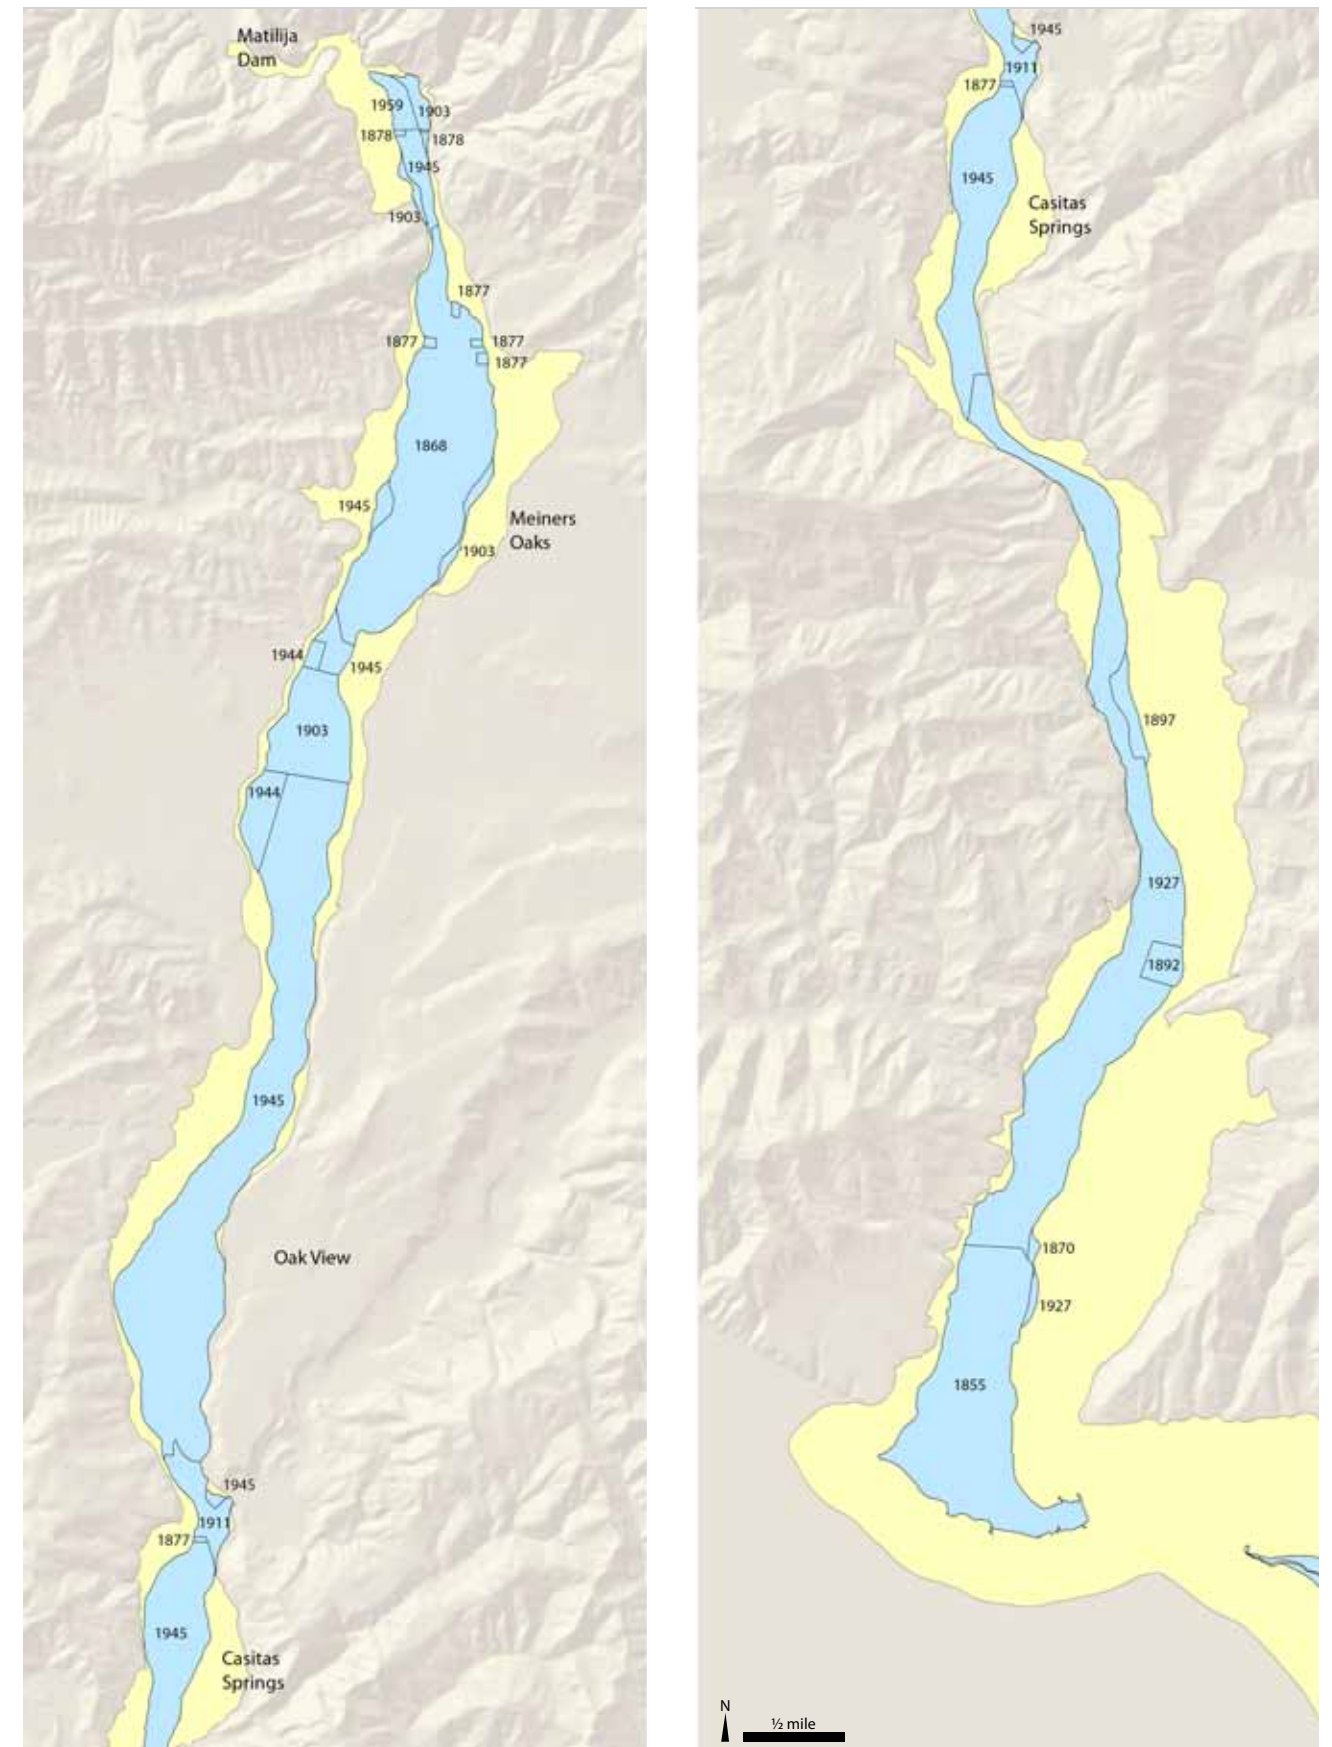
Fig. 4.5. Location of the Ventura River corridor by earliest available source, 1855-1959. We mapped the historical position of the outer bank using the earliest available data for each stretch of the river.

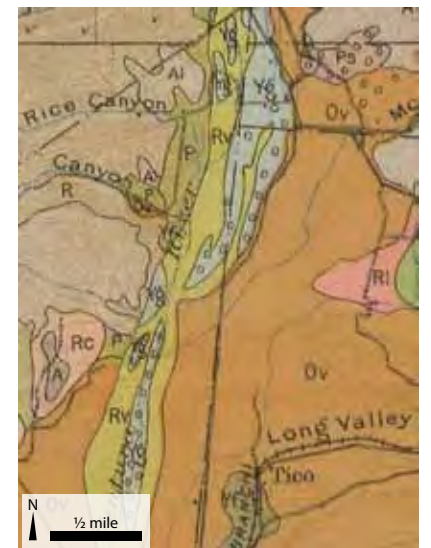
Fig. 4.7. Islands in the Ventura River, 1917. The 1917 soil map shows islands surrounded by riverwash (Rv) over a three mile stretch west of the Ojai Valley. The islands are composed of coarse Yolo gravelly and bouldery fine sandy loam (Yg), a soil type documented to support live oaks and sycamores on alluvial fans in the Santa Clara River valley. (Nelson 1917)

The most notable aspect of these maps is the presence of large, well defined islands; on these maps coarse depictions of the area of individual islands ranges from less than one to over 35 acres. Other sources also describe islands in the river: a *Ventura Free Press* article refers to "rocky islets" near the mouth, and an early soils map shows gravelly and bouldery islands west of Ojai (fig. 4.7). One long-time resident described camping in the

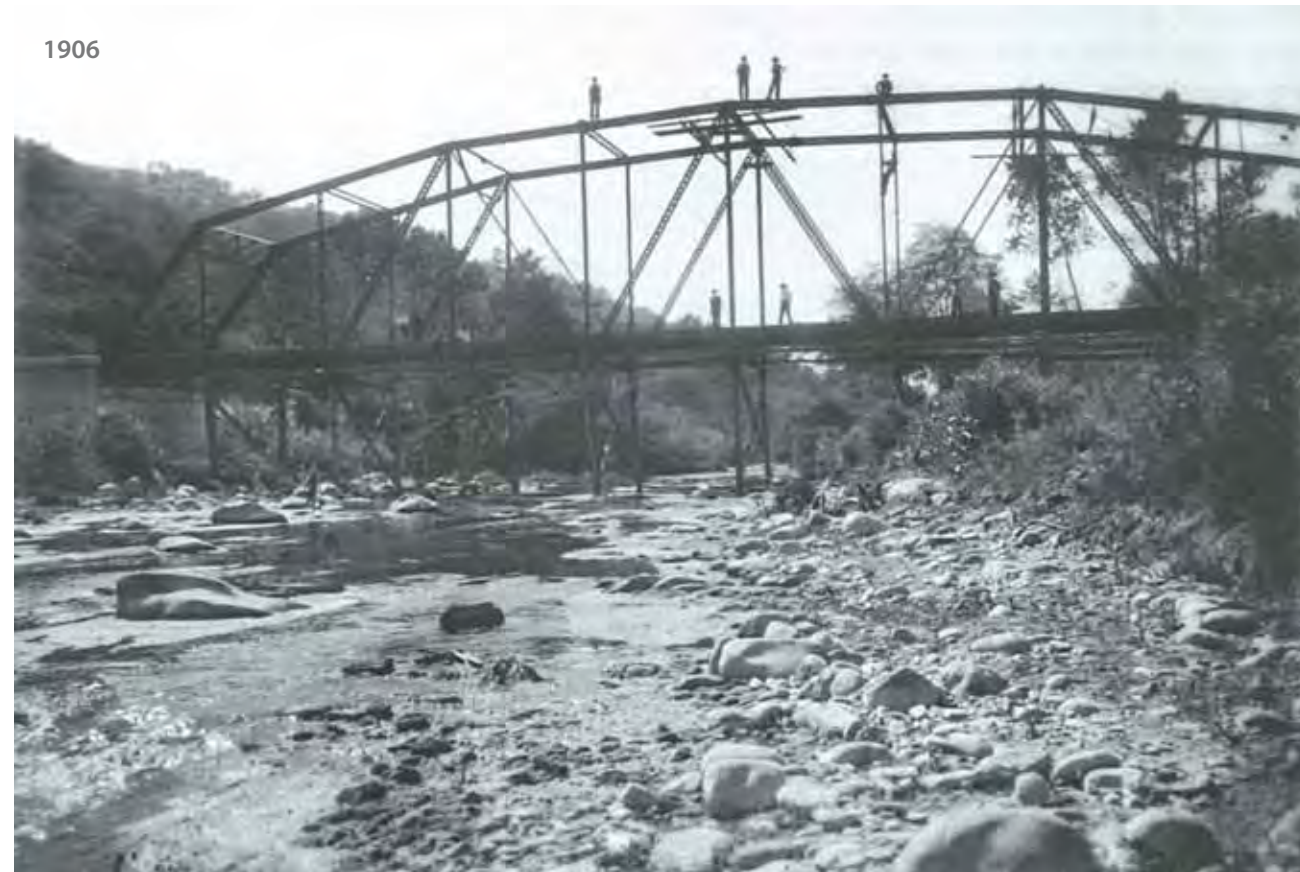
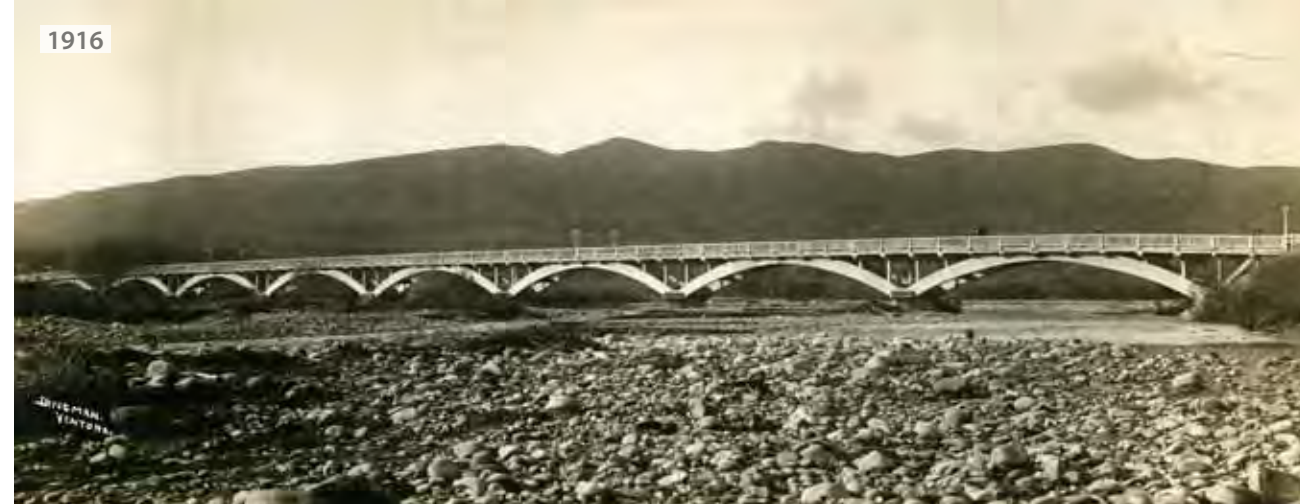
Fig. 4.8. These images of the Ventura River at Foster Park (top, ca. 1906) and at Main Street in Ventura (bottom, 1916) show the abundant cobbles and boulders characteristic of the river bed even nearly at the estuary. (Unknown ca. 1906, courtesy of Craig Held; Unknown 1916, courtesy of the Museum of Ventura County)

river show coarse substrate on the river bed (fig. 4.8). While some of these photographs were taken after floods and thus may somewhat overemphasize the relative proportion of cobbles and boulders to finer substrate, they still reveal an overall trend toward coarse bed material.

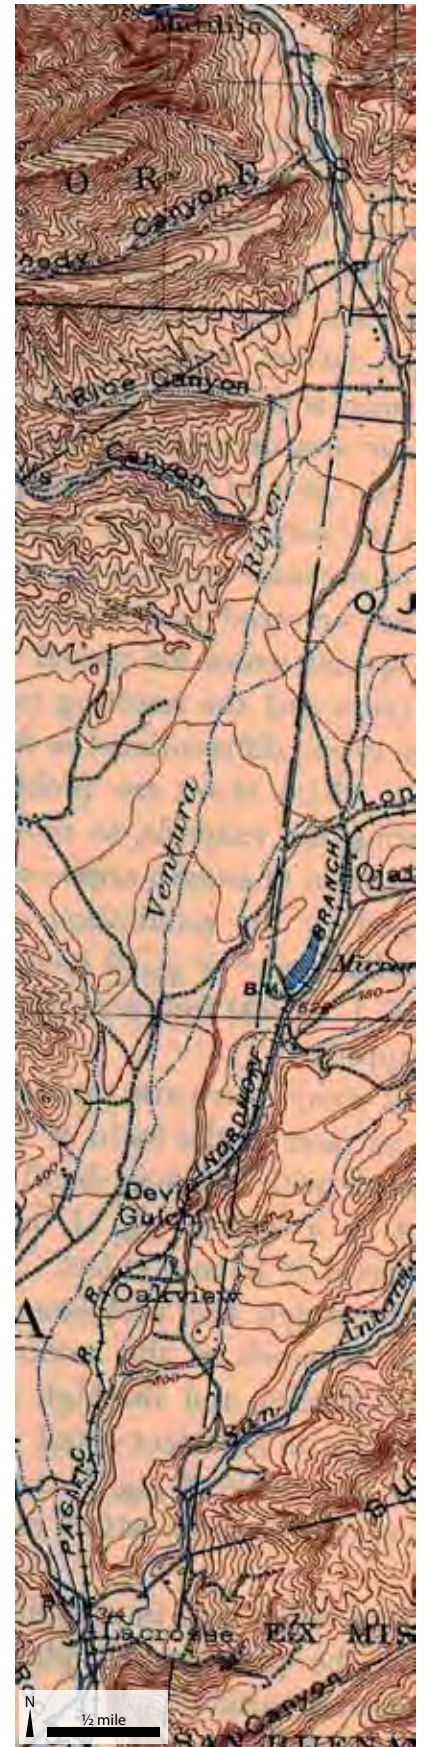
Fig. 4.9. Intermittent and perennial reaches on the Ventura River, 1903. The early USGS topographic quadrangle depicts summer flow conditions on the Ventura River. A solid line indicates perennial flow, while a dashed line signals an intermittent reach. The quad shows the river as about half perennial and half intermittent. (USGS 1903c, courtesy of the Los Angeles Central Library)

Both descriptions of the Ventura River—as an abundant source of water, and as an arid stream—have some element of truth. Documentation of flow conditions on the Ventura River consistently depicts three reaches with distinct summer flow regimes within the study area. These reaches are depicted on the historical topographic quad for the river (USGS 1903c; fig. 4.9). The first perennial reach extends from beyond the northern edge of the study area (Matilija Hot Springs) downstream to around the Cozy Dell Canyon (Matilija reach). Below this, the Ventura River valley begins to open up into the head of the Ojai Valley, and the river is intermittent until below

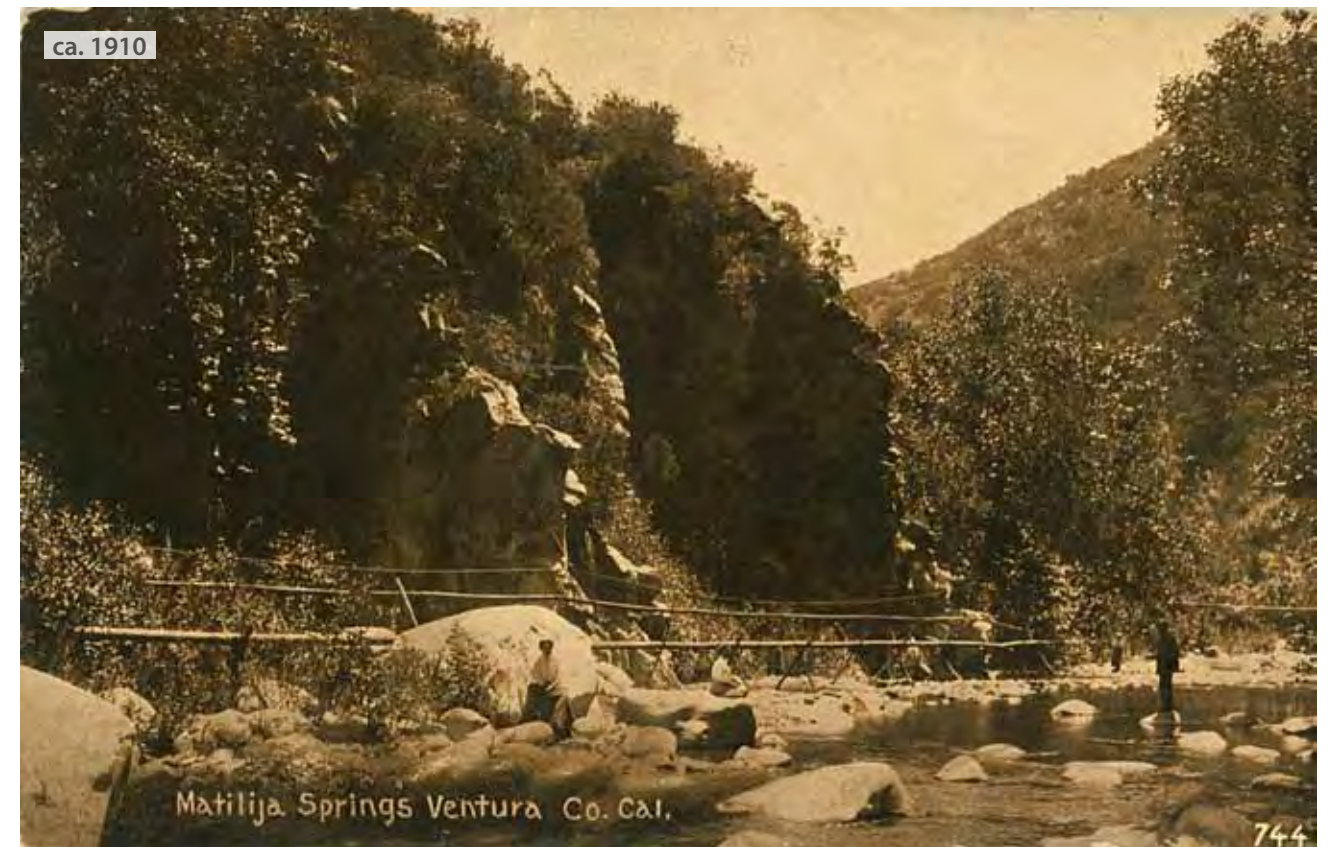
Fig. 4.10. Two views of the upper Ventura River, ca. 1910. These two postcards, both dating from the first years of the 20th century, show the boulder-filled channel of the river in lower Matilija Canyon. The photograph at top was taken at Matilija Hot Springs, just below Matilija dam. The photograph at right was taken less than a half mile downstream. Note the narrow fringe of mulefat, willow scrub, and trees (likely alder, cottonwood, and sycamore). (Unknown ca. 1910b, d)

This representation of Ventura River summer flow is supported by numerous additional early sources. Early photographs from the Matilija Hot Springs area show shallow riffles running over a cobble and boulder-strewn river (see fig. 4.10). Ditches brought water downstream from the perennial Matilija reach to irrigate bottomland alfalfa and orange orchards located in the intermittent reach of the river below (Waud 1903, Lippincott 1903). A GLO surveyor noted water in the river in late September 1878, south of the current intersection of Camino Cielo and Rice Road (Norway 1878a).

account describes seeing, upon entering Matilija Canyon, “patches of wood and verdure which at short intervals break in upon the sand” (Hassard 1887). A number of sandbar willows (*Salix exigua*) were recorded in Matilija Canyon just upstream of the study area (Bracelin 1932). Early images of the canyon corroborate these descriptions of the confined portion of the river (fig. 4.10).

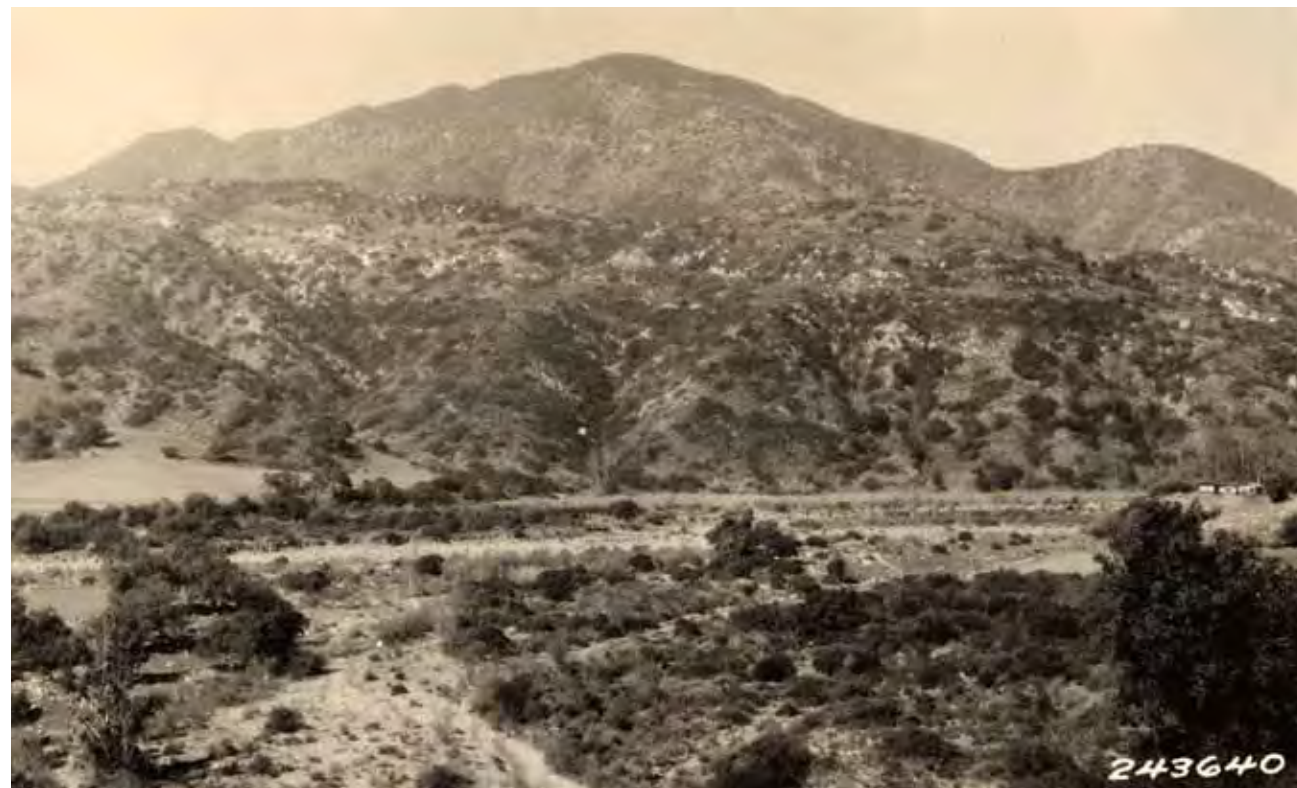
Fig. 4.11. “Looking west across Ventura River, mouth of Matilija Canyon,” February 1930. This photograph, part of the Wieslander Vegetation Type Mapping Project of the late 1920s and early 1930s, shows low scrub flanking riverwash along a shallow, broad channel in the intermittent reach of the river. It was taken approximately one mile below the mouth of Matilija canyon, looking west toward the site of the current Robles Diversion Dam (Capelli pers. comm.). (Clar 1930, courtesy of the Marian Koshland Bioscience and Natural Resources Library, UC Berkeley)

The presence of scrub and trees (overwhelmingly live oaks and sycamores) in this reach is described by a number of narrative and textual accounts. The upper portion of the reach, at the transition to a broad, washy river from Matilija Canyon, was especially commented upon (fig. 4.11). Sheridan (1886) described that the “river rushes out across a broad sycamore dotted flat” from the canyon, and Roberts (1886) described the river here as “overgrown with brush, sycamores, and oaks.” The early presence of oaks and sycamores is corroborated by GLO survey notes, which describe a “timbered bottom” and “bottom land with heavy oak & sycamore timber” (Norway 1877). The few GLO bearing trees documented in this reach also generally support this description (two live oaks 10 and 48 inches in diameter, and one sycamore 20 inches in diameter; Norway 1877).

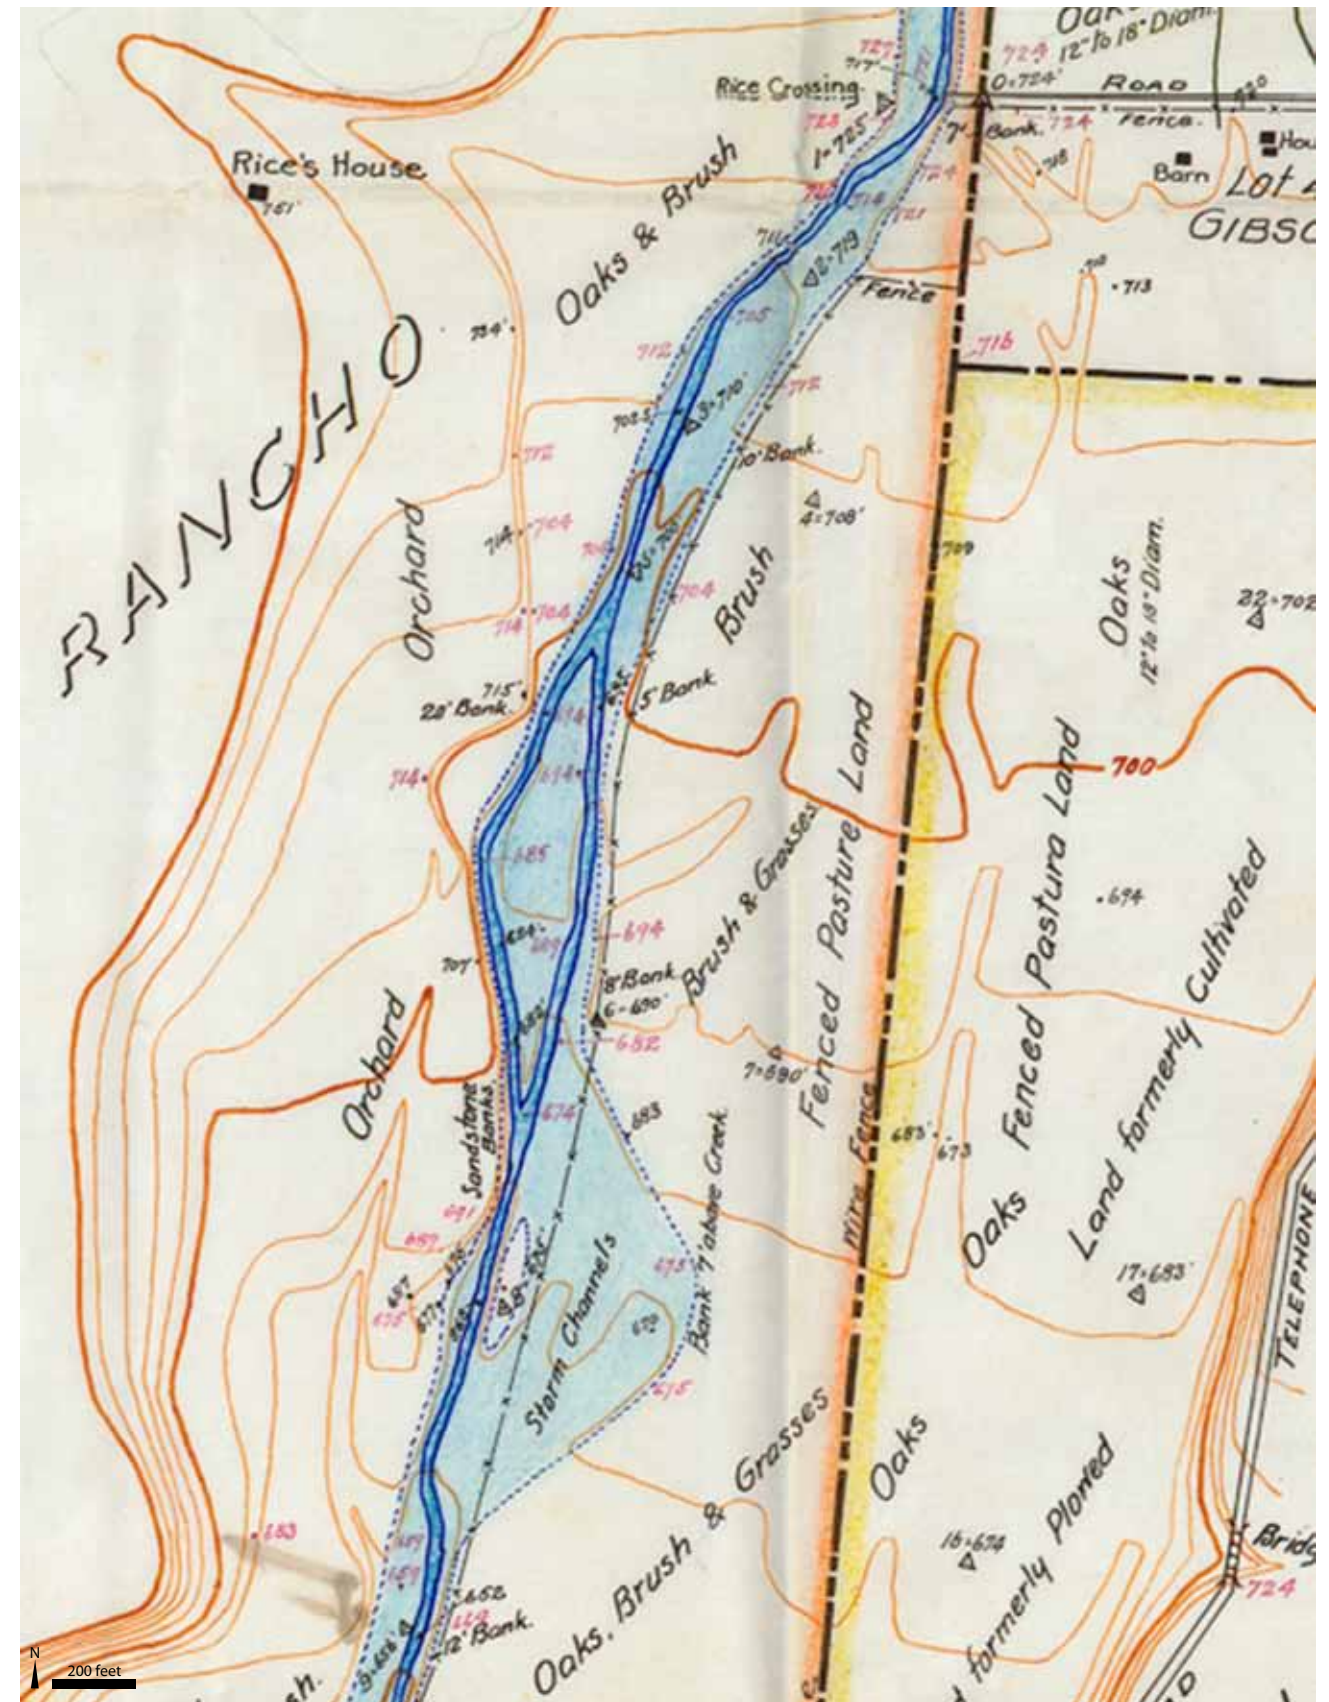
Figure 4.12. Vegetation in the Ventura River, 1903. This map of the river in the intermittent reach near Meiners Oaks shows local-scale variation of riparian vegetation, including oaks, sycamore, and brush, within its outer banks. It is evident from this map that many portions of the bottomland had already been cleared or fenced for pasture. (Lippincott 1903, courtesy of the Museum of Ventura County)

Early maps of the reach also show a mixture of scrubland, oaks, and sycamore. An 1876 map marks “oak and sycamore” near Live Oak Acres toward the bottom of the intermittent reach (Hare 1876). Upstream near Meiners Oaks, a map along two miles of the river shows a combination of oaks, scrub, and grasses present in the river corridor between patches of cultivation, labeling bottomlands “oaks and brush,” “oaks, brush & grasses,” “oaks (12” to 18” diam),” and simply “brush” (Lippincott 1903; fig. 4.12). Aerial images from the 1940s also show oaks and scrub.

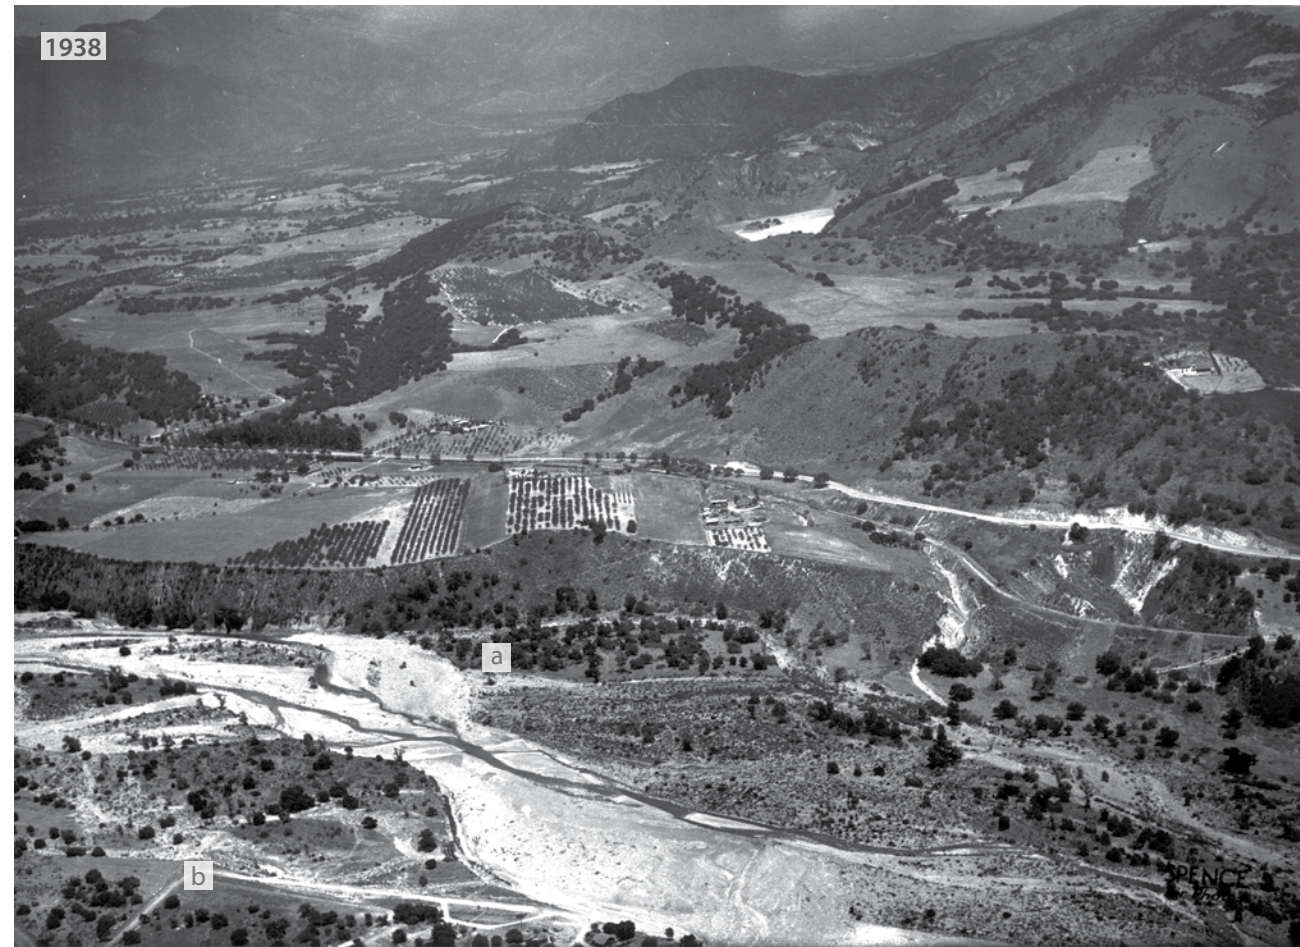
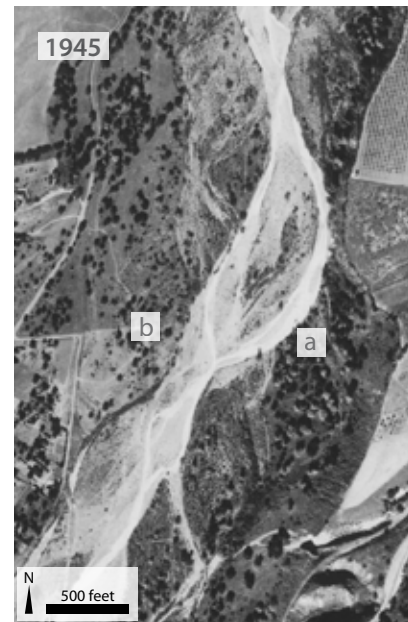
Fig. 4.13. Ventura River at Live Oak Acres. The oblique aerial photograph (top), taken in June 1938, shows characteristic riparian patterns in the Oak View reach. Sparsely vegetated riverwash composes the active channel, flanked by dense scrub on bottomlands. Further away from the active channel, more mature live oaks colonized higher river surfaces. Seven years later, the aerial photograph of the same place in 1945 (left) shows similar patterns of riverwash, scrub, and trees. (Spence Air Photos 1938, courtesy of the Benjamin and Gladys Thomas Air Photo Archives, UCLA Department of Geography; Ventura County 1945, courtesy of UCSB Map and Imagery Library)

Oaks (Hoffmann 1932b), and slender woolly buckwheat (*Eriogonum gracile*) and chaparral yucca (*Hesperoyucca whipplei*) were collected in the river near Oak View (Pollard 1963a, 1969). Mulefat was also documented (*Baccharis salicifolia*; Pollard 1944). These records imply the presence of alluvial scrub; it is likely that a mixture of willow and alluvial scrub was present through this reach (fig. 4.13).

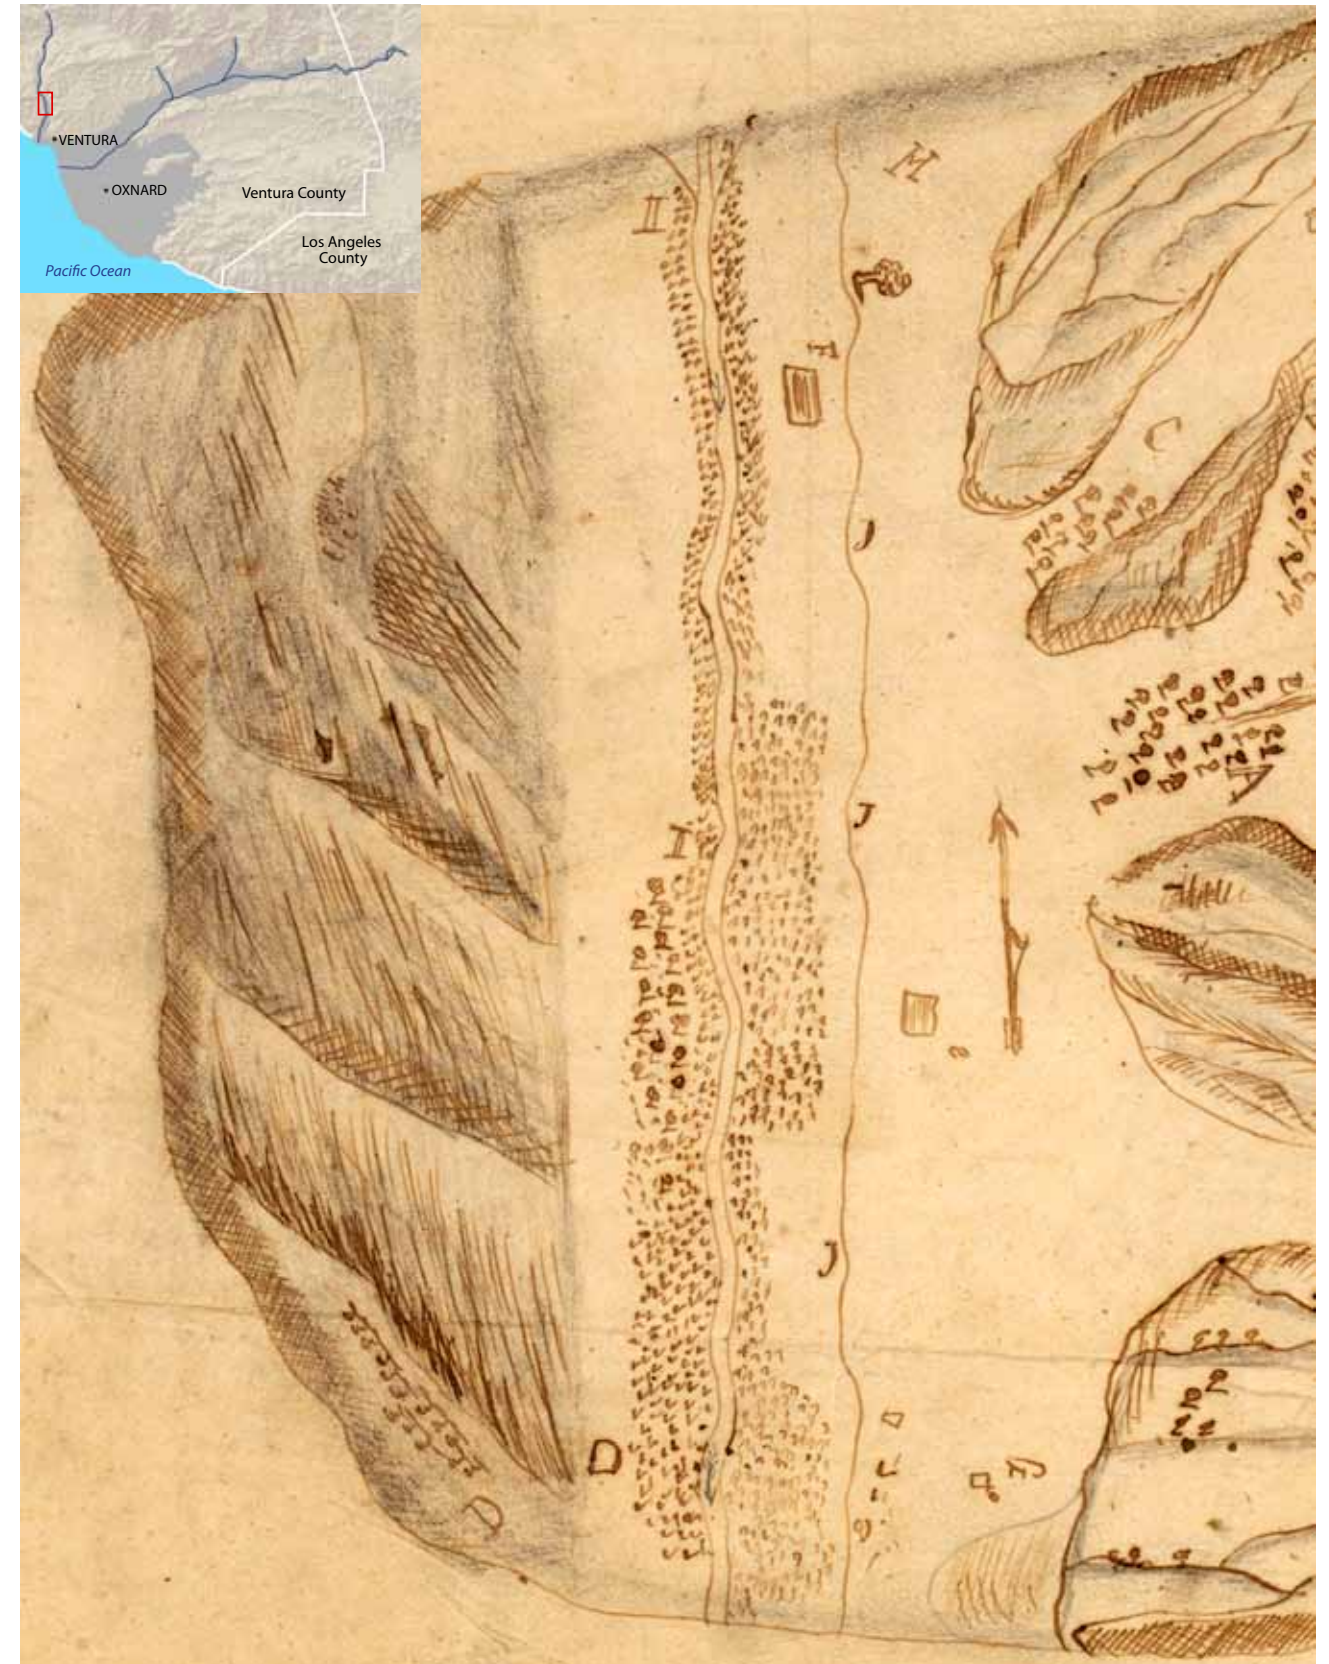
Fig. 4.14. Dense riparian corridor along the Ventura River, ca. 1840. An early depiction of the Ventura River for three miles below Foster Park shows continuous riparian forest flanking the river, of variable—and in many places, substantial—width. A small area of oaks is shown along one portion of the river (below the “I”); the small check marks that line the river are interpreted as mixed riparian forest. (U.S. District Court ca. 1840b, courtesy of The Bancroft Library, UC Berkeley)

Strongly supporting the concept of dense riparian forest in this reach, an 1840s *diseño* of the Cañada Larga ranch shows a continuous riparian corridor stretching the three miles from near Foster Park to Gosnell Hill/Cañada de San Joaquin (fig. 4.14). The riparian corridor is shown of variable width, including a short reach of oaks south of Cañada Larga and a lot of other trees (interpreted as willow-cottonwood forest). This map is supported by
