HISTORICAL ECOLOGY of the lower Santa Clara River, Ventura River, and Oxnard Plain: an analysis of terrestrial, riverine, and coastal habitats

HISTORICAL ECOLOGY PROGRAM
CONTRIBUTION NO. 641 • AUGUST 2011

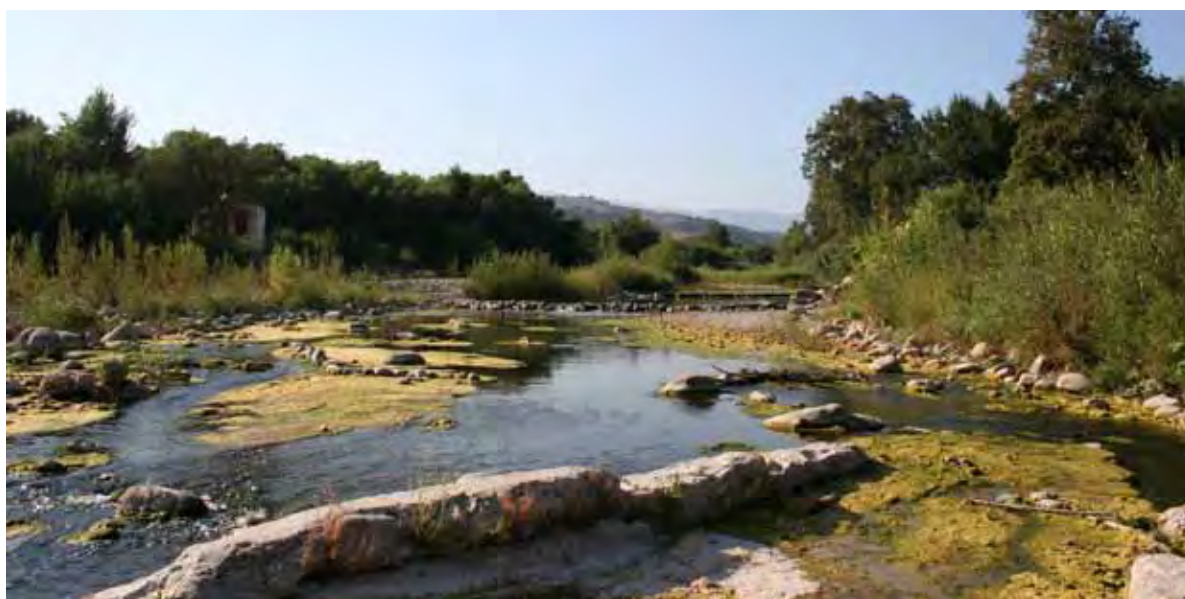
Fig. 4.15. Ventura River at Foster Park looking north from the bridge, July 2008. Cottonwoods and willows flank the river, and willows, mulefat, and *Arundo* colonize coarse bars and islands.

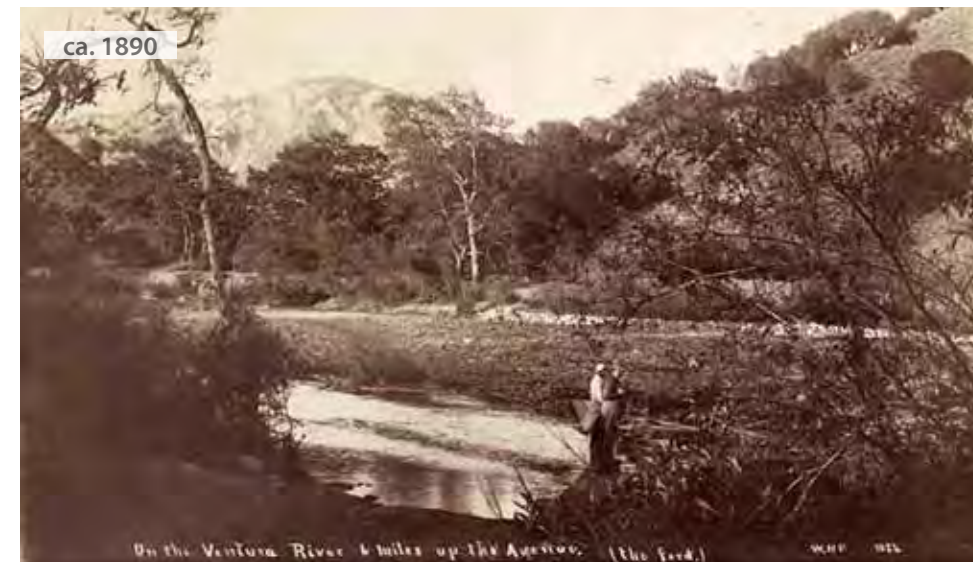
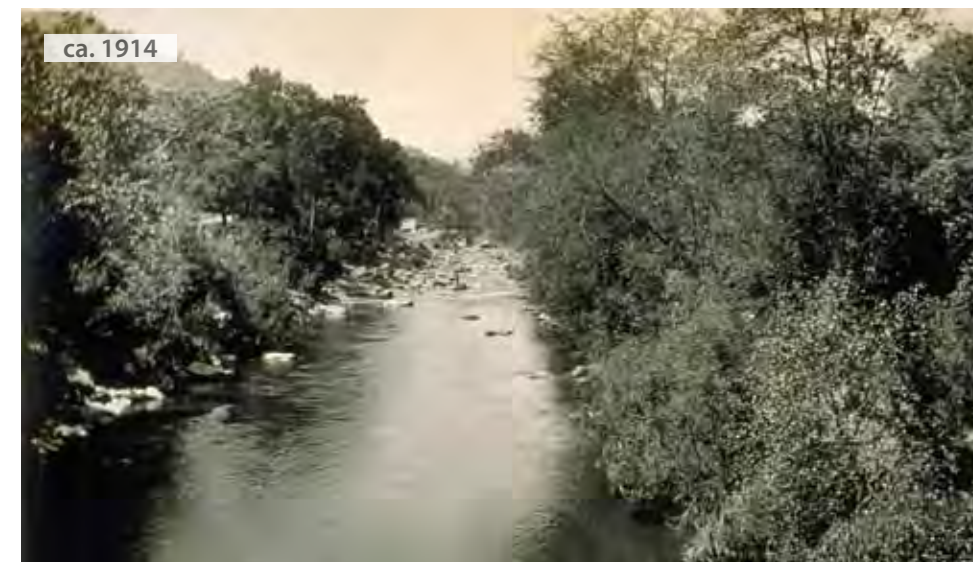
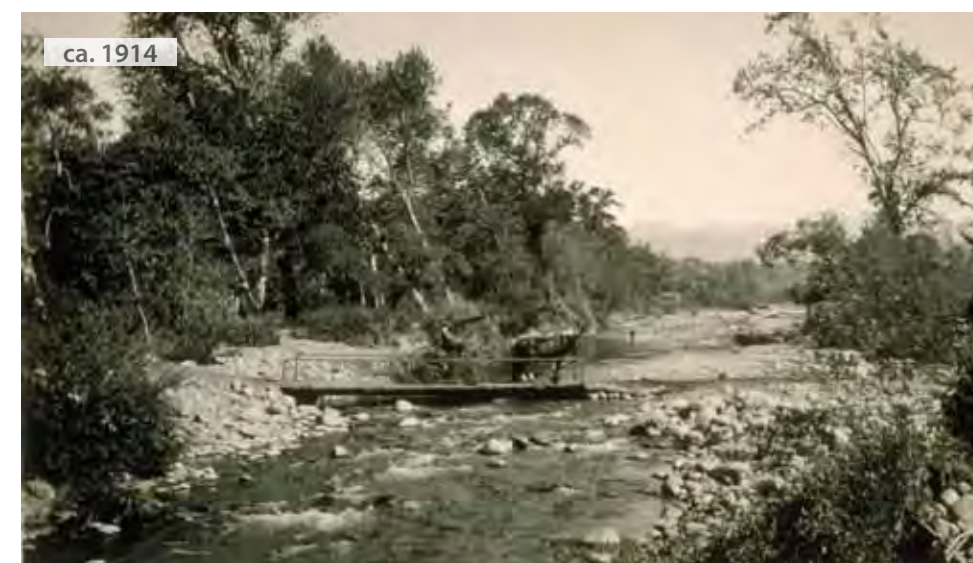
Figure 4.16. Three images of riparian vegetation near Foster Park/Casitas, ca. 1890-1914. Top: “On the Ventura River 6 miles up the Avenue (the ford),” ca. 1890. Middle: “Looking up Ventura River from the Bridge,” ca. 1914. Bottom: “Casitas – View of Ventura River Crossing,” ca. 1914. These images show three versions of the riparian corridor in the vicinity of Foster Park, including sycamore, live oak, willow, cottonwood, and alder. (Fletcher ca. 1890, courtesy of the California State Library; Unknown ca. 1914a and 1914b, courtesy of The Bancroft Library, UC Berkeley)

Within the lower perennial reach of the Ventura River, Foster Park was particularly noted and admired for its riparian trees. The park, created in 1908, is the site of many of the historical data describing the Ventura River, including photographs, specimen records, and textual descriptions. According to one historian, the Foster Park area had been used by both Chumash and Mission fathers (Sheridan 1926). Images of this area show thick stands of trees and scrub growing over cobbles along the river, similar to today (figs. 4.15, 4.16).

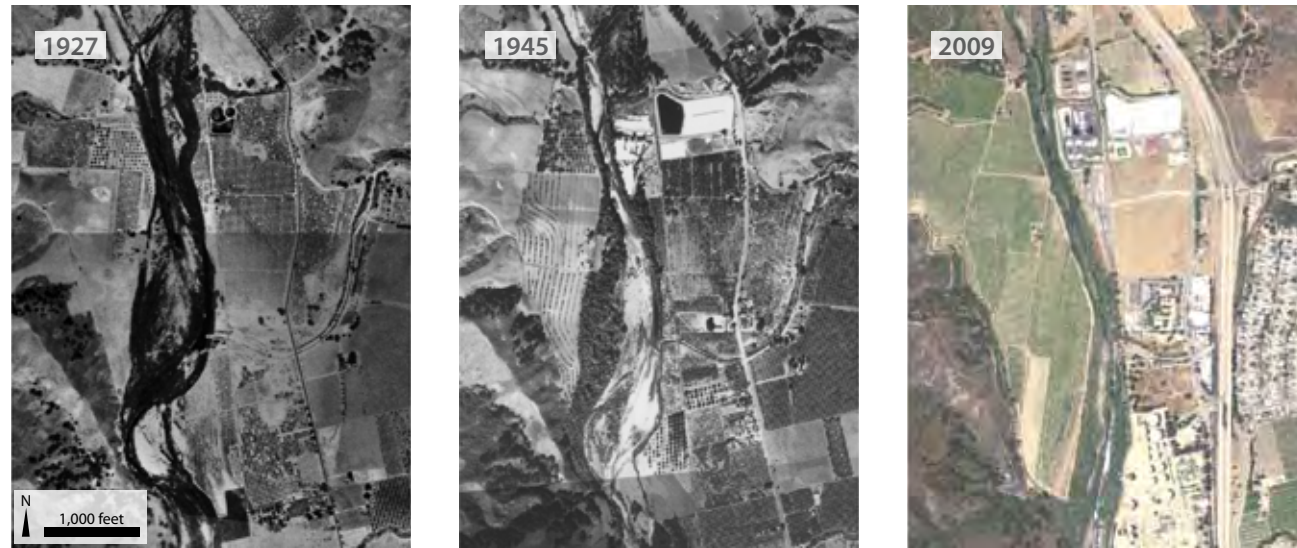
Fig. 4.17. A section of riparian corridor 1.5 miles south of Foster Park. Broad, dense riparian forest present in 1927 (left) and 1945 (middle) has been converted to agriculture by 2009 (right). (Fairchild Aerial Surveys 1927, courtesy of Whittier College; Ventura County 1945, courtesy of UC Santa Barbara Map and Imagery Library; USDA 2009)

aerial imagery from 100 years later, which still shows many stretches of dense mixed riparian corridor (fig. 4.17). Photographs of this reach show a corridor of dense trees and scrub, particularly in the Foster Park area (see spread, pages 146-147).

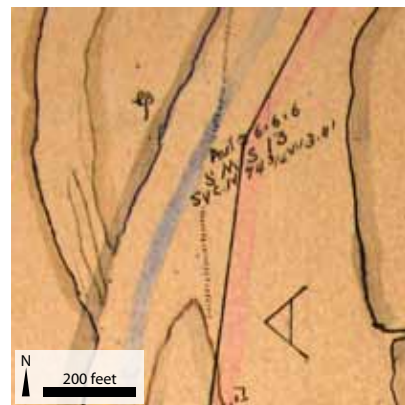
Fig. 4.18. Sycamore on island in the Ventura River, 1894. West of lower Ventura Avenue (and just above the persistent wetland riparian area at the river mouth), this small depiction shows a 24 inch diameter sycamore above the active channel of the river. (Barry 1894, courtesy of the Ventura County Surveyor's Office)

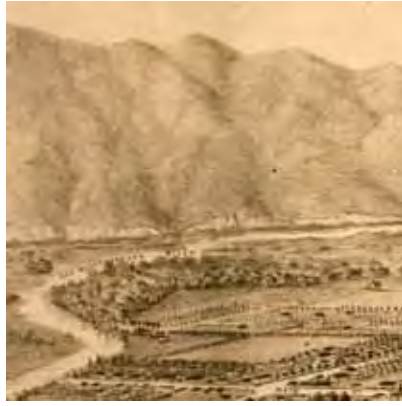
Fig. 4.19. Willows on the Ventura River, 1877 (above). A subset of the forest depicted on the T-sheets is shown in this bird's-eye view lithograph. The view is looking northwest across the river and Main Street in the city of Ventura, drawn seven years after the T-sheet re-survey. It further confirms the presence of trees, although the area appears reduced from the initial T-sheet depictions. (Glover 1877, courtesy of the California Historical Society)

The most persuasive evidence, however, comes from an early T-sheet and resurvey depicting vegetation at the river mouth (Johnson 1855c, Greenwell and Forney 1870; figs. 4.19, 4.20). Since these maps bracket the huge floods of 1861-2, they offer significant evidence of the feature’s resilience over time. For a detailed discussion of more recent ecological characteristics of the Ventura River mouth and estuary, see Ferren et al. (1990).

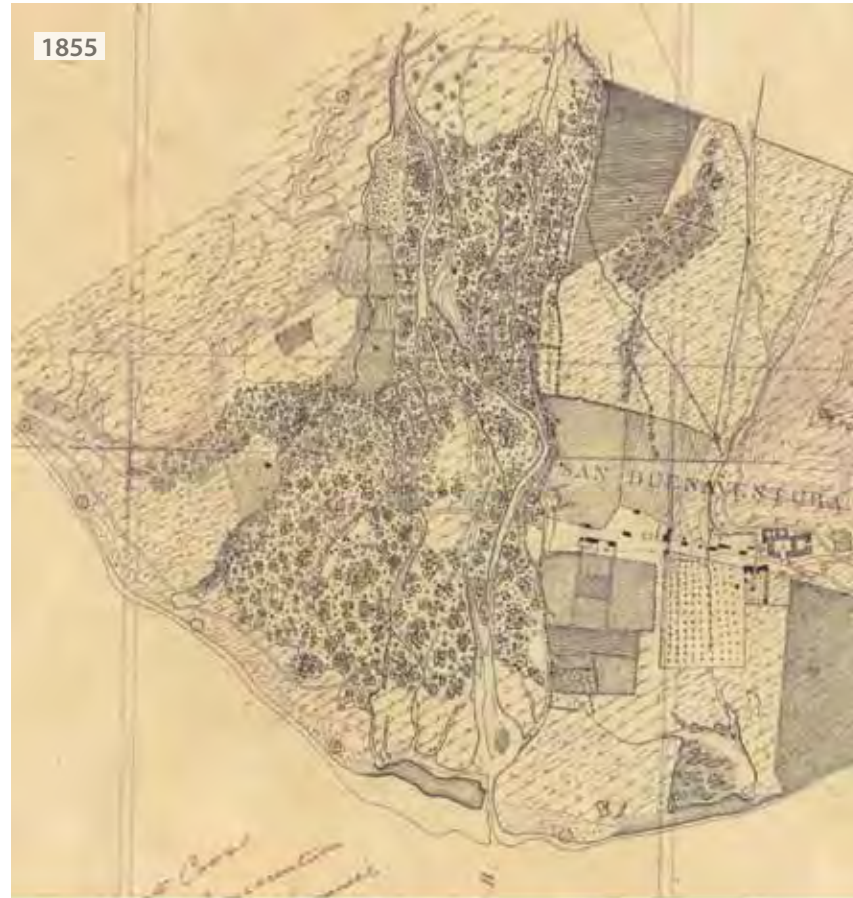
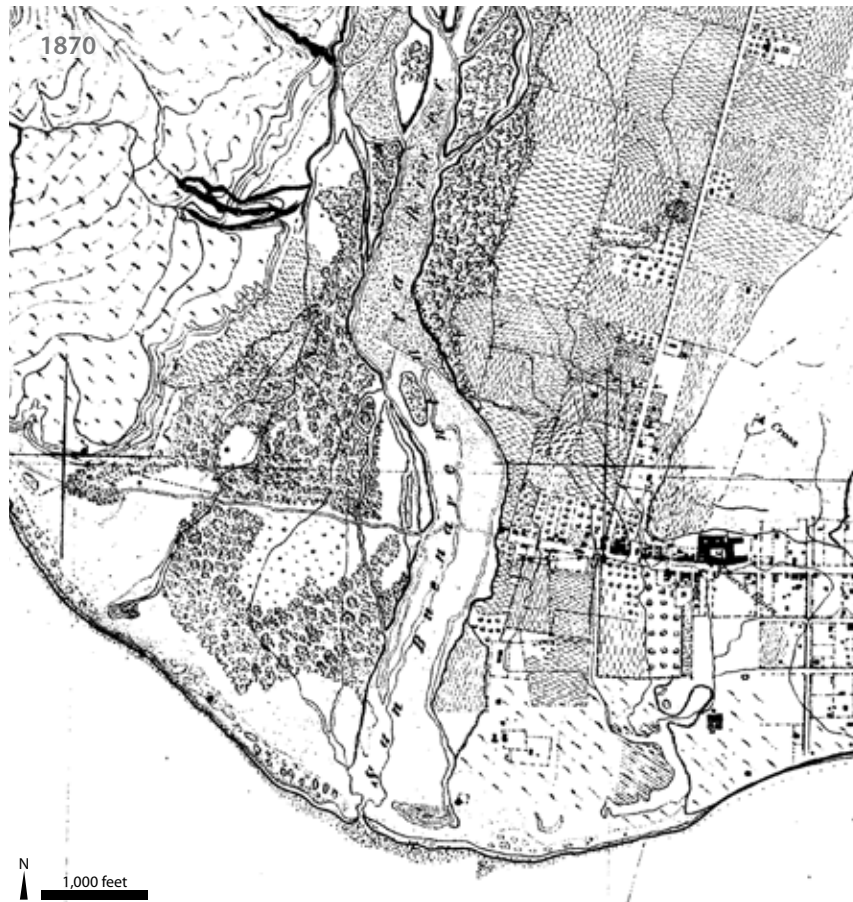
Fig. 4.20. Riparian forest at the mouth of the Ventura River, 1855 and 1870. While the initial survey of the Ventura River mouth by the U.S. Coast Survey (top right) provides evidence of the extent of willow-cottonwood forest at the mouth of the river, the re-survey 15 years later (bottom right) shows that, although trees have been scoured near the main channel, the feature transcended the floods of 1861-2. Dense trees near the mouth of the river taper towards the northern edge of the map. (The freshwater wetland marking a former river route can be seen on the earlier map just north of the nascent city of San Buenaventura; it was almost completely gone by 1870.) (Johnson 1855c, Greenwell and Forney 1870; courtesy of NOAA)

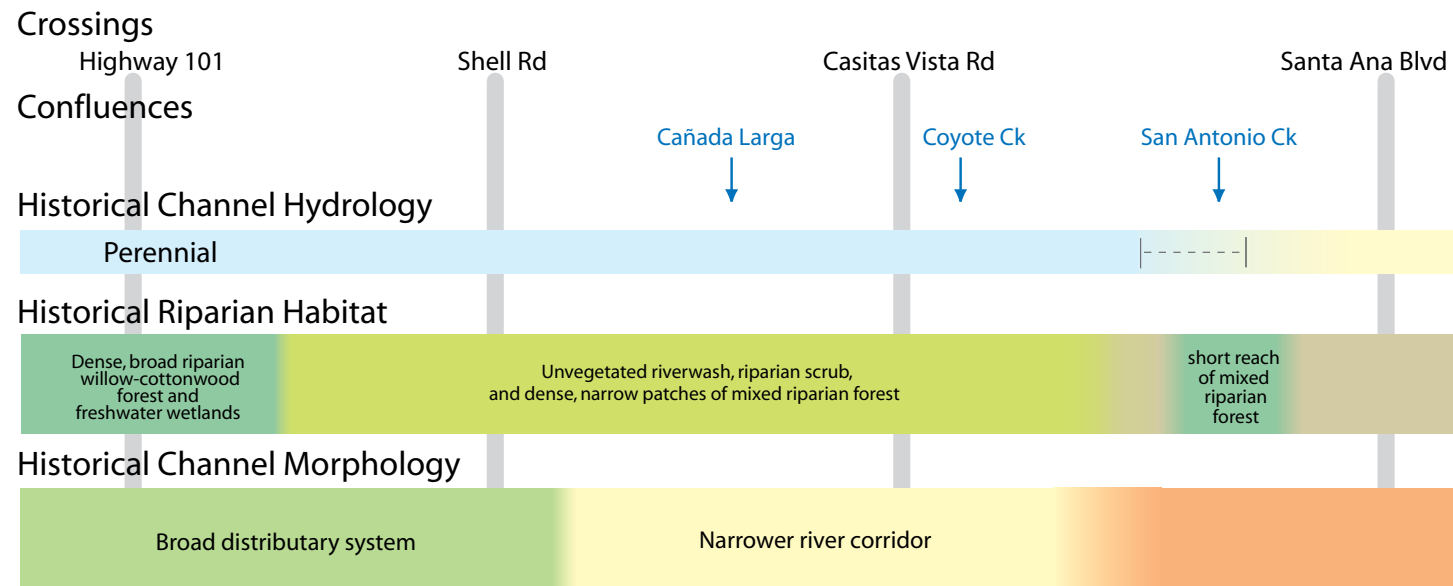
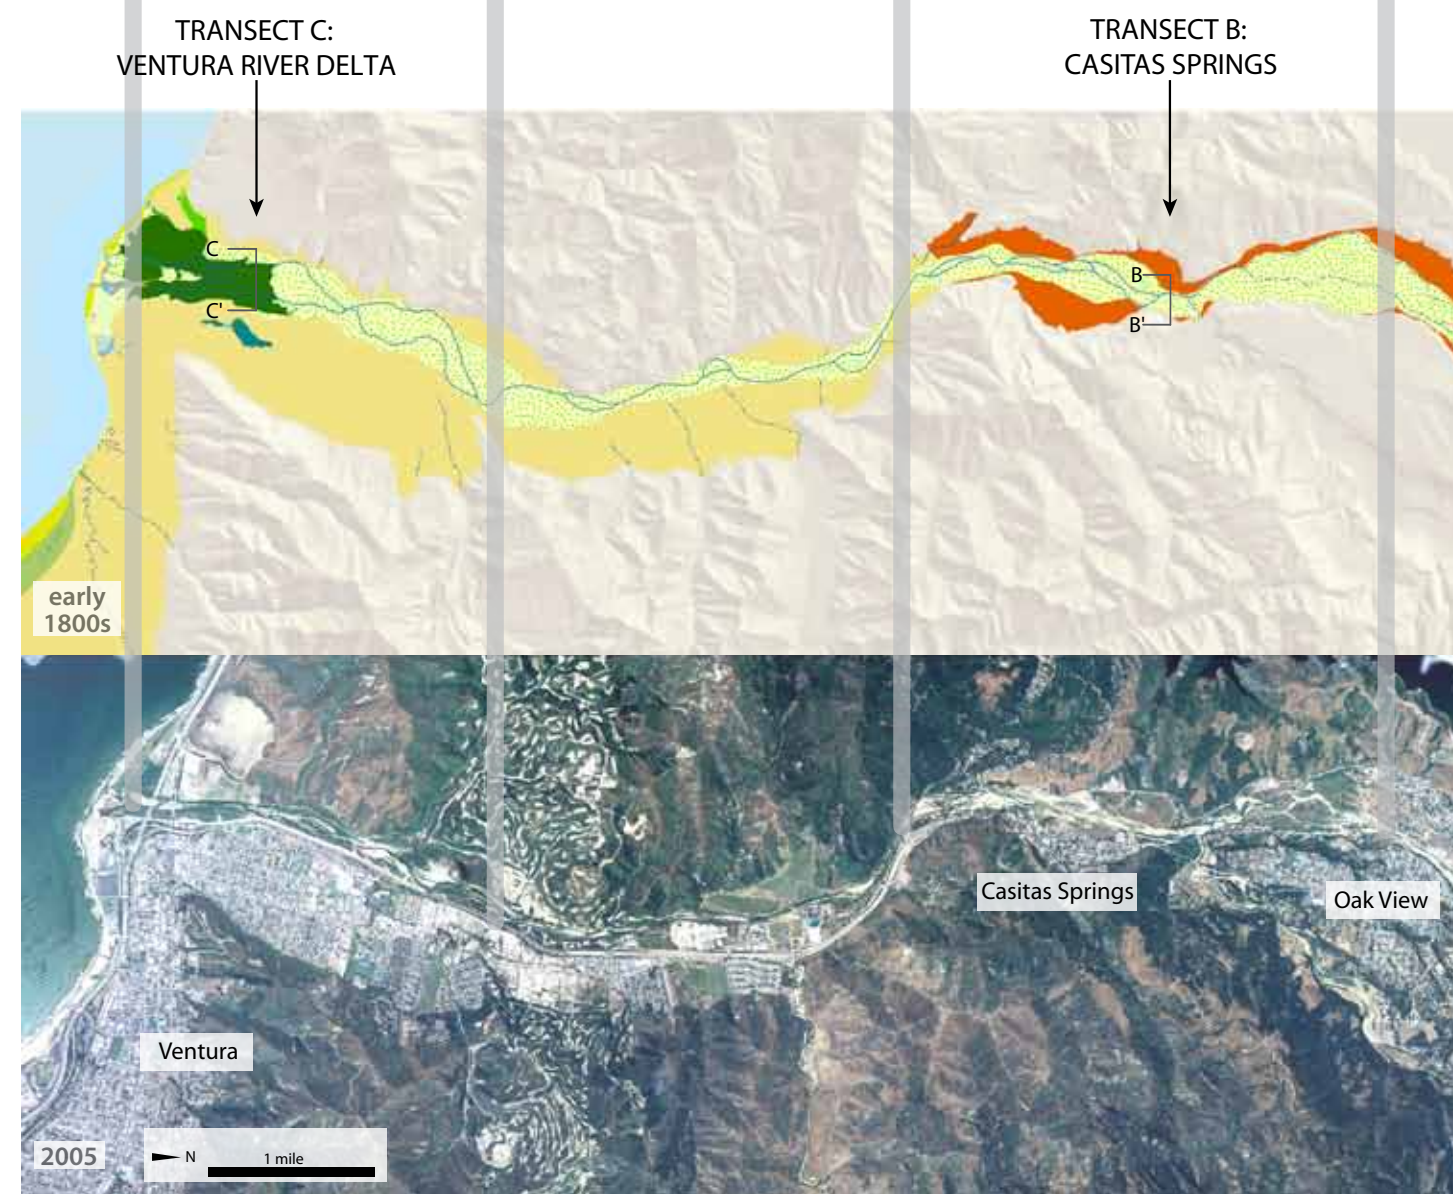
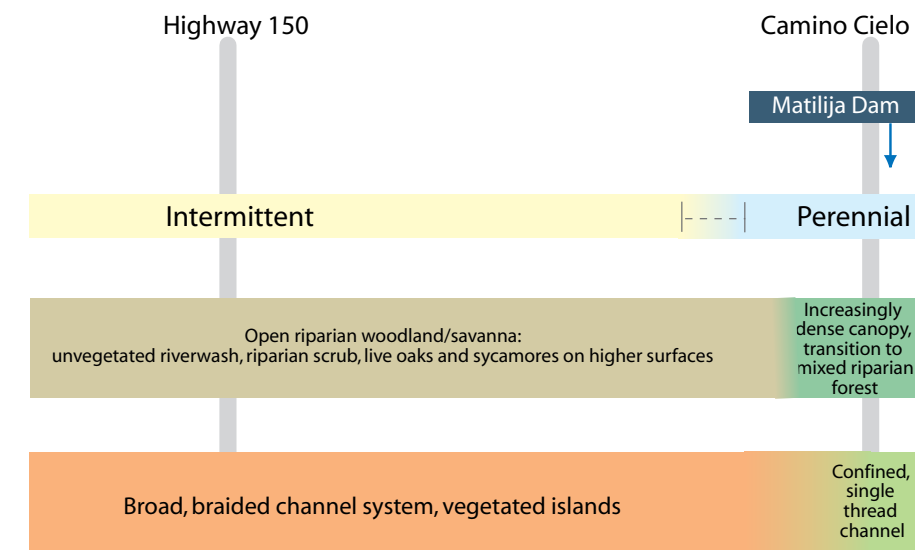
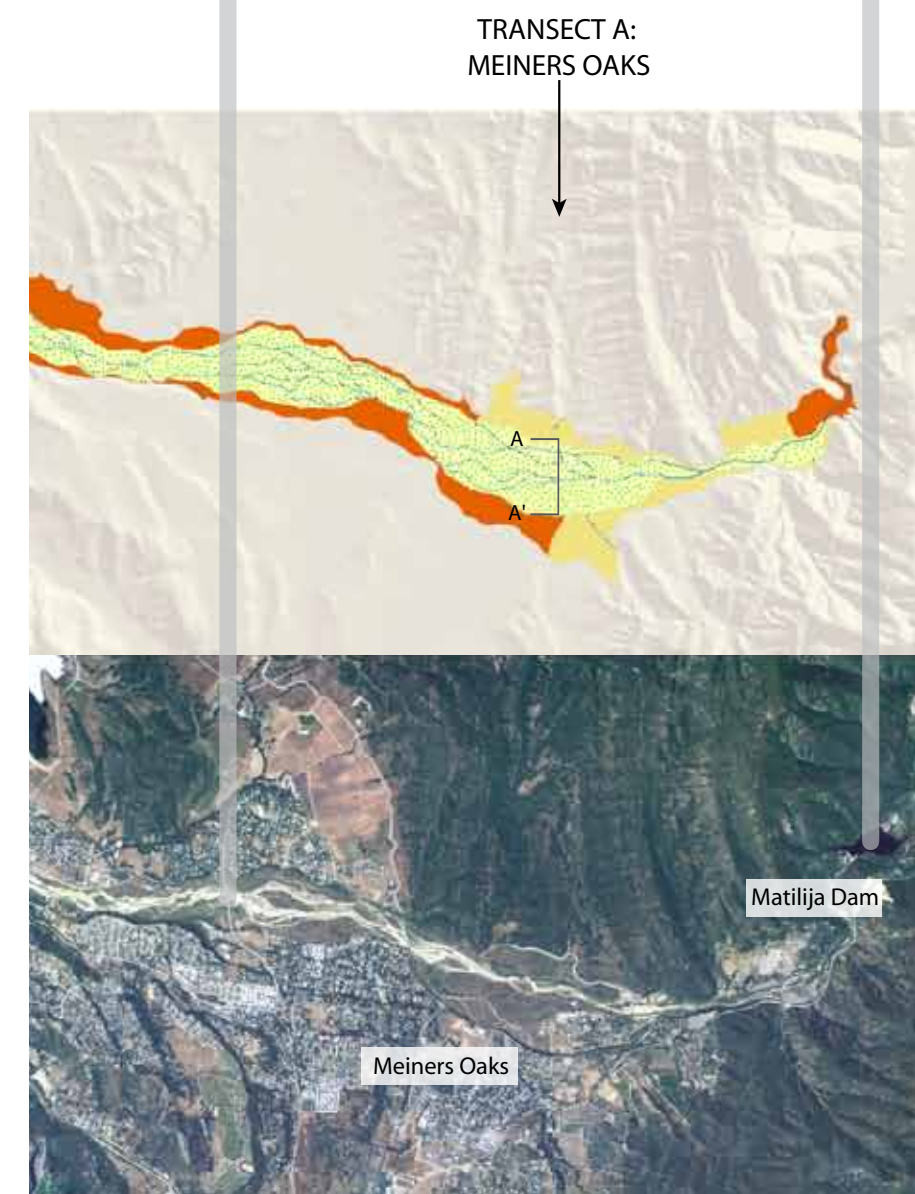
Figure 4.22. Historical characteristics of the Ventura River by reach. This diagram shows how fundamental attributes of the Ventura River varied by reach. The close relationships evident in this diagram between riverine hydrology, ecology, and morphology indicate the interrelated nature of these characteristics. Transitions between reaches were gradual, with variable locations through time. The locations of the three transects (following pages) are also indicated here.

The Ventura River historically exhibited a diverse suite of ecological, hydrologic, and geomorphic characteristics. This section synthesizes the patterns documented in this chapter to provide a more integrative, visual understanding of riverine properties both longitudinally and through time (fig. 4.22). We also provide a summary of our findings and the implications of our research for management strategies in the watershed today.

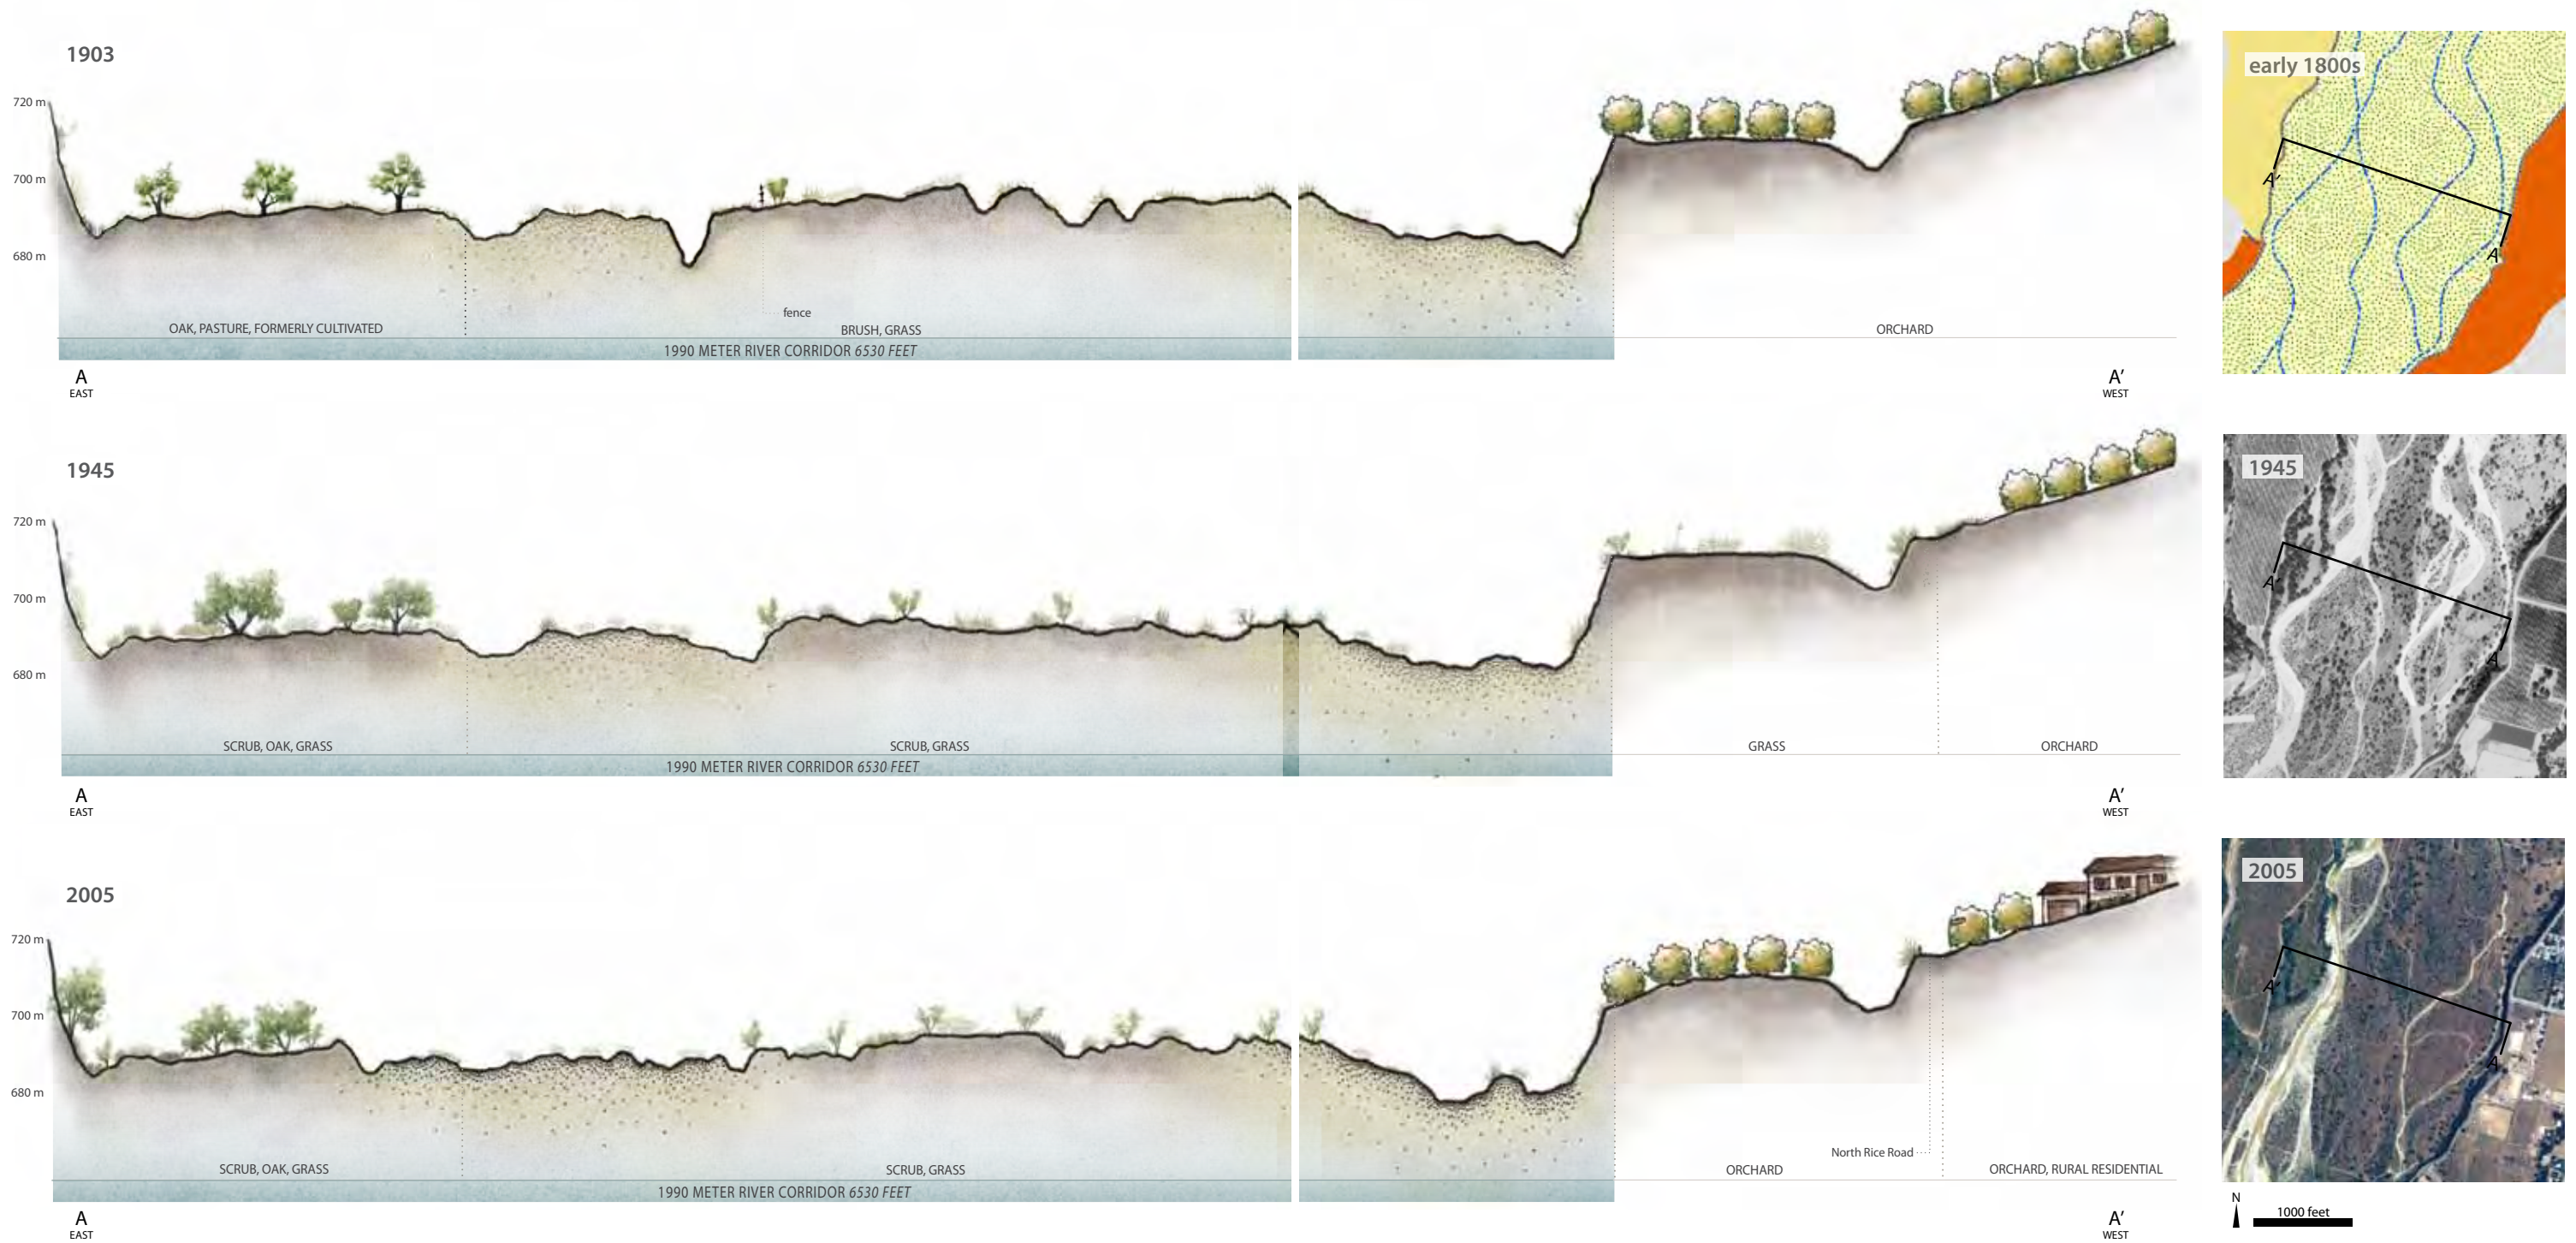
MEINERS OAKS REACH

Fig. 4.23. Historical cross-sections at Meiners Oaks, 1903-2005. This time series shows the Ventura River just west of the town of Meiners Oaks, in a broad, braided section of the river about 2 miles north of the Highway 150 bridge. Broad patterns in river corridor width and ecology have remained remarkably consistent in this reach over time. Cross-sections are drawn with 5x vertical exaggeration. (Waud 1903 and Lippincott 1903, courtesy of the Museum of Ventura County; USDA 1945, courtesy of the UC Santa Barbara Map and Imagery Library; USDA 2005. Cross-sections produced by Jen Natali)

We focus here on three sample reaches chosen to illustrate these concepts in cross-section: an upstream reach at Meiners Oaks (fig. 4.23), an intermediate reach at Casitas (fig. 4.24), and a lower reach near the river mouth (fig. 4.25). The transects and accompanying plan form representations illustrate the historical hydrology, morphology, and ecology of the river in these three very different locations in the 19th and early 20th centuries (1853-1903). We also produced cross-sections presenting conditions in these reaches during the mid-20th century (1927-1945) and early 21st century (2005) to depict the impacts of changing land use over this time. Taken together, these reaches represent a broad variability in vegetation and flow characteristics along the river.

In the absence of historical elevational data, we used modern (2005) LiDAR data as the starting point for historical elevations and valley width, making adjustments as needed for the historical renderings (e.g., removing anachronistic road cuts and levees). As a result, the following cross-sections necessarily focus more on changes in floodplain extent and character than on changes in bed elevation.

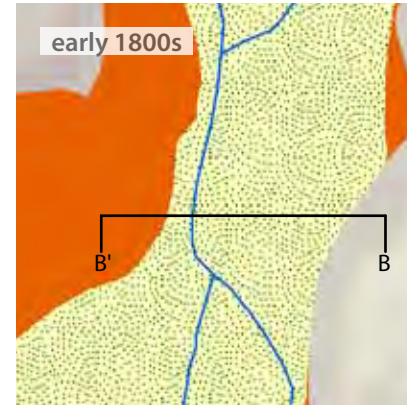
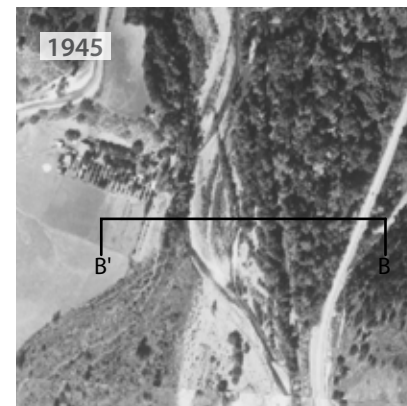
Fig. 4.24. Historical cross-sections at Casitas, 1877-2005. This series of cross-sections shows the Ventura River south of the San Antonio Creek confluence. The transect is in a reach with perennial flow, a relatively narrow river corridor (in comparison to other reaches of the river), and historically abundant live oak and sycamore. Like the Meiners Oaks reach to the north, this reach has retained many of its historical characteristics. Cross-sections are drawn with 5x vertical exaggeration. (Norway 1877; USDA 1945, courtesy of the UC Santa Barbara Map and Imagery Library; USDA 2005. Cross-sections produced by Jen Natali)

On August 3 and 4, 1877, surveyor W.H. Norway walked this transect; his survey forms the basis of the earliest cross section. Norway described the active channel as “riverwash” 460 feet wide, with a low-flow channel 16 feet wide carrying summer water toward the ocean. (This is especially notable given that 1877 was a severe drought year in the region.) On the eastern side of the river between the active channel and the hills, he noted “heavy oak & sycamore timber” on the “bottomland” surface. He also documented early modifications, including the wagon road connecting Ventura and Ojai and paralleling the river on the western side, and a fence separating agricultural fields from the river on the west bank.

Surprisingly, aerial photos from 1945 show evidently little change in riparian composition and river corridor extent from the snapshot provided by Norway in the late 1870s. The wagon road route remained, replaced by a branch line of the Southern Pacific Railroad. Broad, dense riparian forest still characterized the eastern bank. The most severe modifications occurred in the second half of the 20th century, when a levee on the west bank was constructed and the wagon road remnant transformed into several highways, including Highway 33 and the Ojai Valley Trail Road. Significant riparian forest (willows near the channel, and oaks and sycamores on the eastern floodplain) remains, though it is bisected by the Ojai Valley Trail and Highway 33.

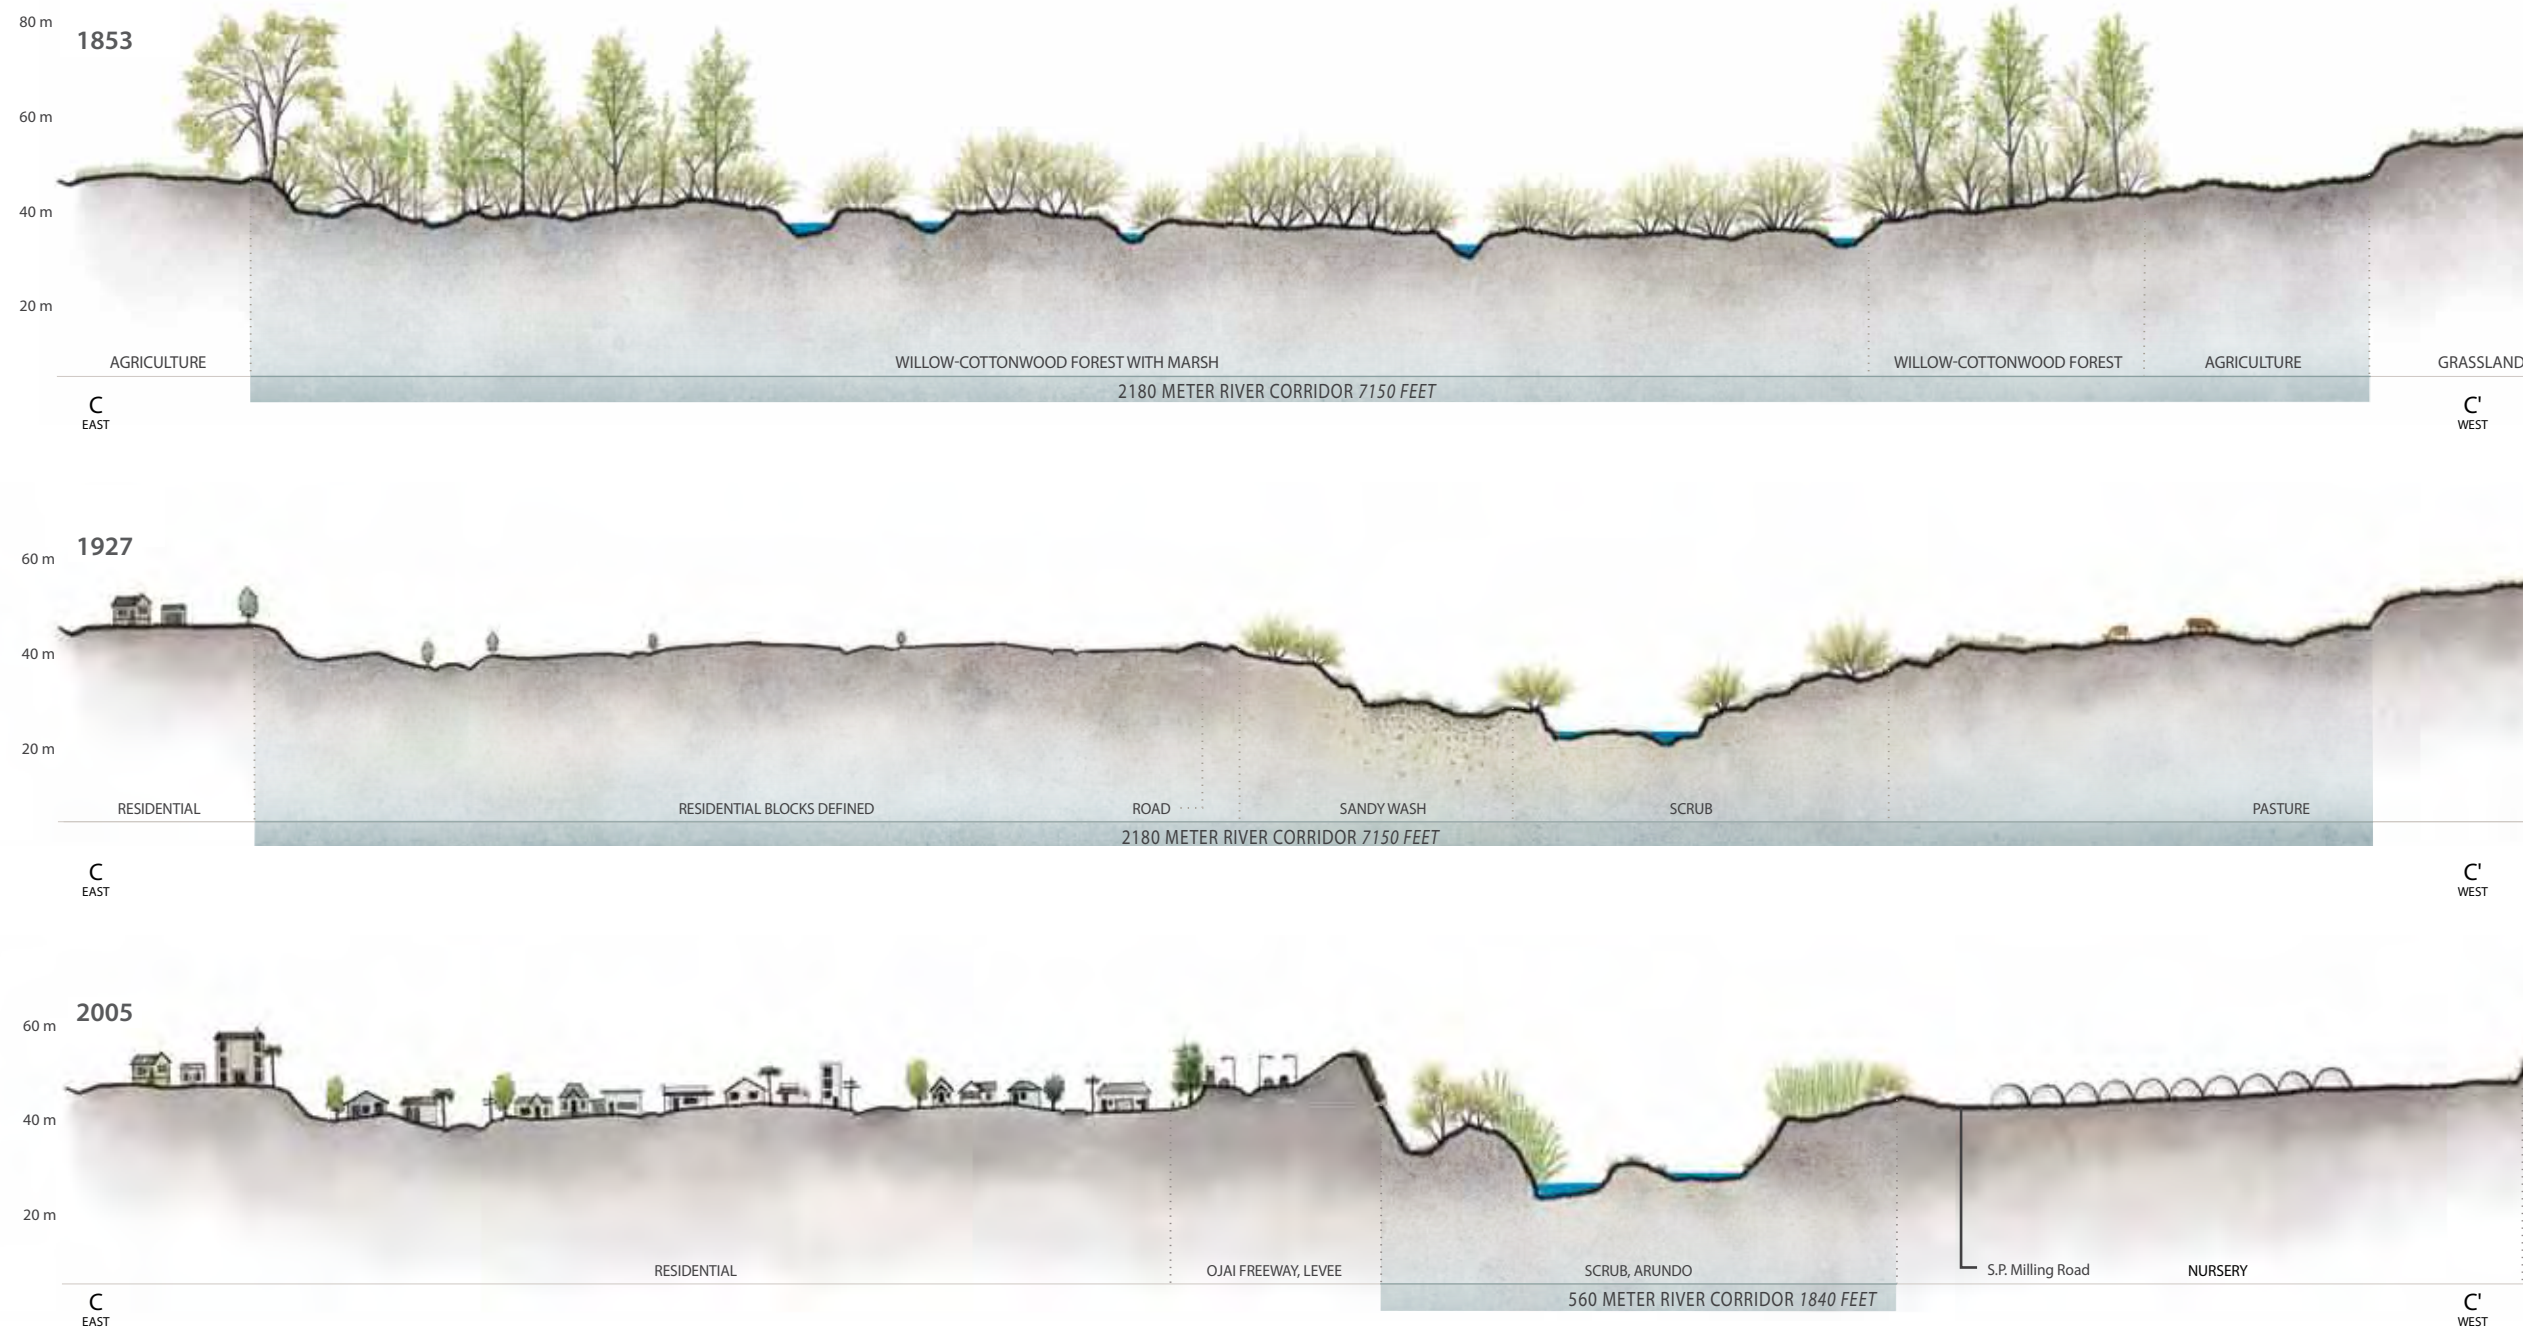
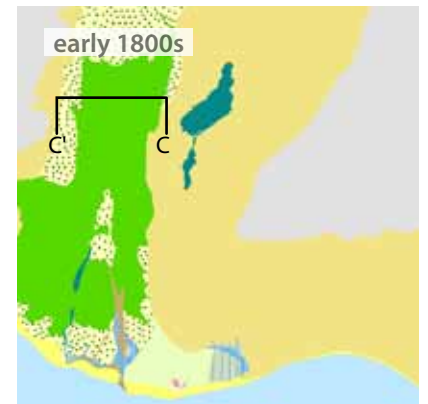
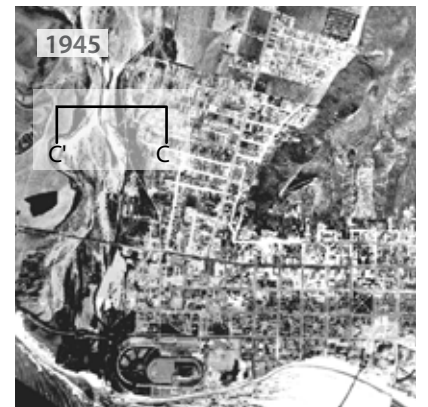
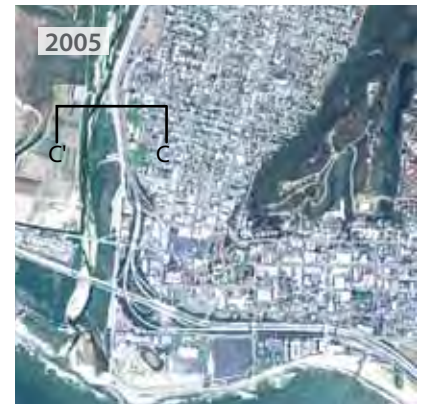
Fig. 4.25. Historical cross-sections at the Ventura River mouth, 1853-2005. This time series shows the Ventura River at its mouth, about ½ mile upstream from the Highway 101 bridge. The area was dominated by broad willow-cottonwood forest and shallow, multi-thread distributary channels. By the early 20th century, the floodplain had been converted into a much narrower, leveed channel to make way for northward expansion from the town of Ventura. The earliest cross-section is derived from GLO notes and the mid-19th century T-sheet drawn of the river mouth by the U.S. Coast Survey. Cross-sections are drawn with 5x vertical exaggeration. (Norris 1853, Johnson 1855c, courtesy of the National Oceanographic and Atmospheric Administration; Fairchild Aerial Surveys 1927, courtesy of Whittier College; USDA 2005. Cross-sections produced by Jen Natali)

This cross section captures the dramatic changes over time at the mouth of the Ventura River, about ½ mile upstream of the current Highway 101 crossing. The T-sheet for this area, surveyed in summer 1855, depicts a broad (over 1.2 miles wide) river corridor dominated by interconnecting distributary channels and dense riparian forest. This is corroborated by a GLO survey conducted two years earlier in October 1853, when surveyor Robert Norris noted crossing four channels in the midst of what he termed a “willow swamp.” Grassland and some early cultivation bounded the river in the “first rate land in bottom.” The 1870 T-sheet resurvey confirms the continued presence of the riparian forest and marsh through the later 19th century (Greenwell and Forney 1870).

river corridor. This may be a snapshot of a post-flood period of rebuilding, or it may be the beginning of a rapid urbanization of the lower watershed. By 2005, the city of Ventura had expanded fully into the floodplain of the river, fortified by a levee and bounded by the Ojai Freeway. *Arundo donax* has established on both sides of the narrowed river corridor; it was described as “well established for many miles along the river” as early as 1945 (Henry Pollard, in Ferren et al. 1990). Industrial agriculture and nurseries have replaced pasture on the west bank of the river.
