HISTORICAL ECOLOGY of the lower Santa Clara River, Ventura River, and Oxnard Plain: an analysis of terrestrial, riverine, and coastal habitats

HISTORICAL ECOLOGY PROGRAM
CONTRIBUTION NO. 641 • AUGUST 2011

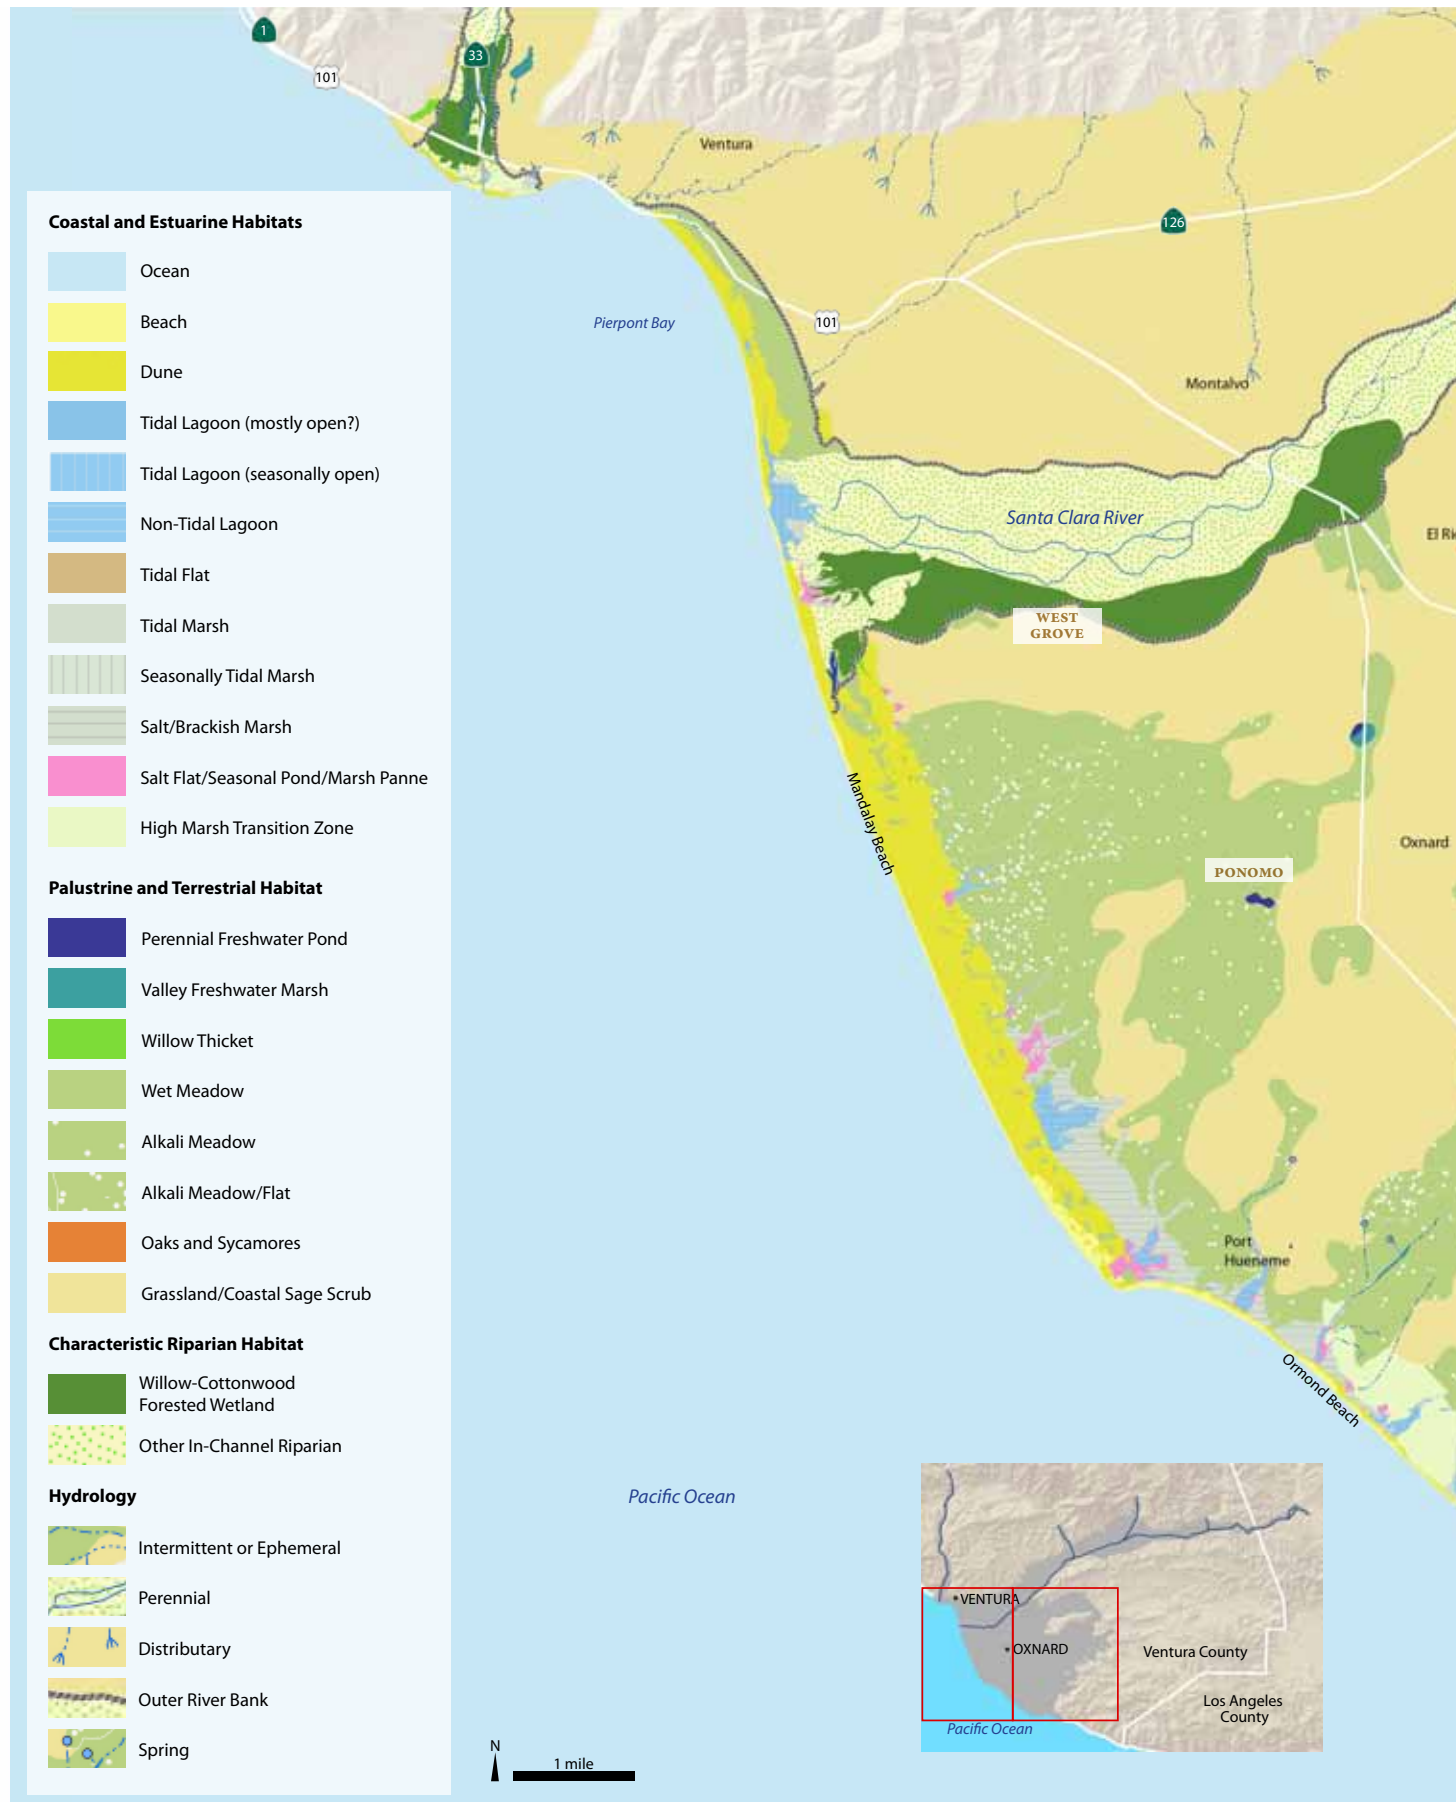
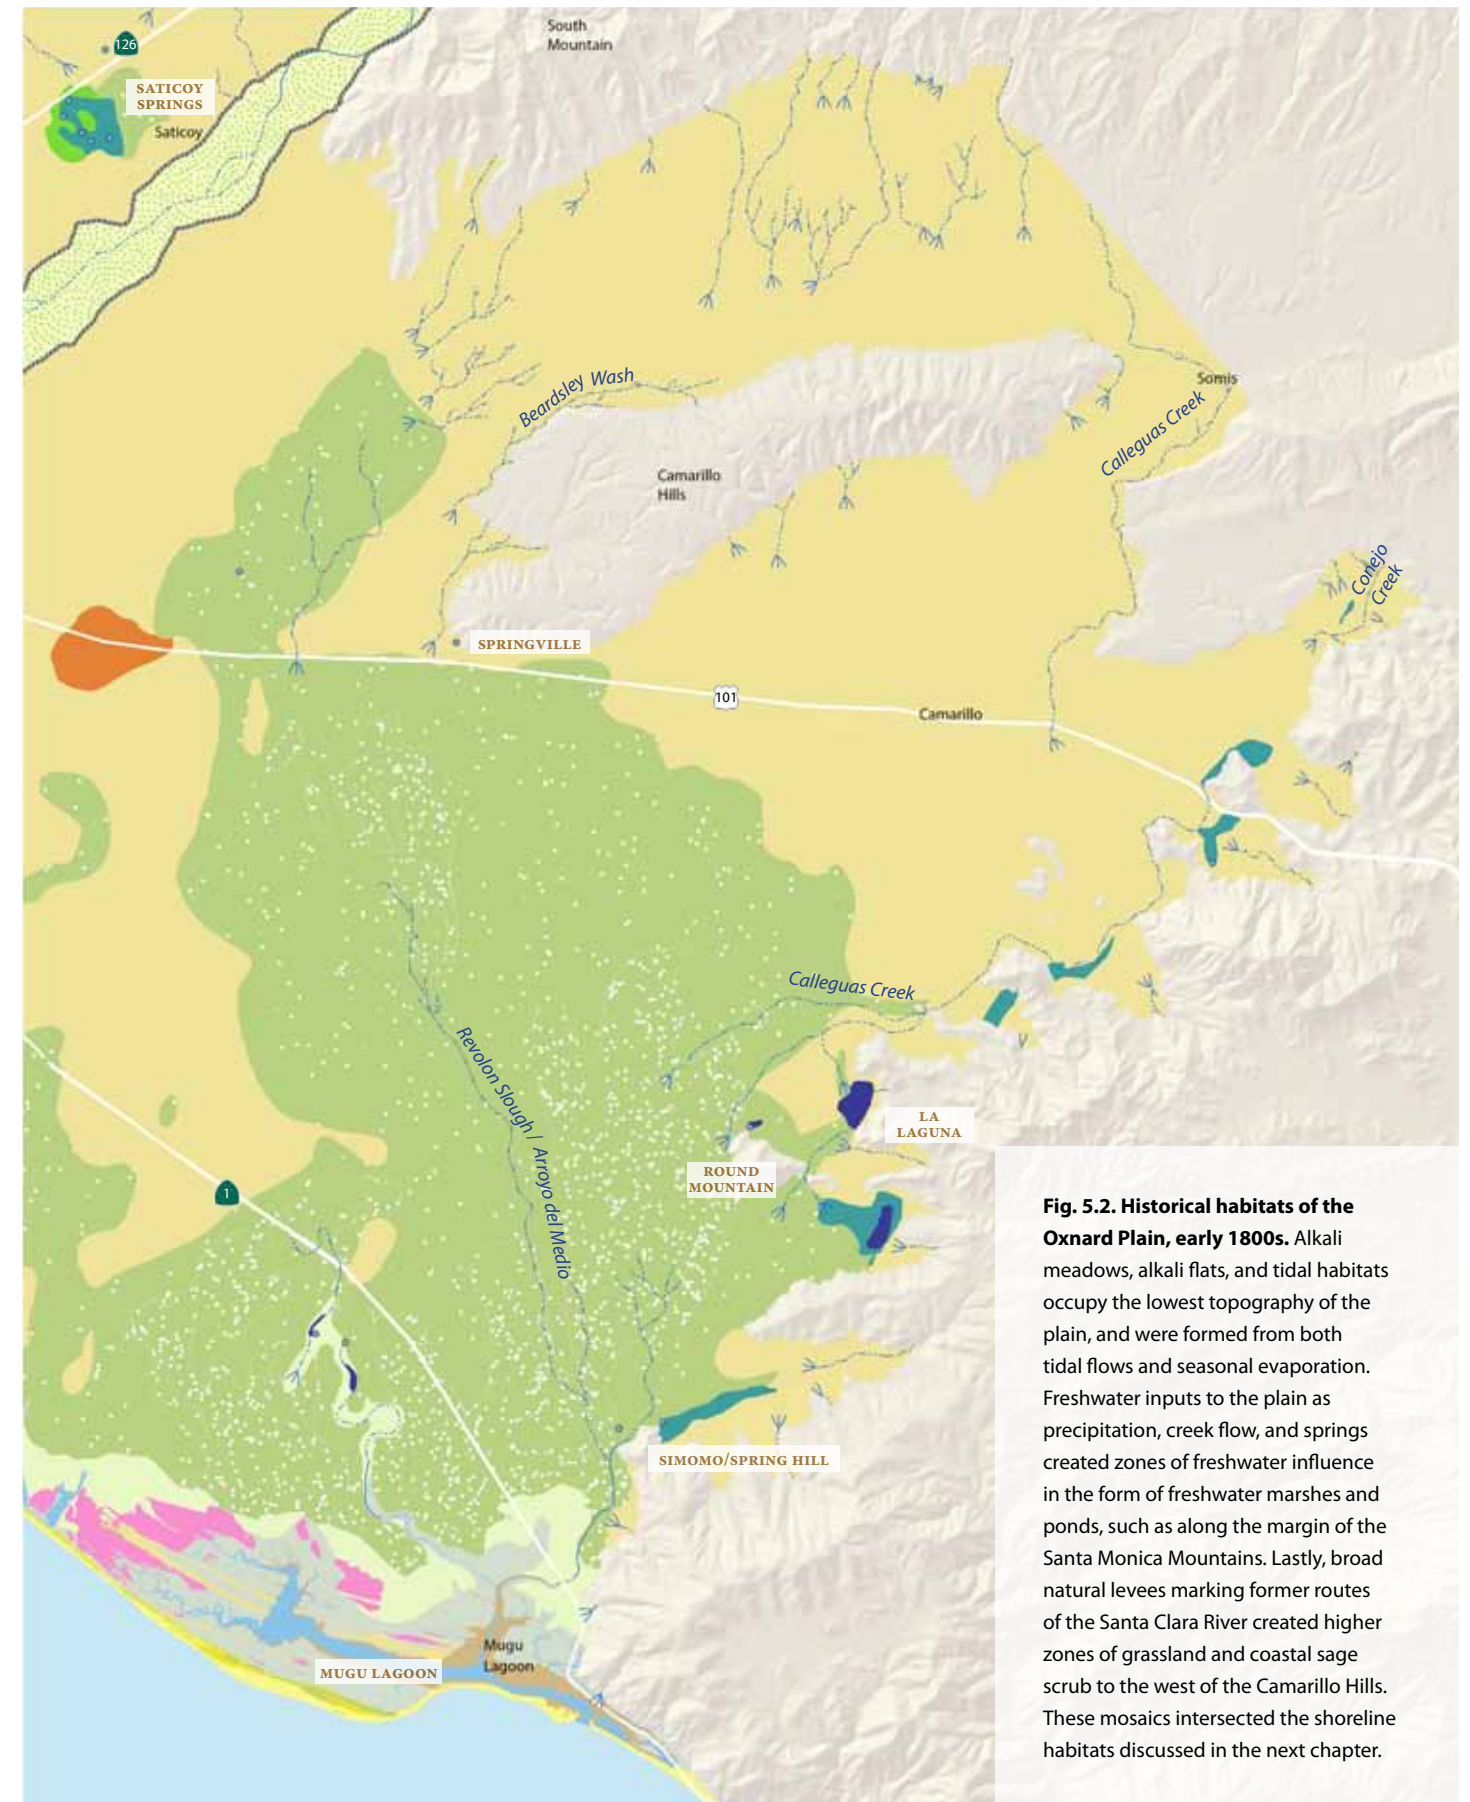
Fig. 5.2. Historical habitats of the Oxnard Plain, early 1800s. Alkali meadows, alkali flats, and tidal habitats occupy the lowest topography of the plain, and were formed from both tidal flows and seasonal evaporation. Freshwater inputs to the plain as precipitation, creek flow, and springs created zones of freshwater influence in the form of freshwater marshes and ponds, such as along the margin of the Santa Monica Mountains. Lastly, broad natural levees marking former routes of the Santa Clara River created higher zones of grassland and coastal sage scrub to the west of the Camarillo Hills. These mosaics intersected the shoreline habitats discussed in the next chapter.

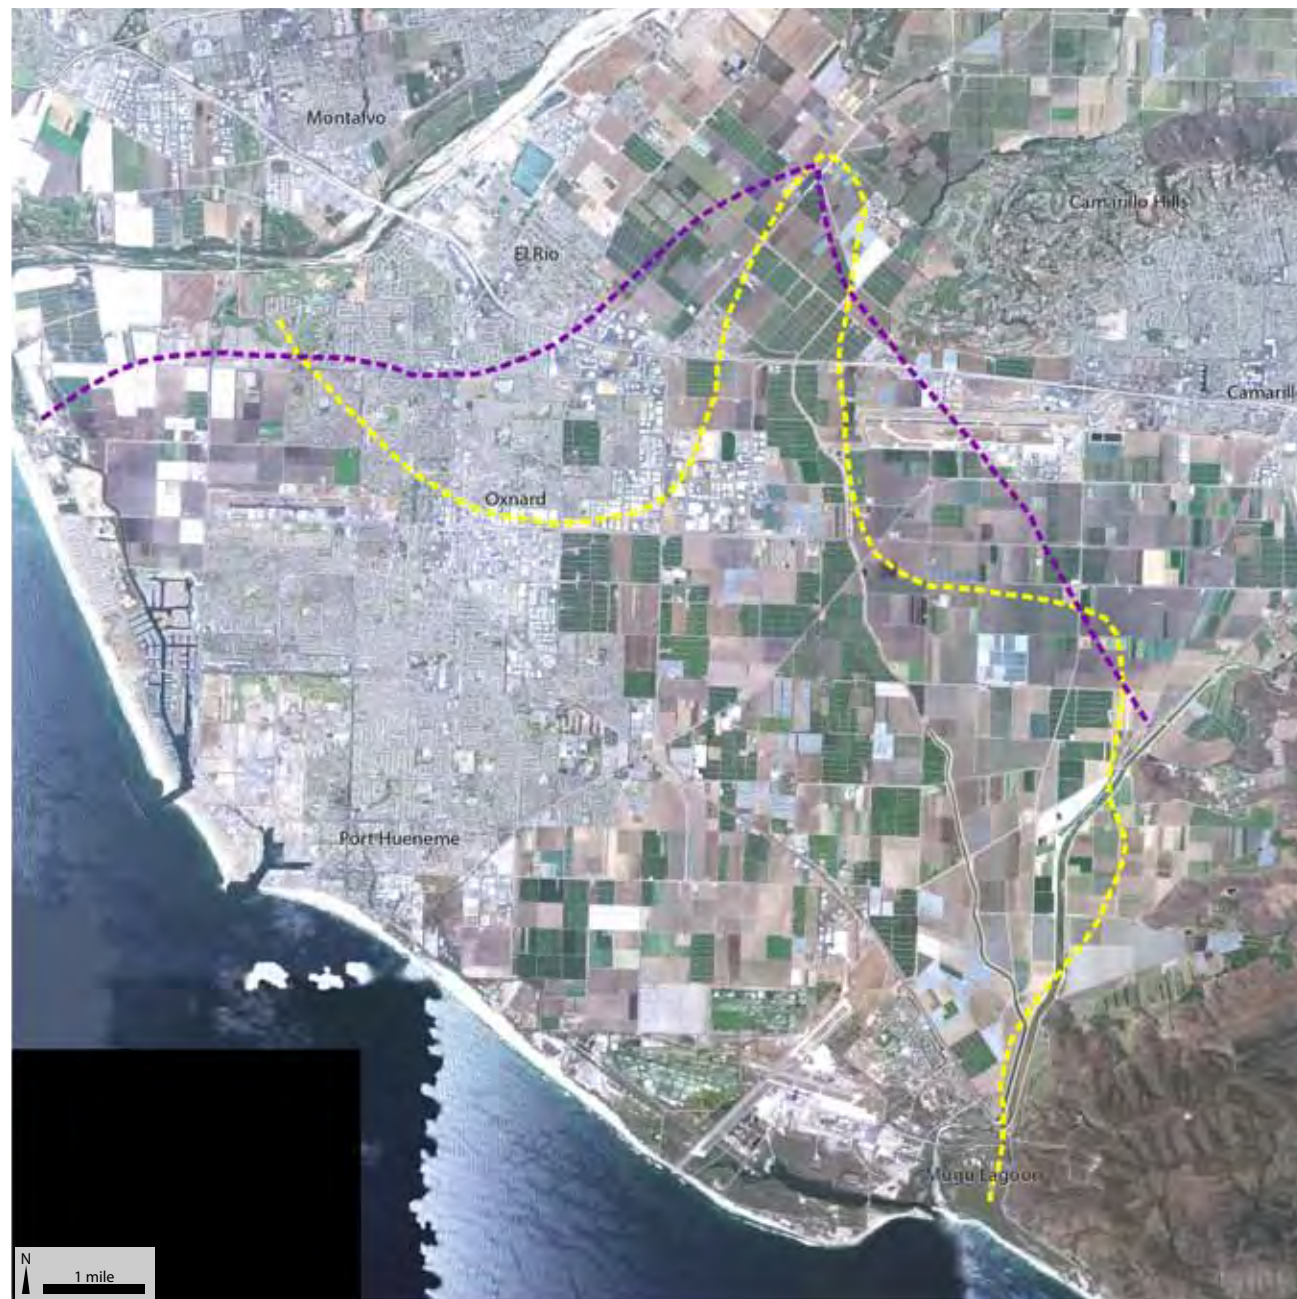
Fig. 5.3. Extent of artesian conditions, 1900 (in purple) and ca.1930 (in yellow). Though both are somewhat coarse delineations, they do suggest some shrinking of the artesian zone in the first quarter of the 20th century. (Schuyler 1900 and Lippincott ca. 1930, courtesy of the Water Resources Collections and Archives)

Much of the Oxnard Plain was subject to artesian conditions, even well into the 20th century (fig. 5.3; Schuyler 1900, Lippincott ca. 1930; see page 38). Long-time residents recalled that “in the old days the water level was right at the surface” on the central Oxnard Plain, an aspect of the plain’s hydrology that manifested as springs, ponds and marshes, and later in the successful development of artesian wells (Bloom 1959). Even in areas outside the artesian zone, abundant water was recorded just below the surface in many places; a GLO surveyor recorded that in March 1874 in the area around the Camarillo Hills there was “no running water but there is a

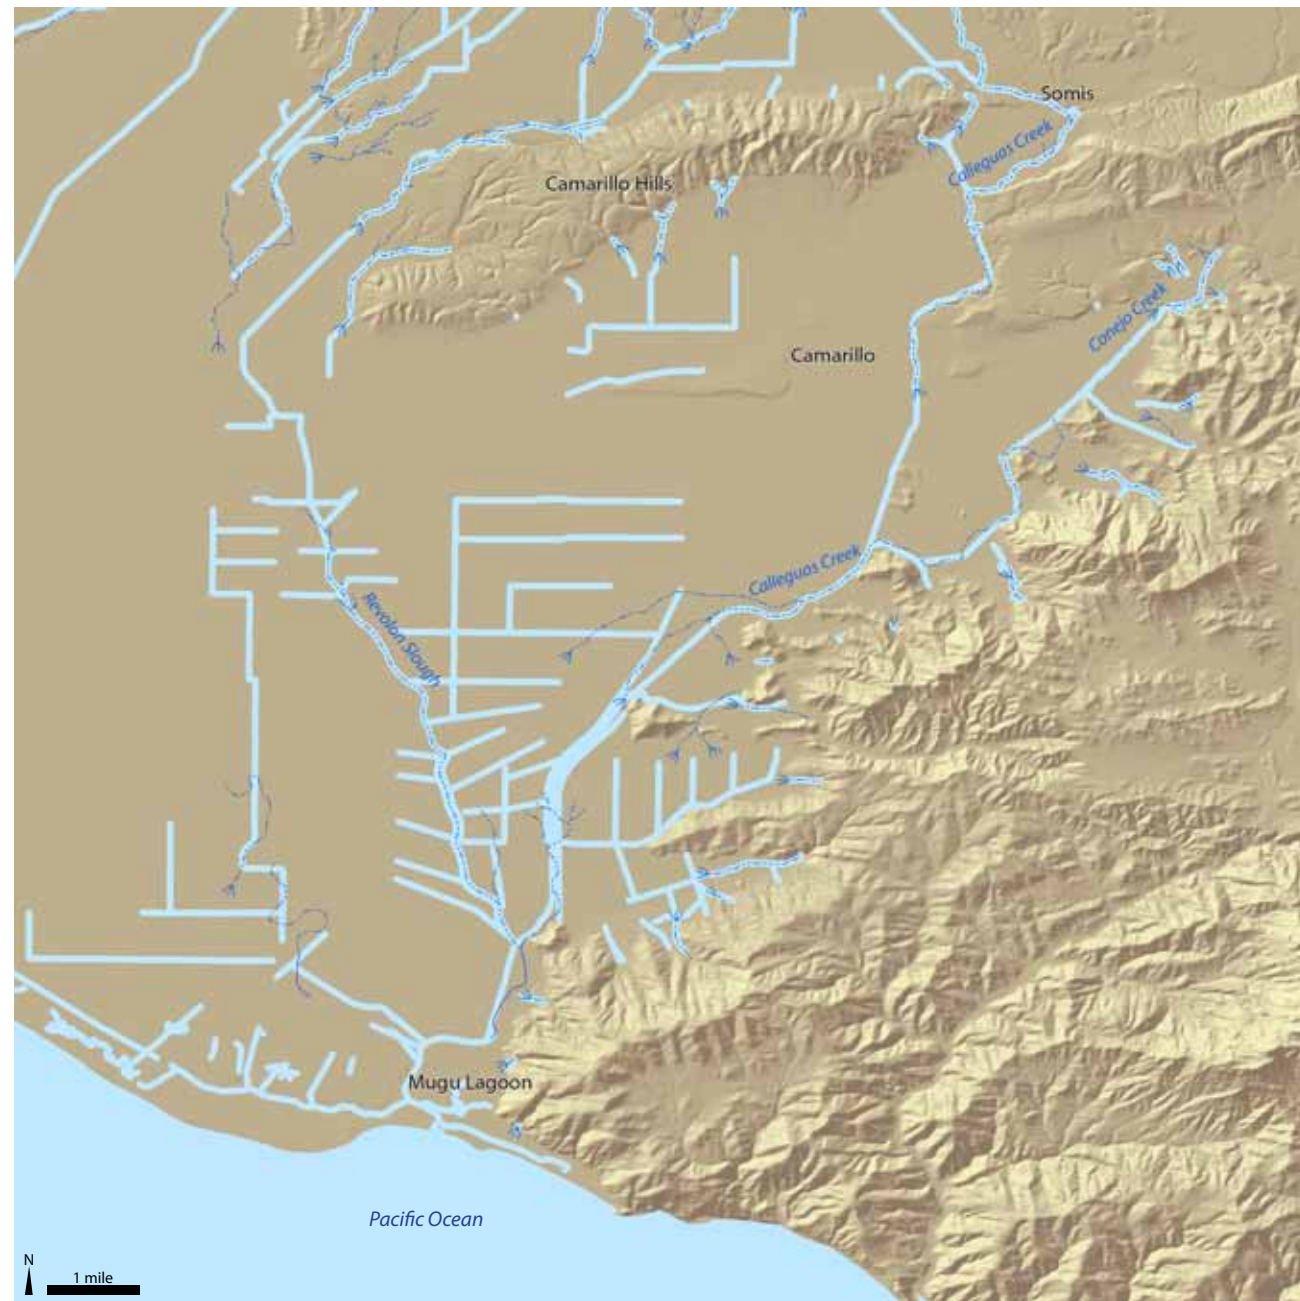
Fig. 5.4. Historical and modern drainage network of the eastern Oxnard Plain, early 1800s and 2005. The creation of new channels, such as drainage and irrigation ditches, has greatly increased the hydrologic connectivity of the eastern plain. Notably, Calleguas Creek now connects to Mugu Lagoon, and Beardsley Wash has been connected to Revolon Slough.

Revolon Slough was notable as a former course of the Santa Clara River (see page 71) and as the predominant watercourse draining the central Oxnard Plain. While the slough ran through the heart of the region's alkali meadows, the natural levees to either side of the slough were not affected by alkalinity, created what Holmes and Mesmer (1901c) called “an oasis in the broad alkali flat.” Farmers took advantage of the slough to drain and flush strongly alkaline lands. Over time, an extensive drainage network was created, connecting Calleguas Creek and (much later) Beardsley Wash into Revolon Slough and providing a direct outlet to the ocean through Mugu Lagoon where there was formerly none. These modifications drastically increased the drainage density of the central Oxnard Plain (see fig. 5.4).

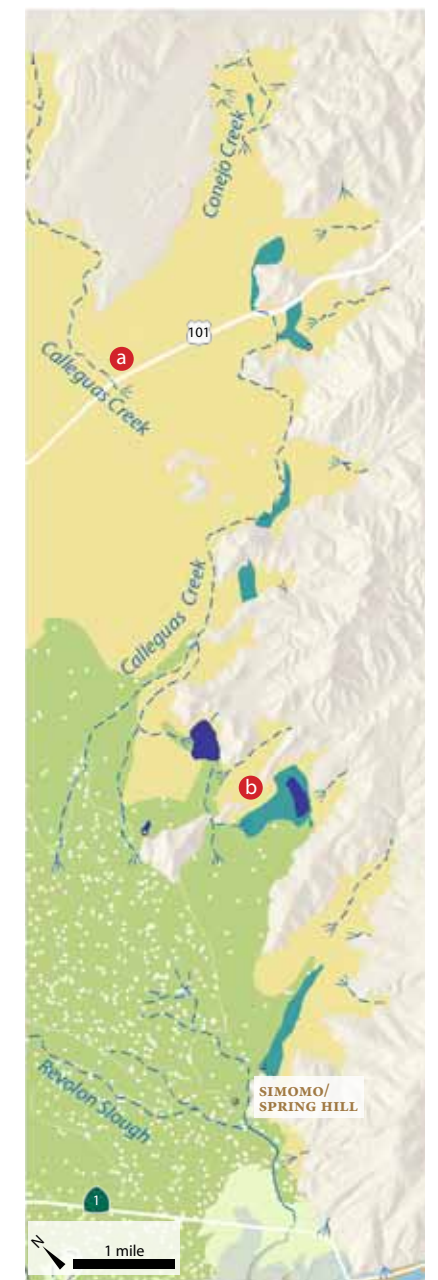
Fig. 5.5. Prior to channelization, Calleguas Creek maintained a defined channel only above Highway 101 (a) and for a few miles above CSU Channel Islands (labeled here at b). Note also the freshwater wetlands, ponds, and springs along the foothills on the eastern edge of the Oxnard Plain.

However, historical maps and textual evidence clearly support the early discontinuous nature of the creek, and its subsequent channelization (fig. 5.5). These sources indicate that Calleguas Creek maintained a defined channel to around the Highway 101 crossing, then emerged again (possibly more associated with the Conejo Creek drainage) at the current confluence of Calleguas and Conejo creeks. The creek maintained a defined channel for a short distance (approximately 2.5 miles) before terminating in a lagoon and distributary channels north of Round Mountain and CSU Channel Islands (see page 186). GLO surveyors crossing the creek recorded widths of approximately 165-230 feet at a point along the creek north of Highway 101 (east of the intersection of Highway 34 and Las Posas Road in Camarillo; Tolman 1873), and about 20-30 feet for the southern articulation of the

of groundwater-fed seeps, springs, lakes, and marshes along substantial portions of the small foothill valleys of the Calleguas watershed (see fig. 5.5). Many of these springs occurred at the contact between alluvial loams of the valley floor and the older, largely volcanic upland bedrock, and some are likely associated with regional faulting (Tan et al. 2004) and possible impoundment behind alluvial deposits from Calleguas and Conejo creeks. We estimate that this area had about 400 acres of wetlands. Many of these areas served as major cultural landmarks in an otherwise relatively dry, alkaline area, and influenced the location of Chumash and early Spanish/Mexican and American settlements in the area.

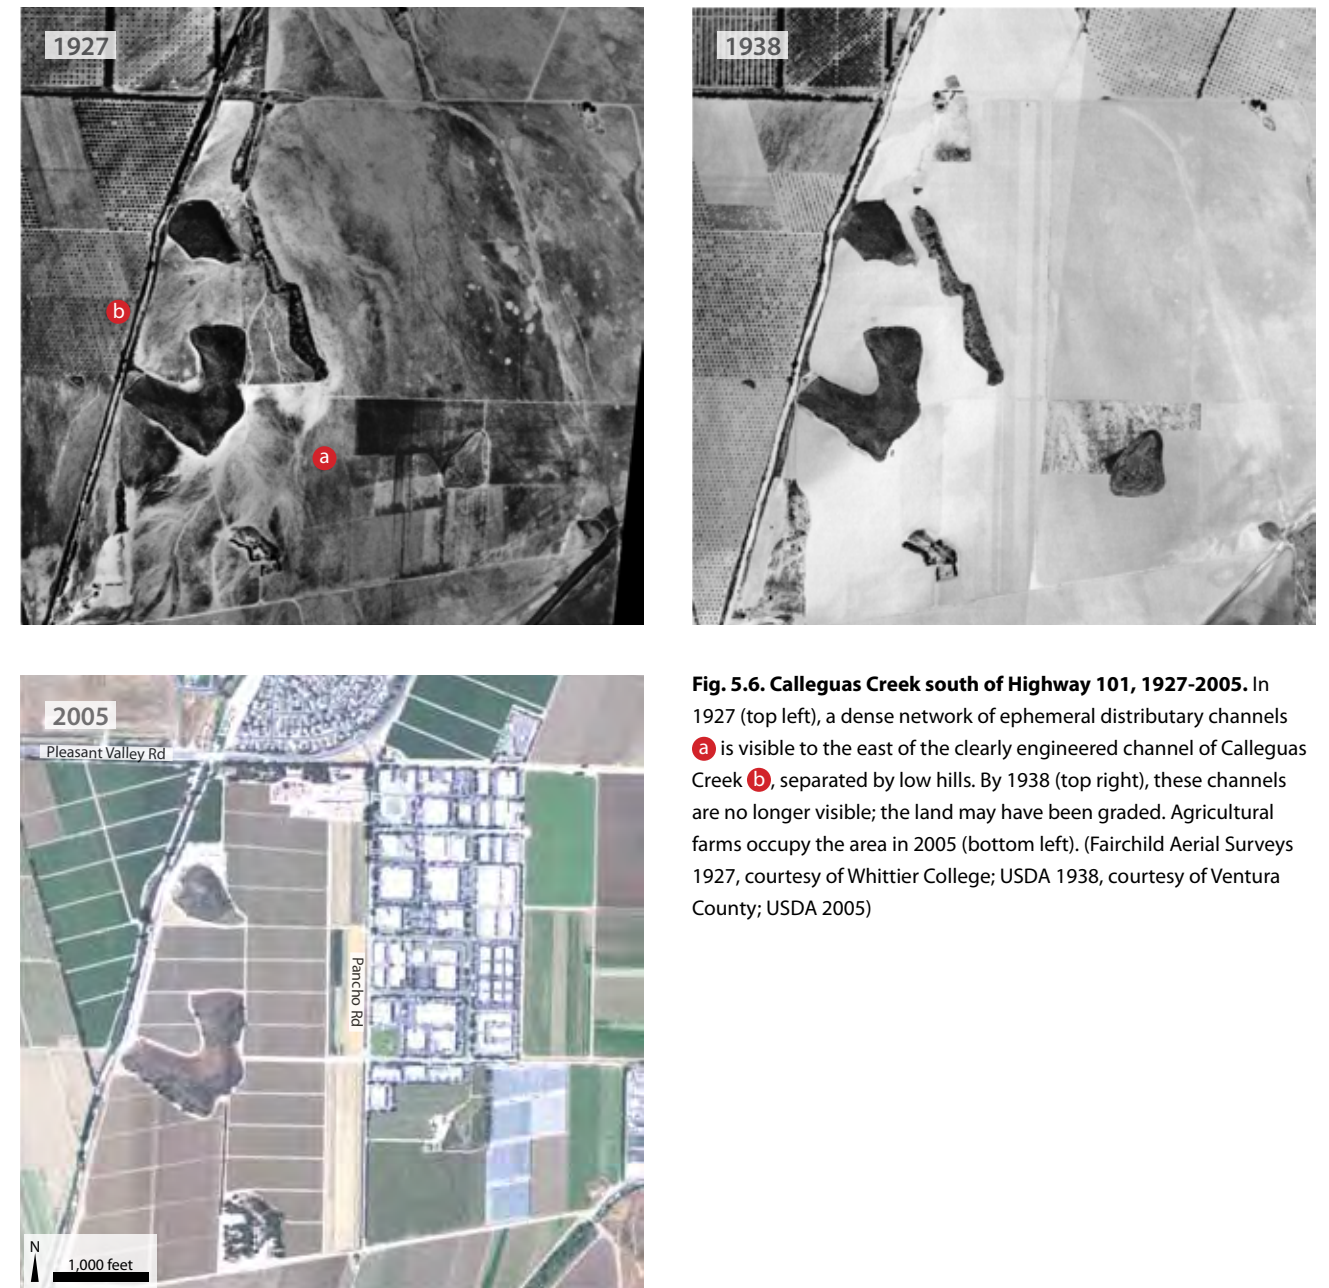
Fig. 5.6. Calleguas Creek south of Highway 101, 1927-2005. In 1927 (top left), a dense network of ephemeral distributary channels **a** is visible to the east of the clearly engineered channel of Calleguas Creek **b**, separated by low hills. By 1938 (top right), these channels are no longer visible; the land may have been graded. Agricultural farms occupy the area in 2005 (bottom left). (Fairchild Aerial Surveys 1927, courtesy of Whittier College; USDA 1938, courtesy of Ventura County; USDA 2005)

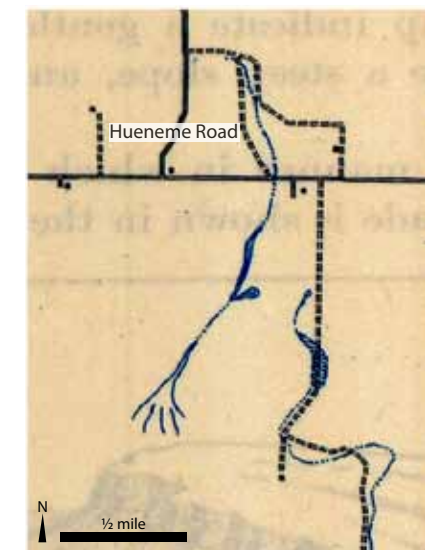
Fig. 5.7. Channels west of Revolon Slough, 1904. Disconnected sloughs west of Revolon Slough carried water from the central Oxnard Plain into Mugu Lagoon. Broader ponded areas are shown within the channel on this early USGS quad. Highway 1 now runs to the north of this complex. A willow thicket currently occupies an undeveloped segment of the meanders at lower right. (USGS 1904, courtesy of California State University Northridge Map Library)

Revolon Slough, also known as Arroyo del Medio (“creek of the middle”; Norway 1860), was one of the few natural drainages on the Oxnard Plain between Calleguas Creek and the Santa Clara River. Revolon Slough had its source just below the modern intersection of East Fifth Street and Pleasant Valley Road east of Oxnard (Norway 1860, USGS 1904), and drained into the sloughs above Mugu Lagoon (fig. 5.7).

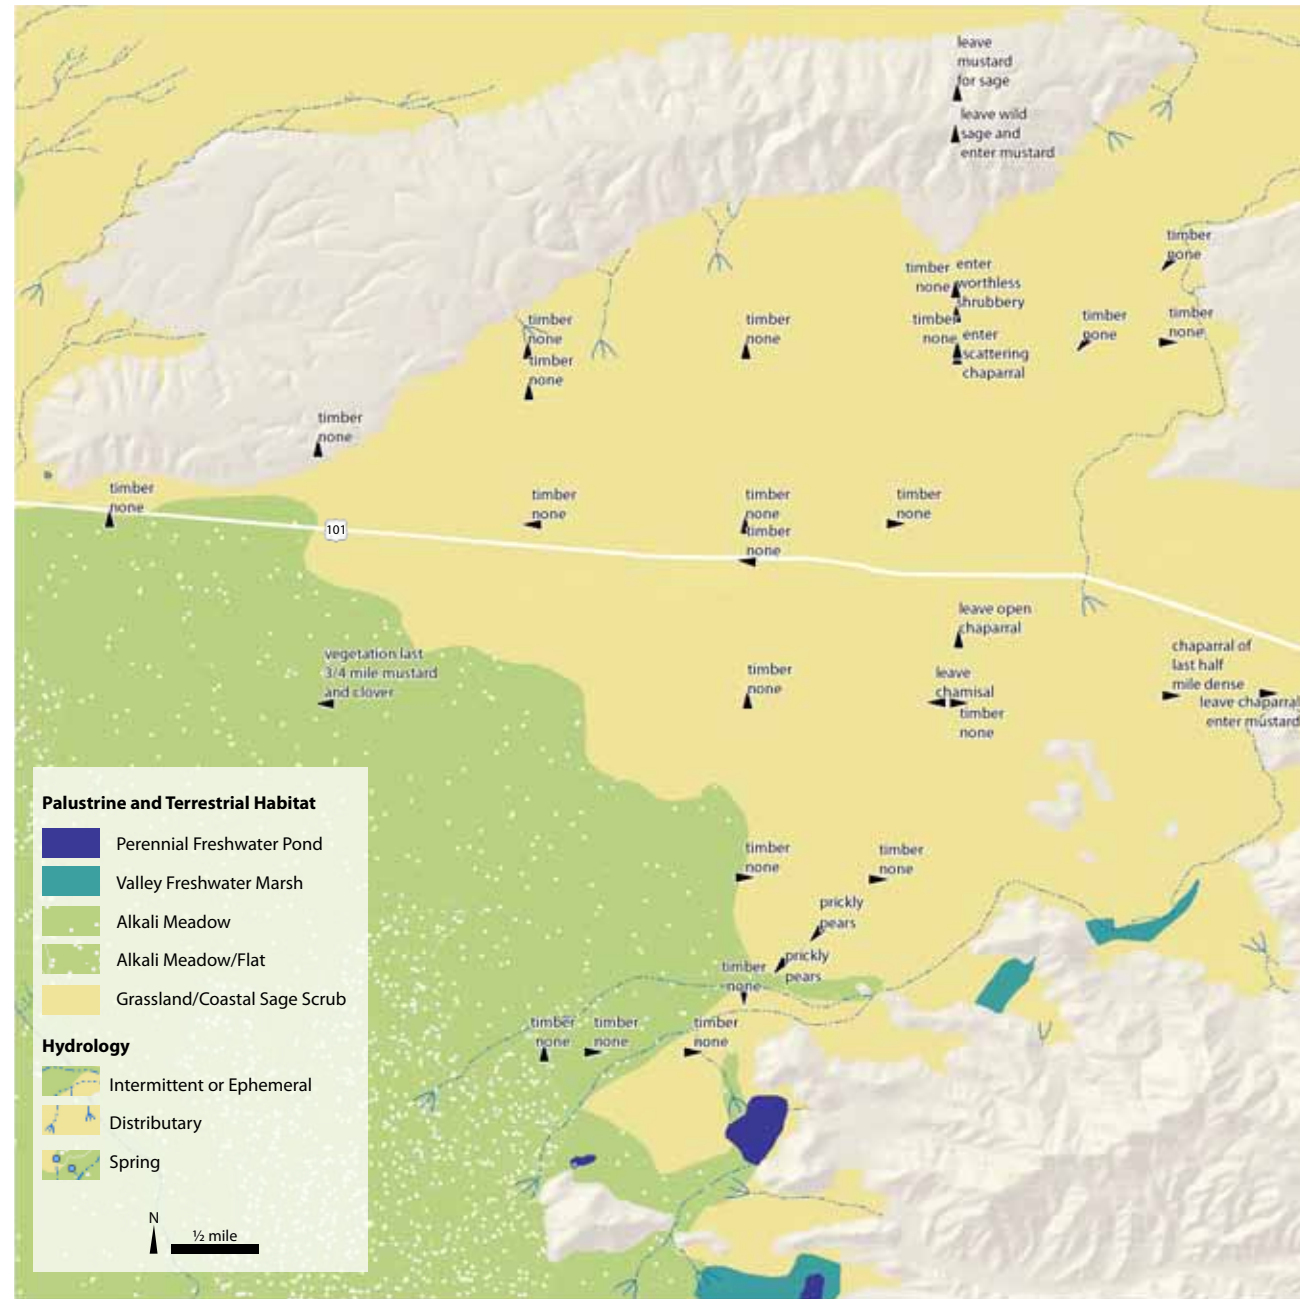
Fig. 5.8. Early evidence for historical vegetation near Camarillo, 1853-1873. General Land Office surveyors noted large areas covered in scrub, while noting no bearing trees. These quotes provide a glimpse into the variation in land cover represented by the grassland/coastal sage scrub habitat class. (The arrows represent direction of travel.) (Hancock 1854, Terrell 1861a, Tolman 1873; courtesy of the Bureau of Land Management)

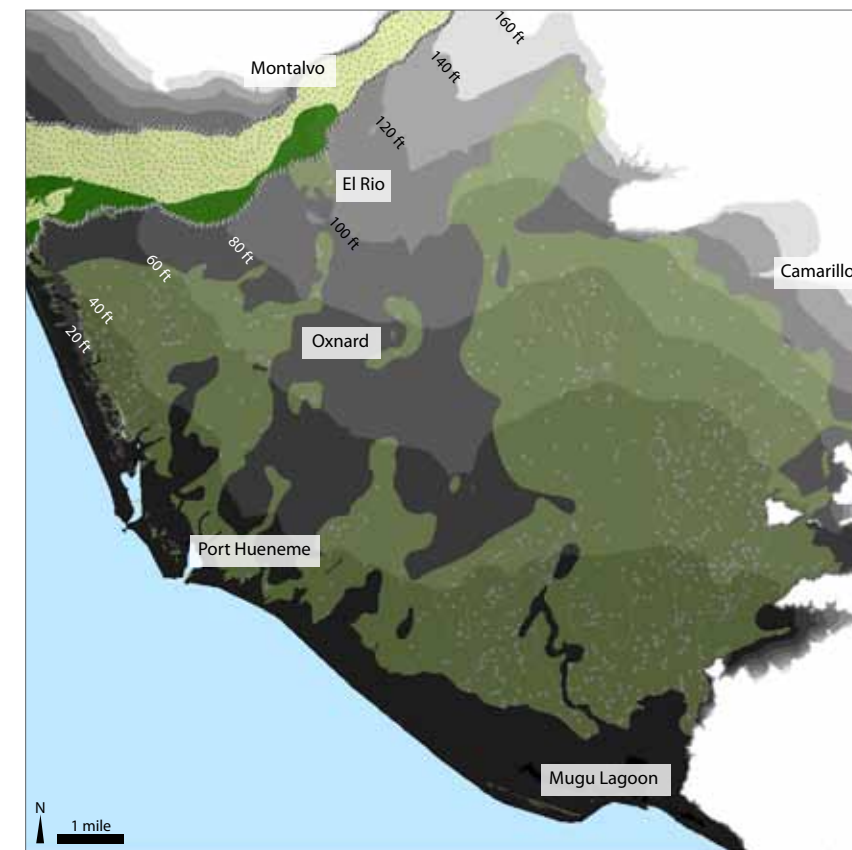
Fig. 5.10. This contour map shows the topography of the Oxnard Plain, with an overlay of mapped historical extent of alkali meadow and alkali meadow/flat. While the entire plain is extremely flat, these contours show lower elevations extending further inland west of the Camarillo Hills, matching the furthest inland extent of alkali meadow, and reflecting the spatial extent of the Santa Clara River’s alluvial fan.

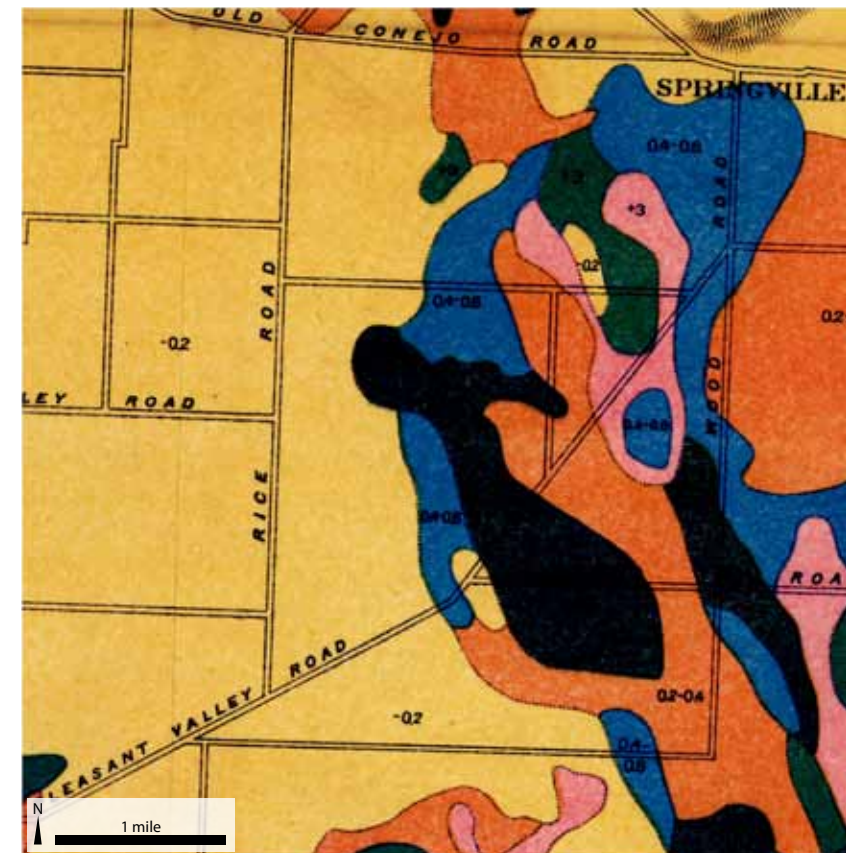
Fig. 5.11. Alkali concentrations on the Oxnard Plain, 1901. Various concentrations of alkali in the first 6 feet of the soil column were measured in the soil near the historical head of Revolon Slough (east of Oxnard and southwest of the Camarillo Hills). Concentrations of less than 0.2% were not considered to be affected by alkali, while concentrations of 0.2%-1% were mapped as alkali meadow. The most strongly alkaline areas, with concentrations over 1%, were described in the soils report as unfarmable areas where “alkali weeds and salt grass alone are able to subsist,” and were mapped as alkali meadow/flat. (Holmes and Mesmer 1901a, courtesy of The Bancroft Library, UC Berkeley)

While sugar beets created a profitable industry on much of the previously unfarmable plain, even sugar beets were not salt-adapted enough to successfully grow in some areas: “a great deal of this land is too alkaline even to raise beets, and it will have to be reclaimed before it can produce any useful crop” (Holmes and Mesmer 1901c). These were the most strongly alkaline areas (over 1% alkali), where “alkali weeds and salt grass alone are able to subsist, but do not afford much pasturage” (fig. 5.11; see page 180).

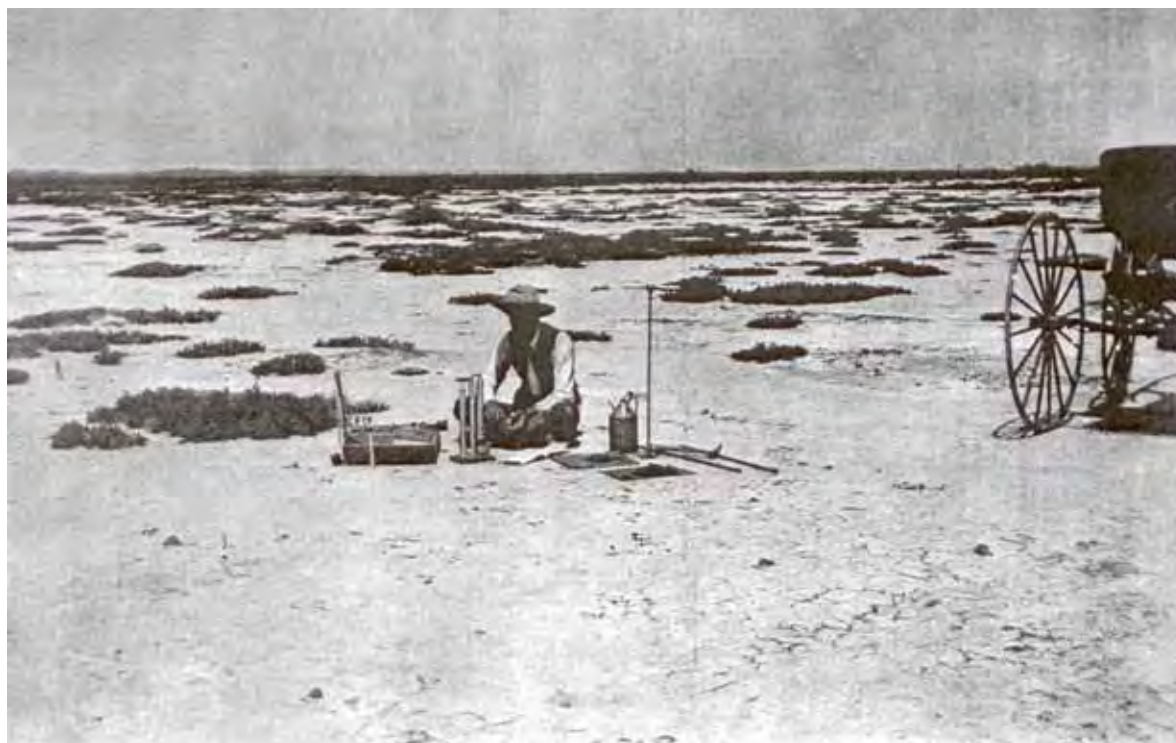
Fig. 5.12. "Alkali flat in the Delta portion of the Ventura area," ca. 1901. This turn of the century photograph of the Oxnard Plain shows what the soil survey terms "alkali flat," a region with >1% alkalinity. Some alkali vegetation is shown among substantial bare, cracked ground. (Holmes and Mesmer 1901c)

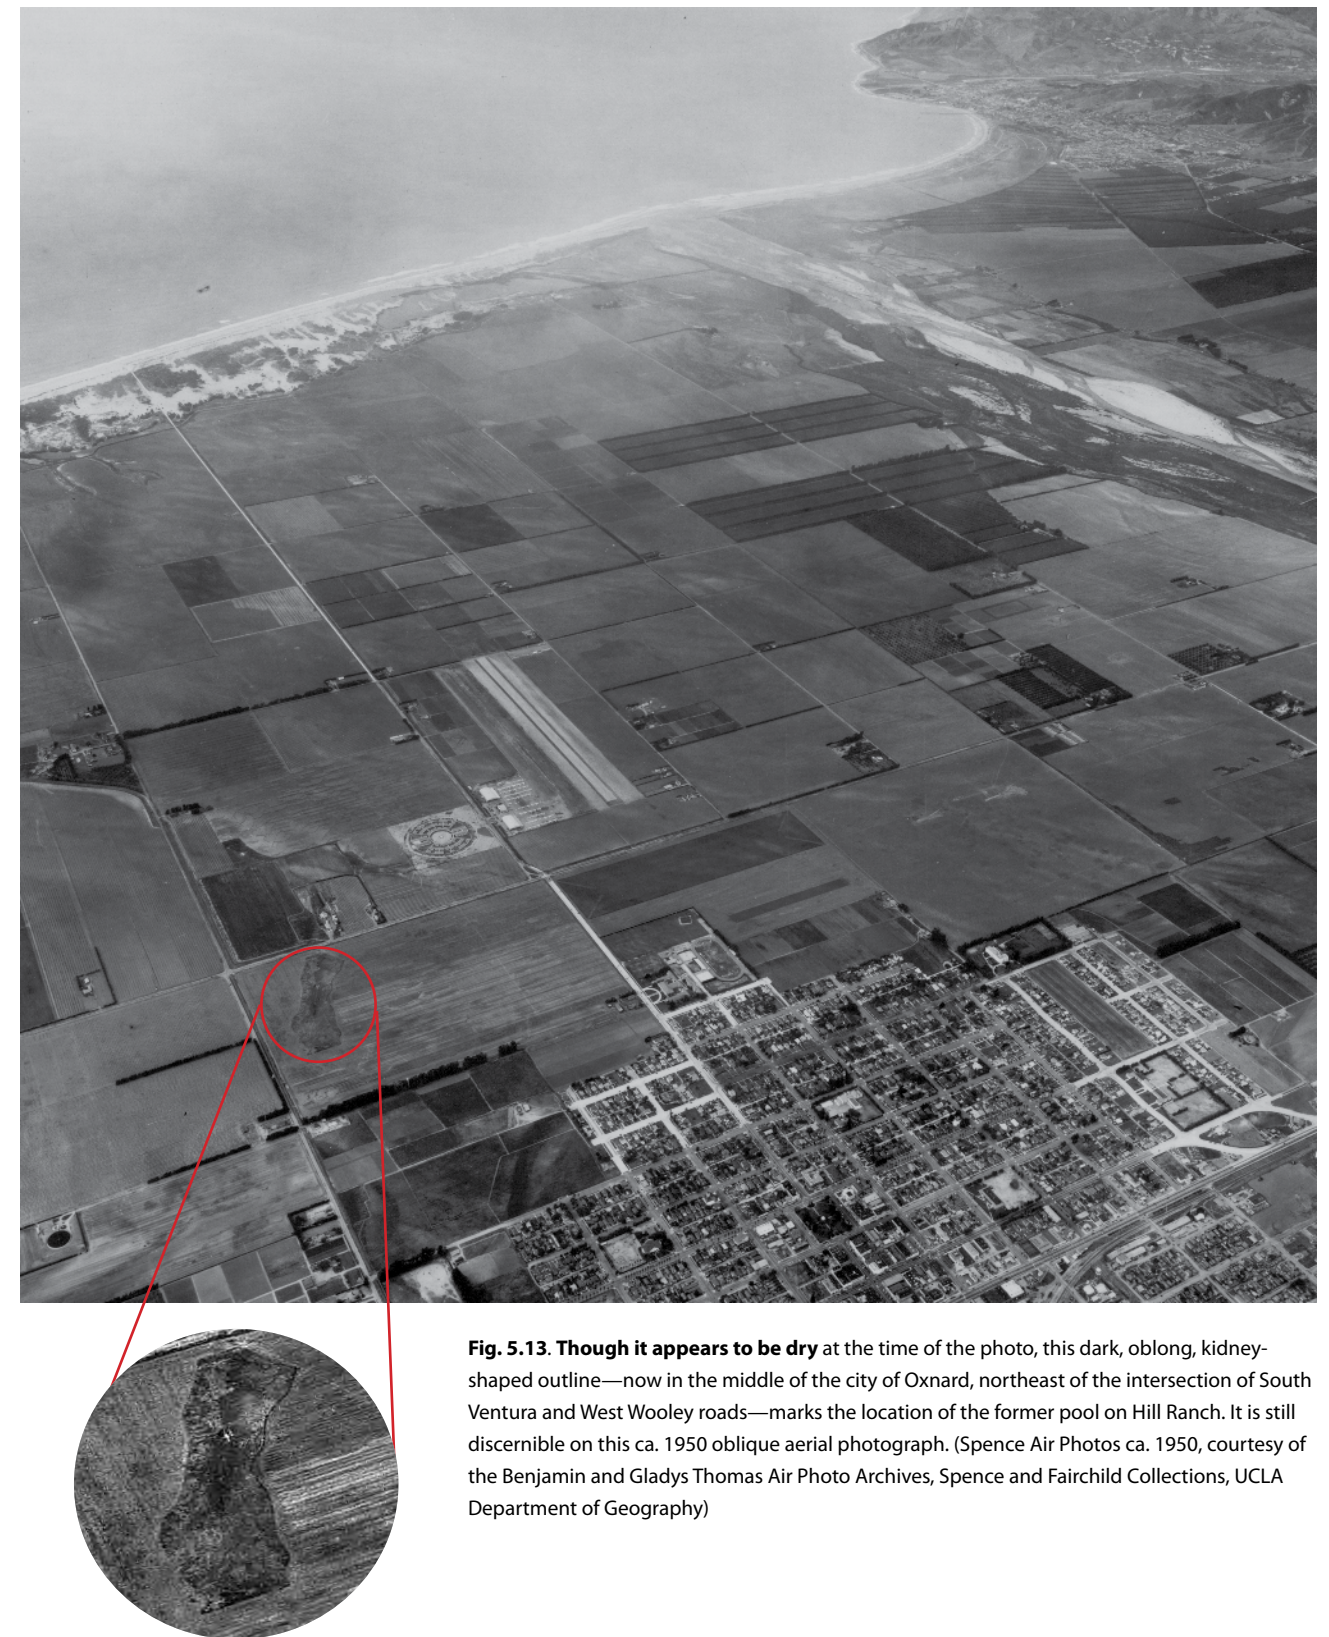
Fig. 5.13. Though it appears to be dry at the time of the photo, this dark, oblong, kidney-shaped outline—now in the middle of the city of Oxnard, northeast of the intersection of South Ventura and West Wooley roads—marks the location of the former pool on Hill Ranch. It is still discernible on this ca. 1950 oblique aerial photograph. (Spence Air Photos ca. 1950, courtesy of the Benjamin and Gladys Thomas Air Photo Archives, Spence and Fairchild Collections, UCLA Department of Geography)

The first pool mentioned above by Haydock (located on the southwest part of the Hill Ranch) was also mentioned by Bloom (1959) as a “four or five acre lake...that some years lasted all summer” and that attracted flocks of hundreds of geese. The lake is still visible in oblique aerial photography from circa 1950 as a mottled, darker area (fig. 5.13).

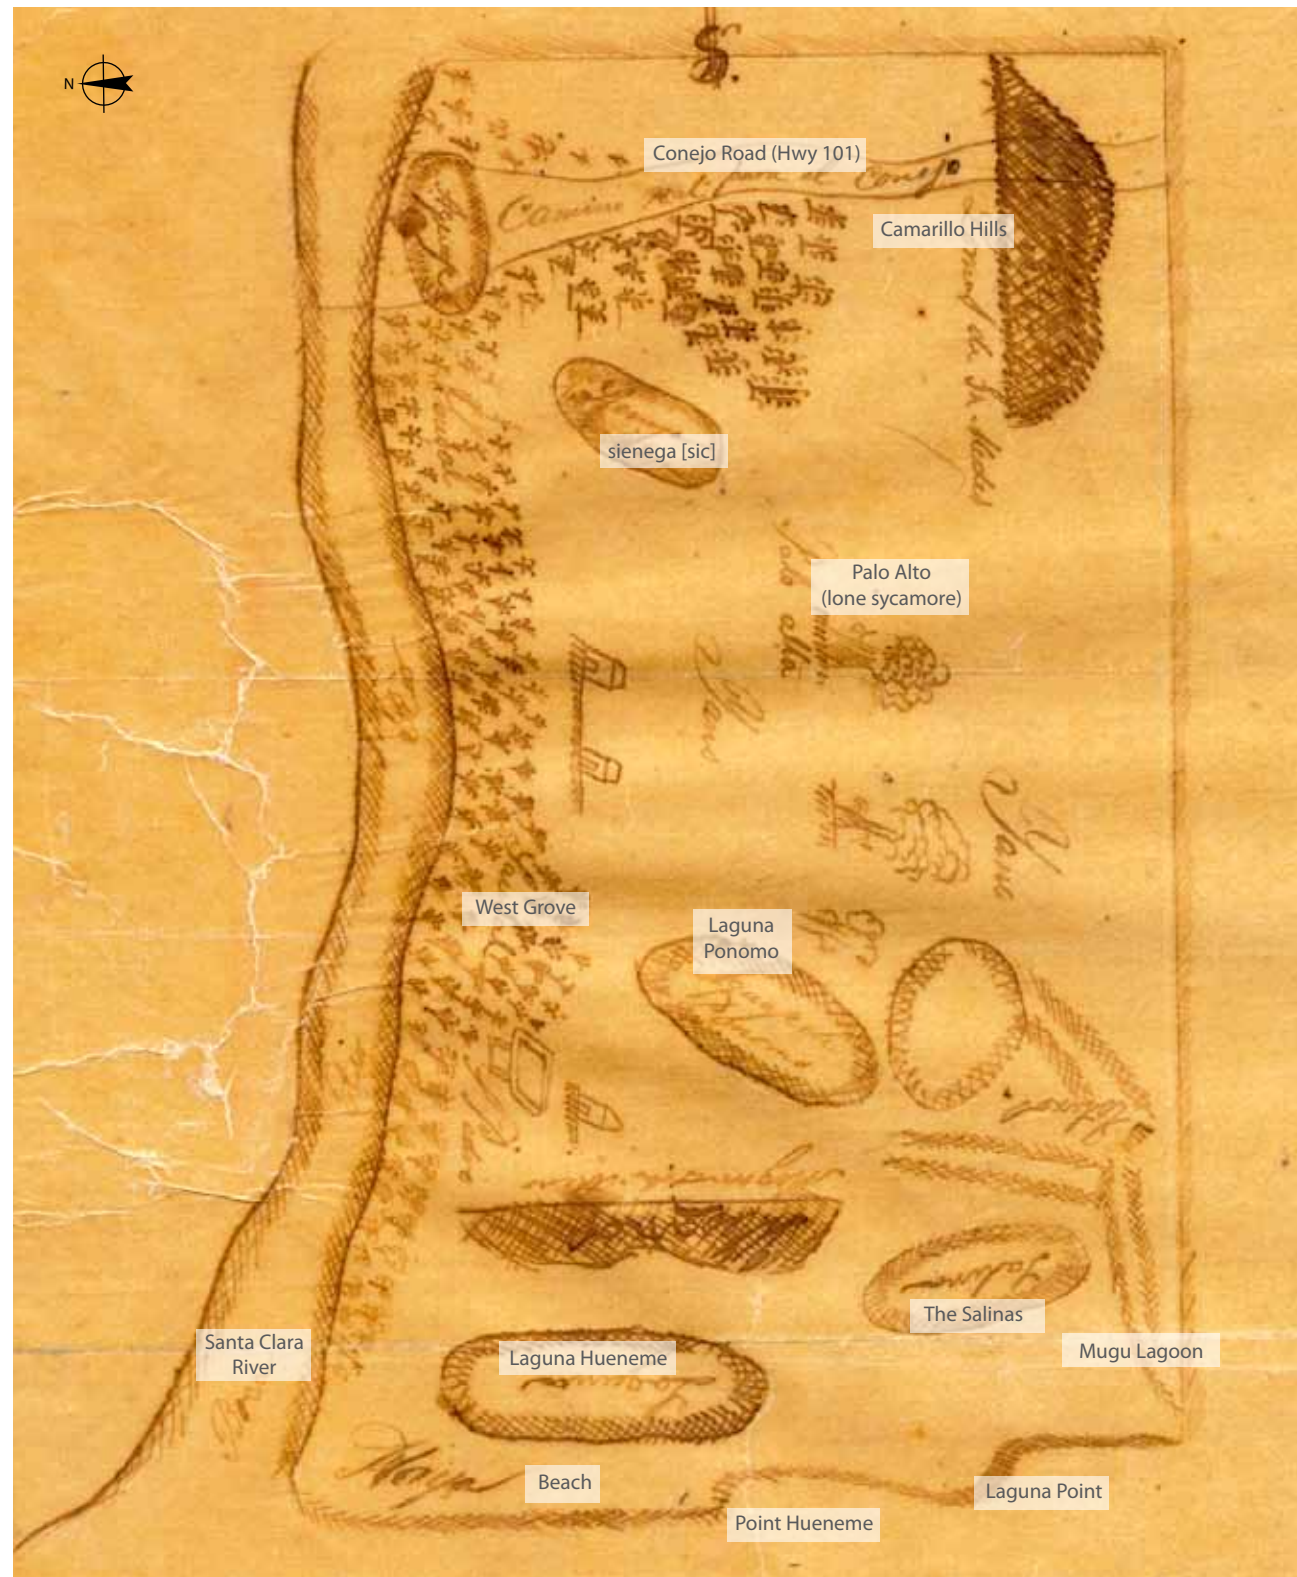
Fig. 5.14. Landmarks of the Oxnard Plain, ca. 1840. This remarkable *diseño* compresses what the cartographer perceived to be the most important features of the deltaic Oxnard Plain into one compact, rectangular drawing. While the distances are inaccurate, the relative position of features drawn on the plain is broadly correct. We were ultimately able to map some of these features, though others—such as the *ciénega* (wetland) south of Highway 101—remain mysterious. Laguna Ponomo is here shown just east of Laguna Hueneme, though later depositions record that the pond is “about five miles due north of the laguna called Hueneme” (Bard 1869). (U.S. District Court ca. 1840e, courtesy of The Bancroft Library, UC Berkeley)

Also of note was Ponom or Ponomo, a pond and marsh north of Oxnard (the second, smaller pool mentioned by Haydock). The pond was noted as early as the 1840s (fig. 5.14), and was described as a “pond of fresh water” (Bard 1869) and a “tule pond” (Bloom 1959). Ponom was also a significant Chumash site, noted by Harrington’s informants as a place with “a ciénega, tular and some sauces” (marsh, tules, and willows; Harrington 1913b). The name “ponom” was reported to mean “hay que cuidar” (one must be careful), because “they had fear that sometime the river of Santa Clara could change its course back to Point Mugu” (Harrington 1986a).

Undoubtedly, there were additional, less well documented wetlands historically present on the plain. In particular, one early map shows a large “sienega [sic]” south of the Santa Clara River on the plain, but without enough precision to map (U.S. District Court ca. 1840e; see fig. 5.14). Another large area that may have been a large wetland or wet meadow was shown on a later map south of the river with a somewhat characteristic wetland symbol, but more information is needed to resolve nature of this feature (Power 1891).
