HISTORICAL ECOLOGY of the lower Santa Clara River, Ventura River, and Oxnard Plain: an analysis of terrestrial, riverine, and coastal habitats

HISTORICAL ECOLOGY PROGRAM
CONTRIBUTION NO. 641 • AUGUST 2011

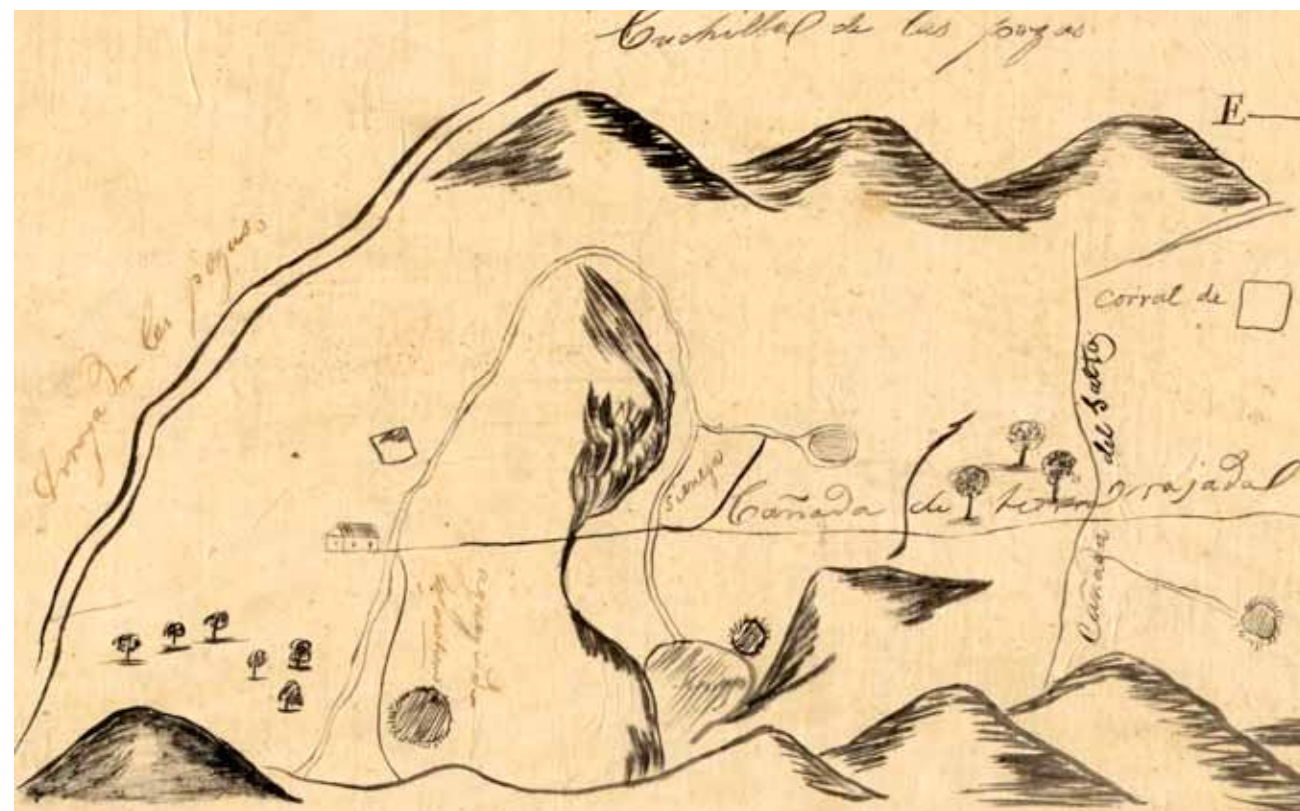
Fig. 5.15. While this ca. 1840s *diseño* is very schematic, it provides a generalized picture of the landscape of springs and wetlands present between Calleguas Creek (“Arroyo de las Pozas”) and the Santa Monica Mountains. It depicts springs (shown as dark circles with small radiating lines) flowing into small creeks and wetlands (labeled “sienega” [sic]). One wetland shown is up against the base of the hills, while the other is just upstream of the confluence of two creeks. (U.S. District Court ca. 1840a, courtesy of The Bancroft Library, UC Berkeley)

This pattern is confirmed by an early *diseño* of Calleguas Rancho (roughly the Pleasant Valley area; U.S. District Court ca. 1840a; fig. 5.15). The map shows a series of wetlands (*sienegas* [sic]) and springs up against the hills east of Calleguas Creek (Arroyo de las Posas). While the *diseño*

is roughly drawn, it does depict the same pattern shown on our habitat map, suggesting that these wetlands and springs were persistent, historical features.

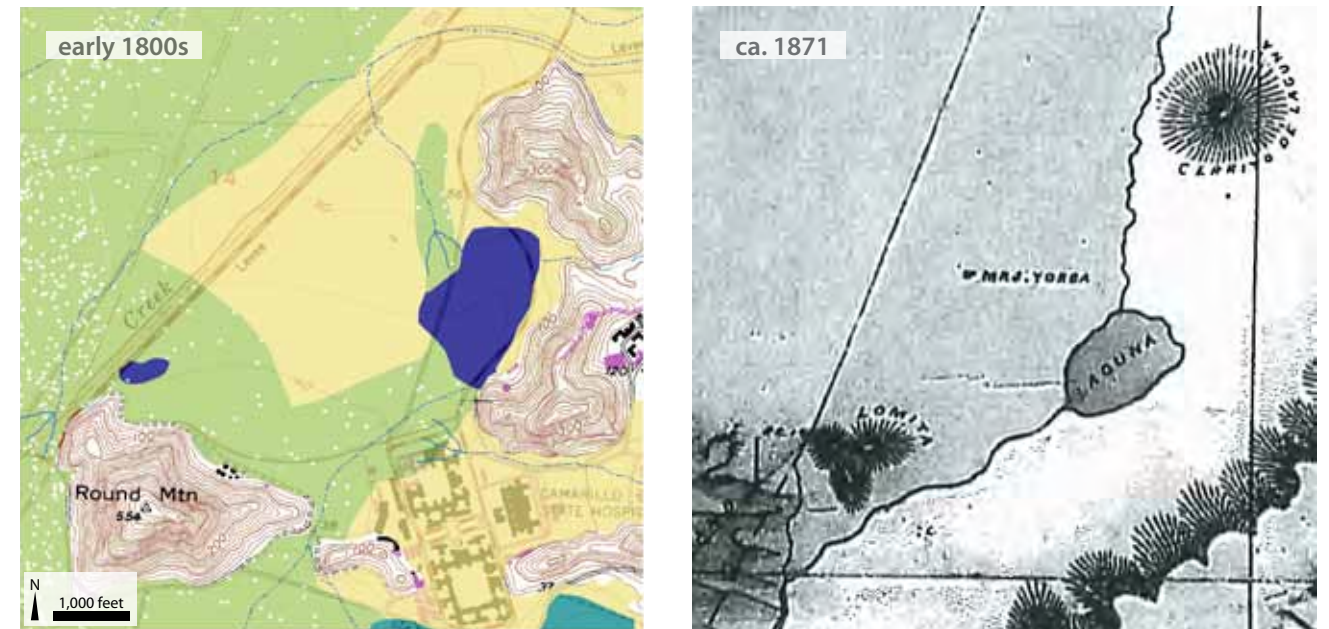
Fig. 5.16. The Laguna. Historically one of the most prominent features on the Oxnard Plain, this lake was the namesake for the Guadaluca or Laguna Rancho. It was located at the terminus of Calleguas Creek; below the laguna series of shallow sloughs and overflow connected the creek to Mugu Lagoon. Historical mapping of the lagoon is shown at left; an early map of the lake is at right. (Reed ca. 1871, courtesy of The Bancroft Library, UC Berkeley)

One notable feature was the freshwater lake at the terminus of Calleguas Creek (fig. 5.16). South of the lake, Calleguas Creek ceased to have a defined channel, instead connecting to Mugu Lagoon through a series of swales and wetlands. Guadaluca Rancho, on which the lake was located, was alternatively known as the Laguna Rancho: “The old Californians familiarly call the ‘Guadaluca’ the ‘Laguna’ (Thompson 1873, in Thompson 1869). In addition to flow from Calleguas Creek, two springs in the area—one called Guadaluca—formed the lake (Lugo 1855). The lake was described as the “only considerable watering place” on the

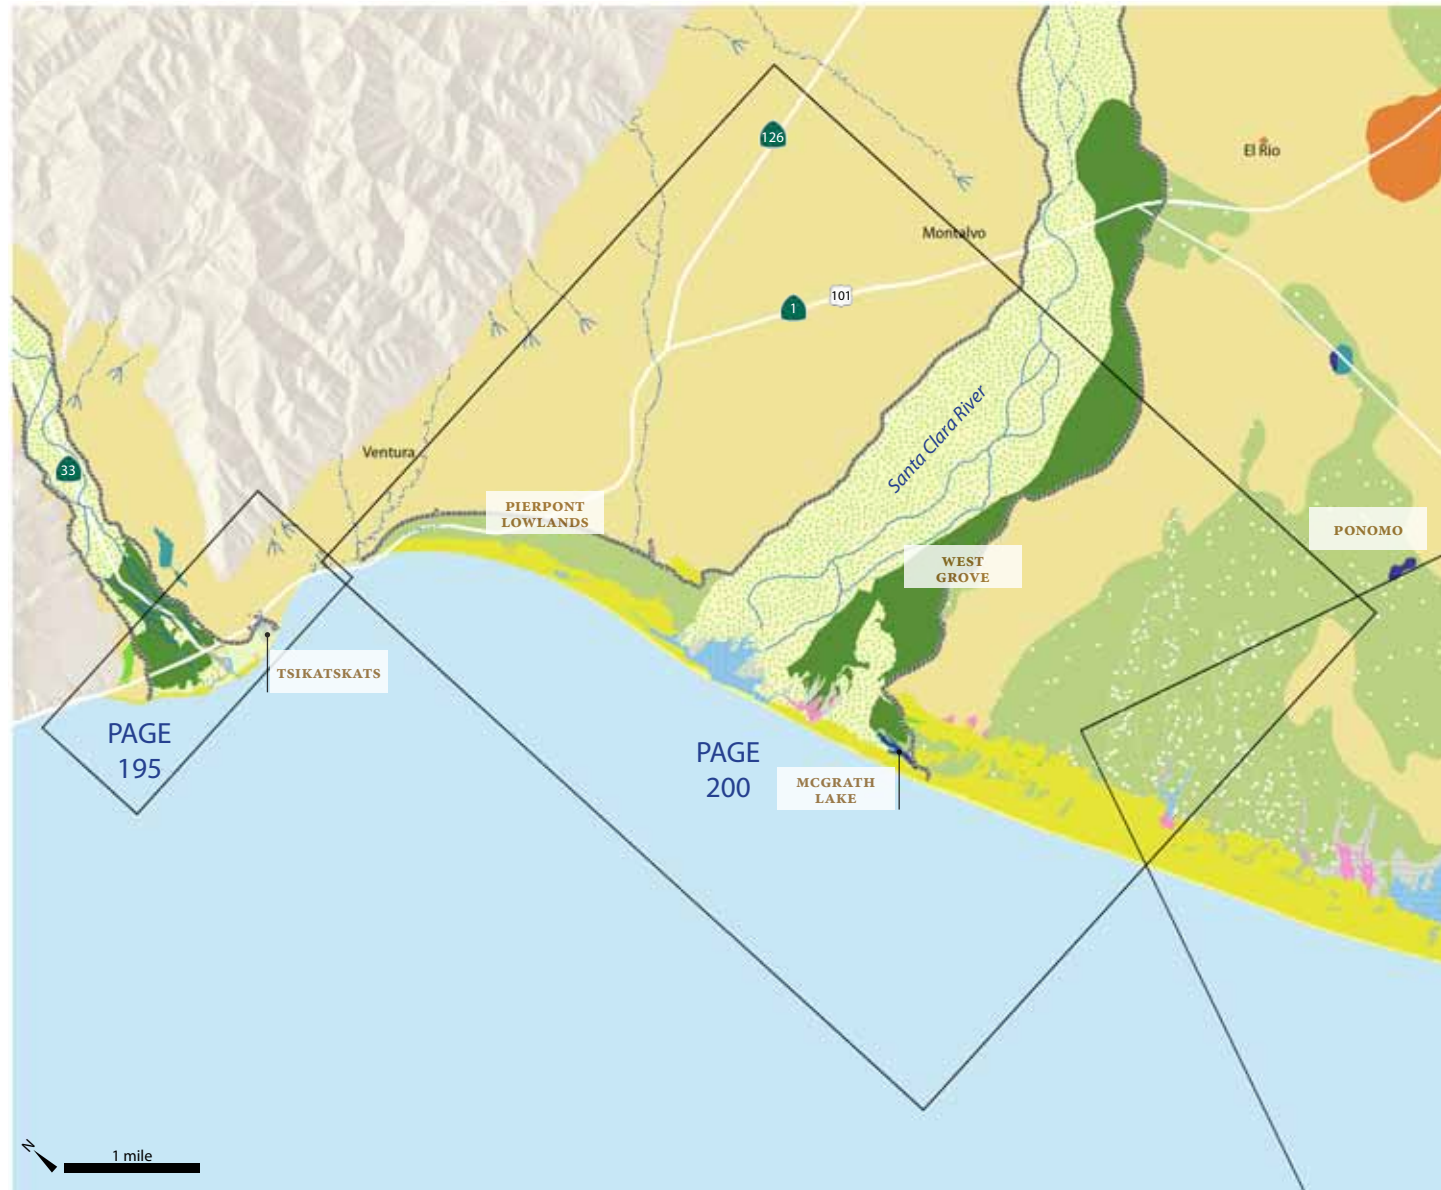
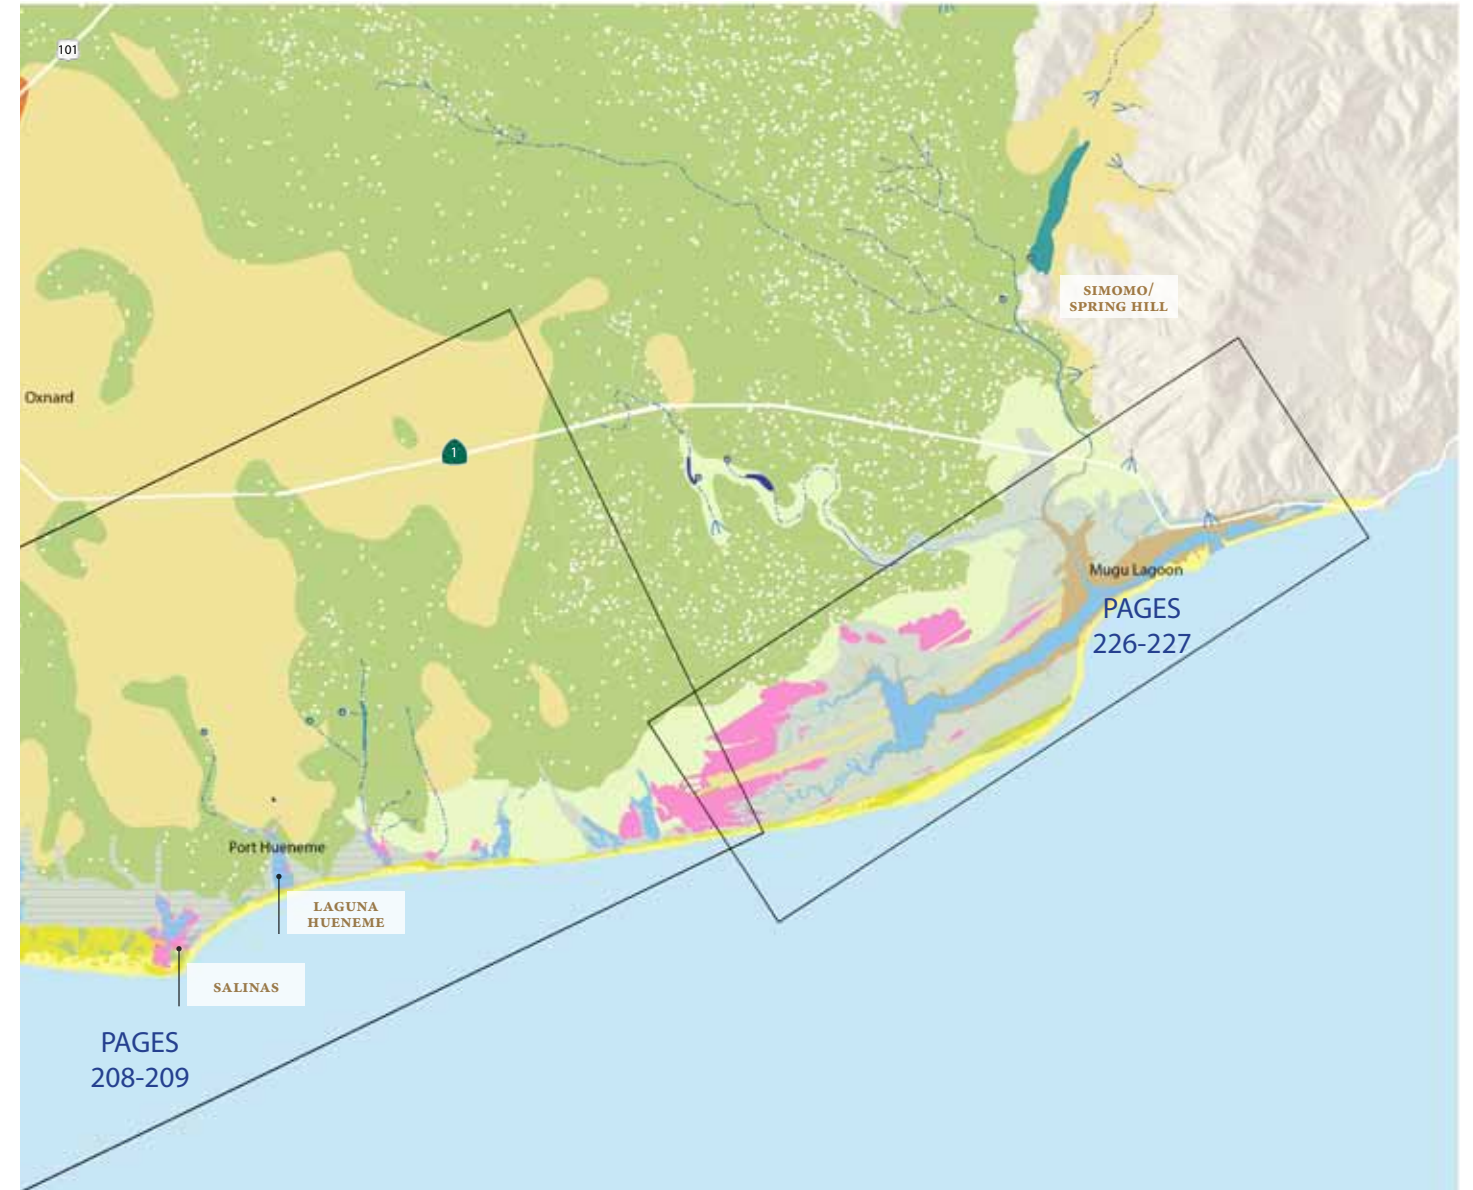
Fig. 6.2. Habitats of the Ventura County shoreline, early 1800s. At least three general types of coastal systems, or coastal archetypes, can be identified along the Ventura shoreline: freshwater-brackish estuaries associated with the Santa Clara and Ventura river mouths, dune-dammed non-tidal lagoon systems (with associated salt/brackish marsh and salt flats) marking former Santa Clara River mouths, and the large coastal wetland system at Point Mugu.

Nineteenth century Ventura County exhibited a complex and heterogeneous shoreline, with a variety of habitats and morphologies associated with different estuarine and wetland systems and different formative processes (fig. 6.2). At the Ventura River mouth, willow-cottonwood forest transitioned into a small, intermittently closed lagoon, while a culturally significant beach-dammed freshwater wetland complex occupied a former river mouth to the east. A distinctive seasonal wetland area—the Pierpont lowlands—extended in a broad arc from Ventura to the Santa Clara River mouth, nearly connecting the eastern edge of the Ventura River corridor to the northwestern edge of the Santa Clara River (they were separated by less than one mile). Here sand dunes trapped Santa Clara River floodwaters and valley seepage in a recently prograded portion of the shoreline, creating a large area of seasonally inundated meadow. At the Santa Clara River mouth, willow swamps bordered a small seasonal estuary similar in form and function to the Ventura River delta (and including a freshwater wetland complex, McGrath Lake). To the south, a series of at least nine elongate lagoons—some brackish, some saline—incised the Oxnard Plain shoreline, marking former mouths of the meandering Santa Clara River. Usually blocked from the tides by substantial beaches and dunes, the water source for these lagoons was a varying mix of saline (through dune overwash and seepage) and fresh water (from precipitation, runoff, and springs). As a result, the lagoon complexes supported a gradient of heterogeneous habitats ranging from freshwater to brackish to saline, including vegetated marsh, salt flat, and open water. At the southern edge of the Oxnard Plain, Mugu Lagoon represented by far the largest coastal wetland system in the county, with extensive subtidal, tidal flat, tidal marsh, and salt flat habitat.

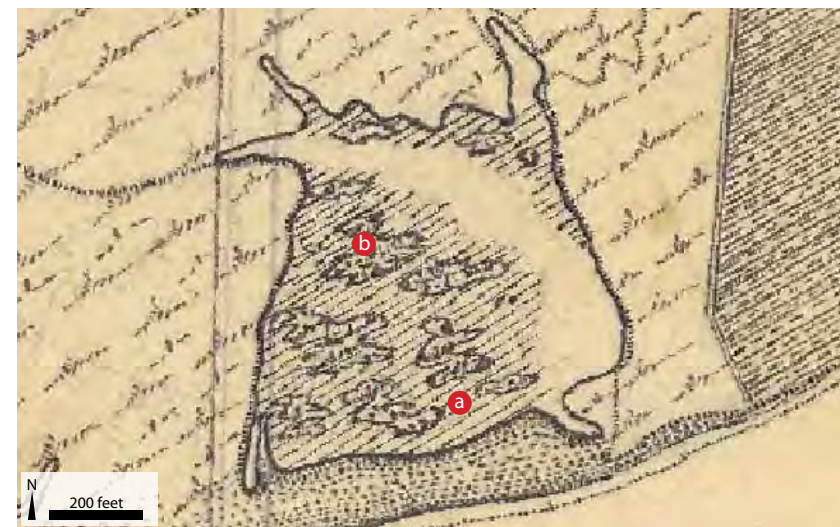
Fig. 6.4. Lake east of the Ventura River, 1855. This small brackish lake marked the easternmost extent of the historical Ventura River floodplain, and was surrounded by extensive tule marsh (shown by the closely spaced lines in the marsh on this map **a**). Though the symbol within the marsh is non-standard **b**, we interpret it to be patches of grassy cover, such as saltgrass or seasonally inundated meadow. (Johnson 1855c, courtesy of the National Oceanographic and Atmospheric Administration)

On the earliest (1855) T-sheet, the lake is shown occupying a low spot behind a narrow beach, not connected with the ocean and with substantial surrounding marsh (Johnson 1855c; fig. 6.4). It is documented similarly on the 1870 resurvey, though with a larger amount of open water adjacent to the beach. An unrelated survey from May 1868, however, shows a small lake with marsh in this vicinity with a clear connection to the ocean (Bard 1868). If this is indeed the same body of water, then the lake may have had at least an intermittent connection to the ocean.

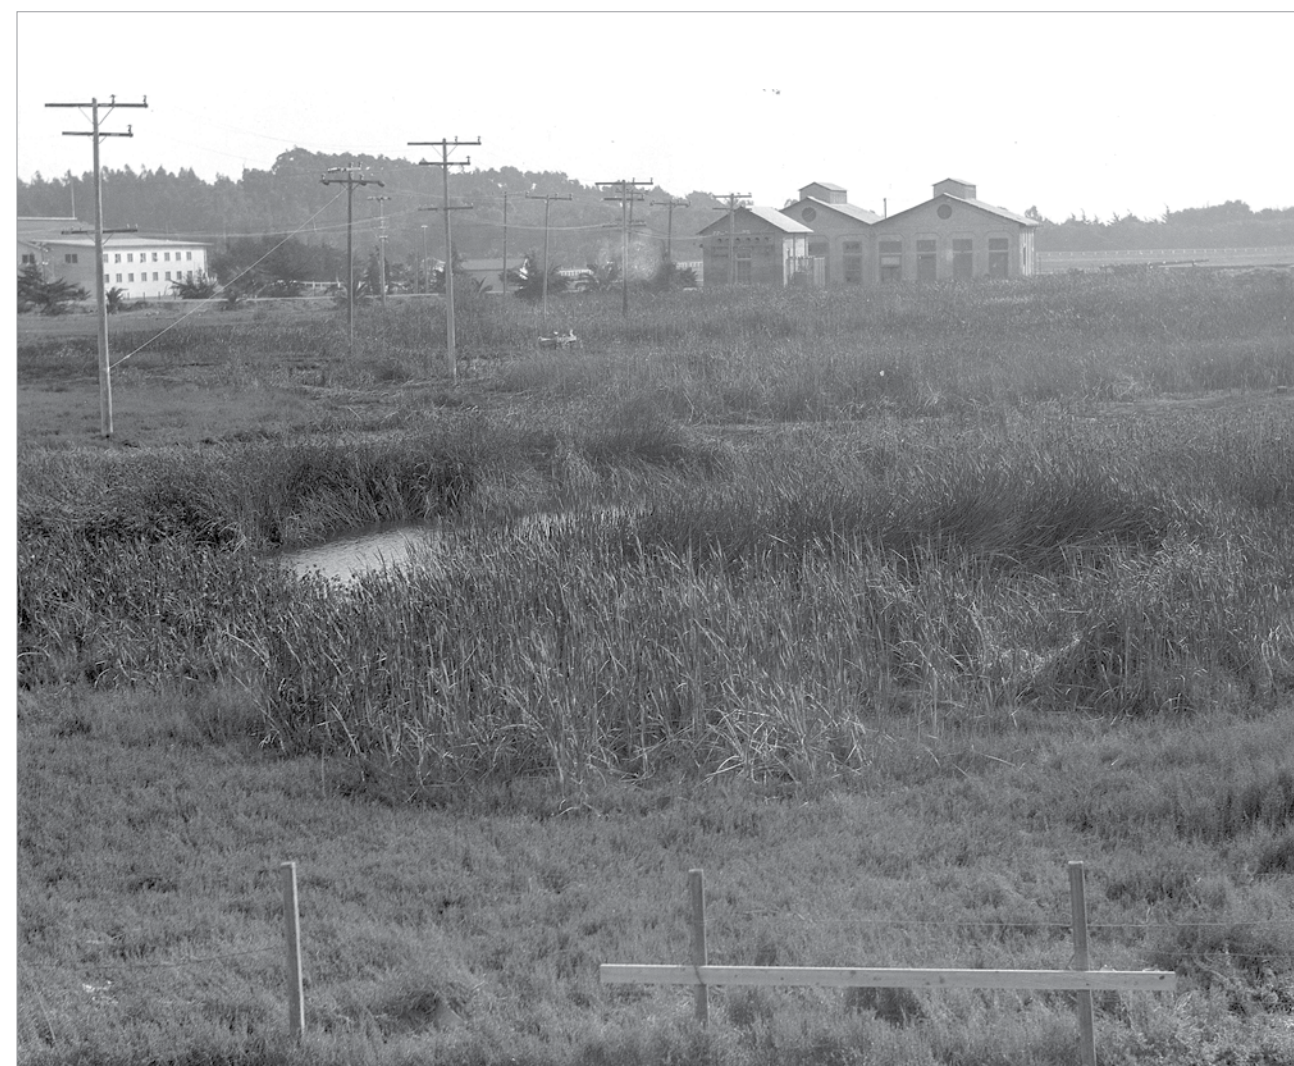
Fig. 6.5. Tsikatskats, the lake at the end of Figueroa Street. This photograph, taken in the fall of 1923, shows the remnant of what was once a well known brackish lake in the Ventura River floodplain. What are likely cattails (*Typha latifolia*) are visible in the foreground, along with stands of alkali bulrush (*Scirpus [Bolboschoenus] maritimus*) and bulrush/tule (*Scirpus [Schoenoplectus] californicus*; see particularly the matted vegetation to the right of the open water). Pickleweed (*Salicornia virginica*) dominates the foreground. (Harrington 1923b, courtesy of the Smithsonian Institution; plant interpretation, Baye pers. comm.)

The lake is vividly described by Chumash residents interviewed by John P. Harrington in the early 20th century. Though at the time they were interviewed the lake no longer existed, his informants recalled what it had been like decades earlier (fig. 6.5). The lake was called Tsikatskats (with variable spellings in Harrington’s notes), which was translated by his informants as “sweet water running below,” presumably referring to

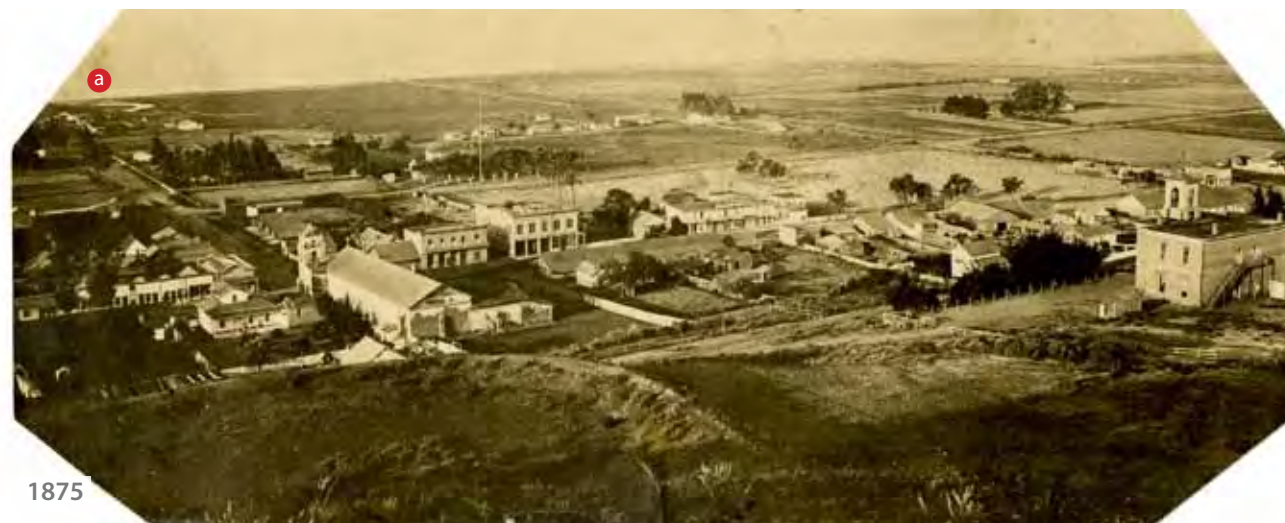
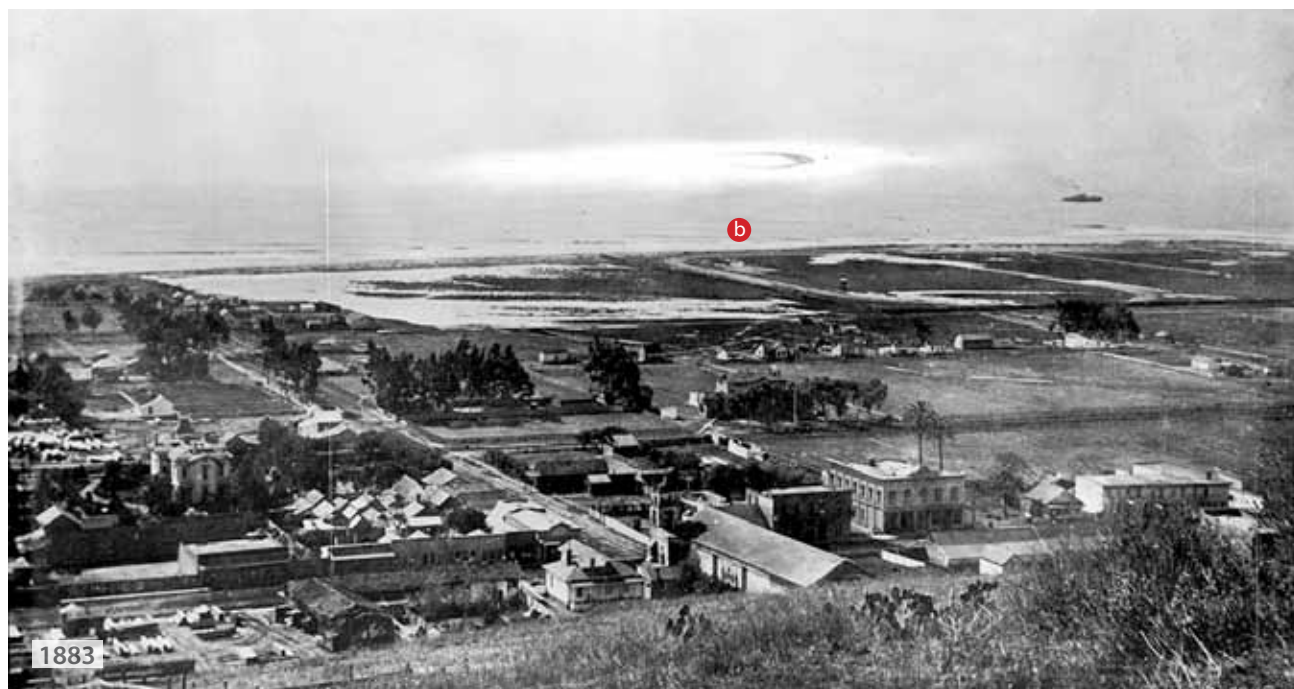
Fig. 6.6. Two views looking across the city of Ventura to the shoreline. A circa 1875 image (top), taken from the hill behind Mission San Buenaventura facing southwest, shows the low floodplain area east of the Ventura River. A portion of what is likely Tsikatskats lake can be seen in the distance, at **a**. A nearly identical view (below), taken about eight years later, shows the same area in flood. What appears to be a small seasonal pond or panne, corresponding in shape to one depicted on the T-sheet 28 years earlier, can be seen at **b**. (This feature is visible on fig. 6.3 as the leftmost salt flat/seasonal pond/marsh panne, shown in pink.) (Unknown ca. 1875, Pierce ca. 1883; courtesy of the California Historical Society)

The lake, only present as a small pond/slough complex in 1913 as described by Harrington’s informants, was barely visible on the 1927 aerial imagery, and left unmapped on the 1933 T-sheet resurvey. The area, historically part of the Ventura River delta, continued to flood well into the 20th century (fig. 6.6). It has remained in relatively unintensive use even today (it is now the parking lot across from Seaside Park at the Derby Club).

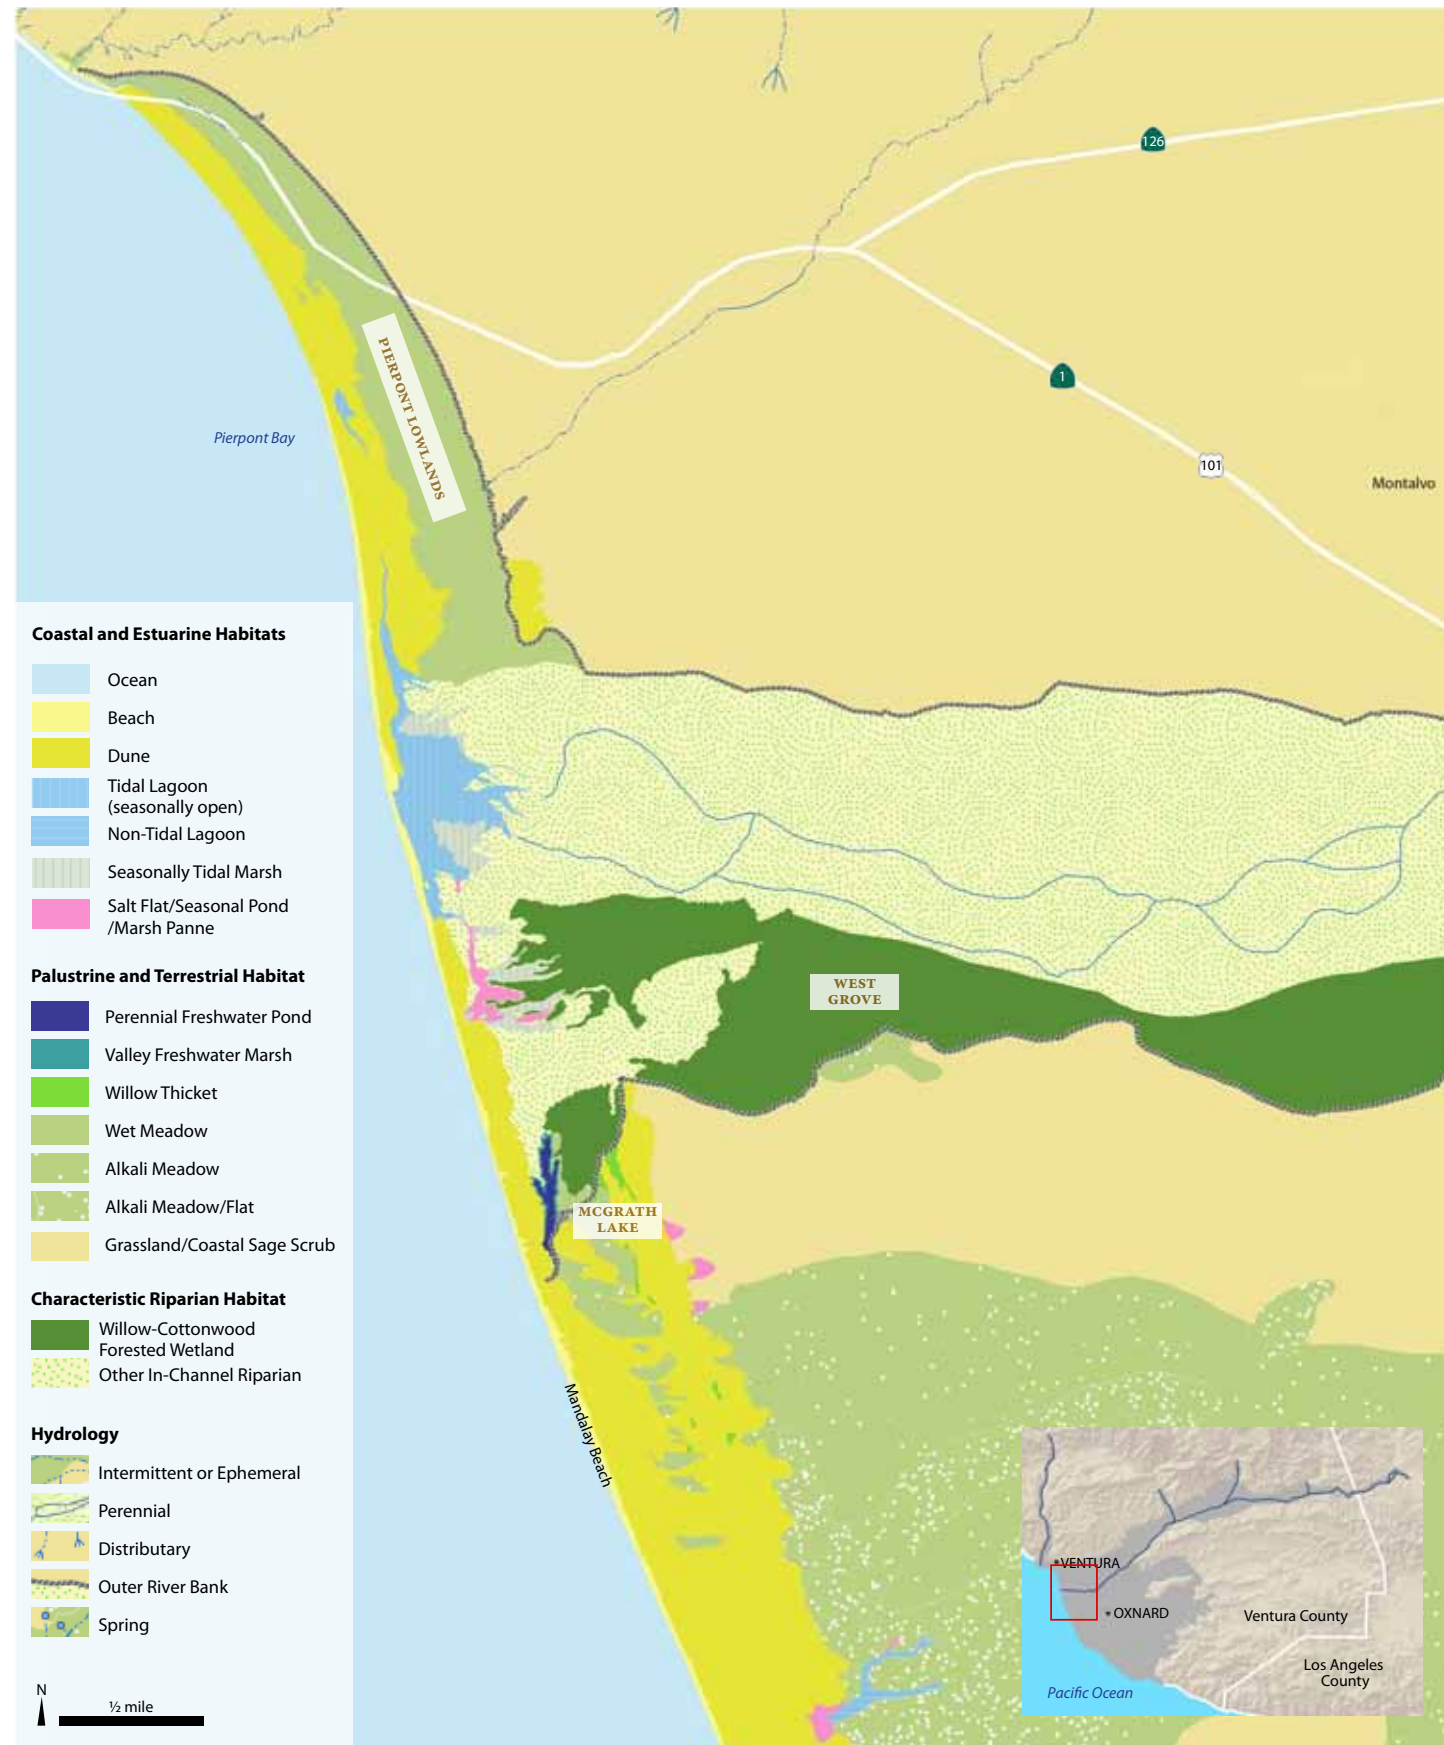
Fig. 6.7. Habitats of the Santa Clara River mouth, early 1800s. A seasonally open tidal lagoon, tidal marsh, alkali meadows, and salt flats, as well as abundant freshwater habitats (wet meadows, willow-cottonwood forests, and a freshwater lake/surrounding marsh) characterized the mouth.

The mouth of the Santa Clara River encompassed a diverse array of freshwater, brackish, and saline habitats. A seasonally open tidal lagoon, bordered by tidal marsh, formed the outlet of the river. To the north and south, alkaline/saline habitats (e.g., alkali meadows and salt flats) as well as abundant freshwater habitats (wet meadows, willow-cottonwood forests, and a freshwater lake and surrounding marsh) were also present (fig. 6.7 and 6.8). Under Jacobs et al.’s (2010) definitions, the Santa Clara River mouth regularly closed above high-high tide or perched, with seasonal breaching and opening to the subtidal level. This closure pattern reflects the river mouth’s exposure to wave action in addition to freshwater inputs from the watershed.

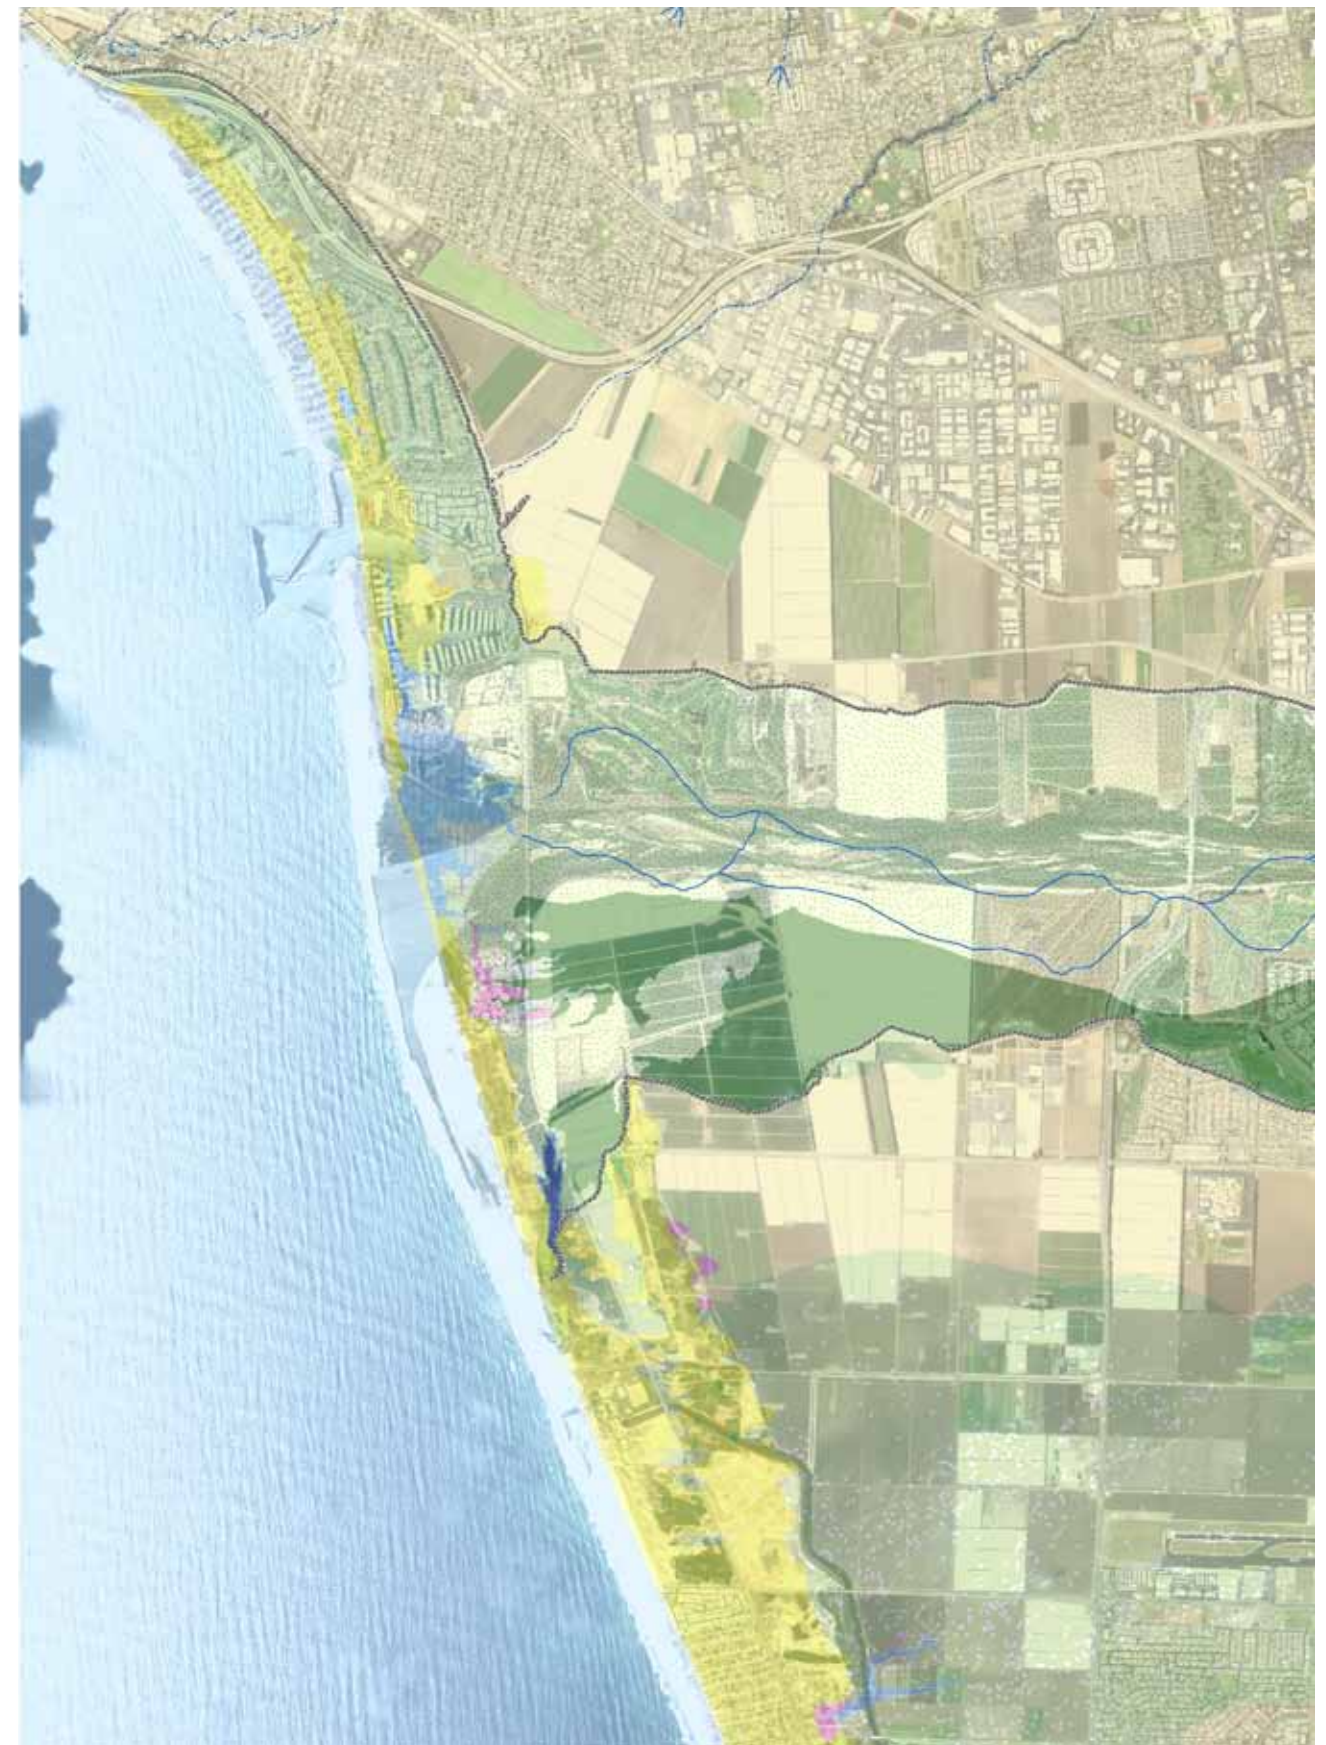
Fig. 6.8. Habitats of the Santa Clara River mouth, here overlaid on a modern aerial image, illustrate the former extent of estuarine and riparian habitats. (USDA 2009)

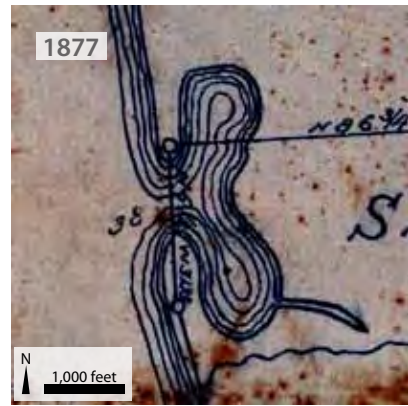
Fig. 6.9. Seasonally tidal lagoon at the mouth of the Santa Clara River, 1877. An early depiction of the lagoon open to the ocean. (Stow 1877, courtesy of the Museum of Ventura County)

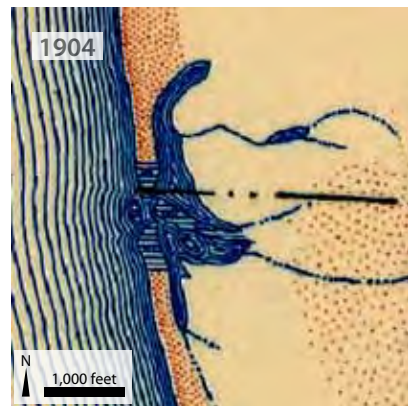
Fig. 6.10. Seasonally tidal lagoon at the mouth of the Santa Clara River, 1904. Rather than showing the lagoon as open or closed, this historical topographic quad uses thin blue lines perpendicular to the coastline to represent the connection between the lagoon and the ocean. (USGS 1904, courtesy of CSU Northridge Geography Map Library)

Maps also support this variability: some cartographers showing the lagoon open to the ocean, while others show no connection. One early sketch shows a narrow “salt laguna” at the mouth of the river, with no connection to the ocean (Unknown ca. 1870). Another much later map also shows a large, disconnected lagoon (Farrell 1935). However, other maps show the lagoon with a clear tidal connection (e.g., Stow 1877, Schuyler 1900, Holmes and Mesmer 1901b, Kelsh 1933b; fig. 6.9). The earliest topographic quad and a historical soil survey contain an intermediate depiction, showing thin blue lines connecting the lagoon to the ocean (USGS 1904,

Nelson et al. 1917; fig. 6.10). Unfortunately, none of these maps specify the season of survey.

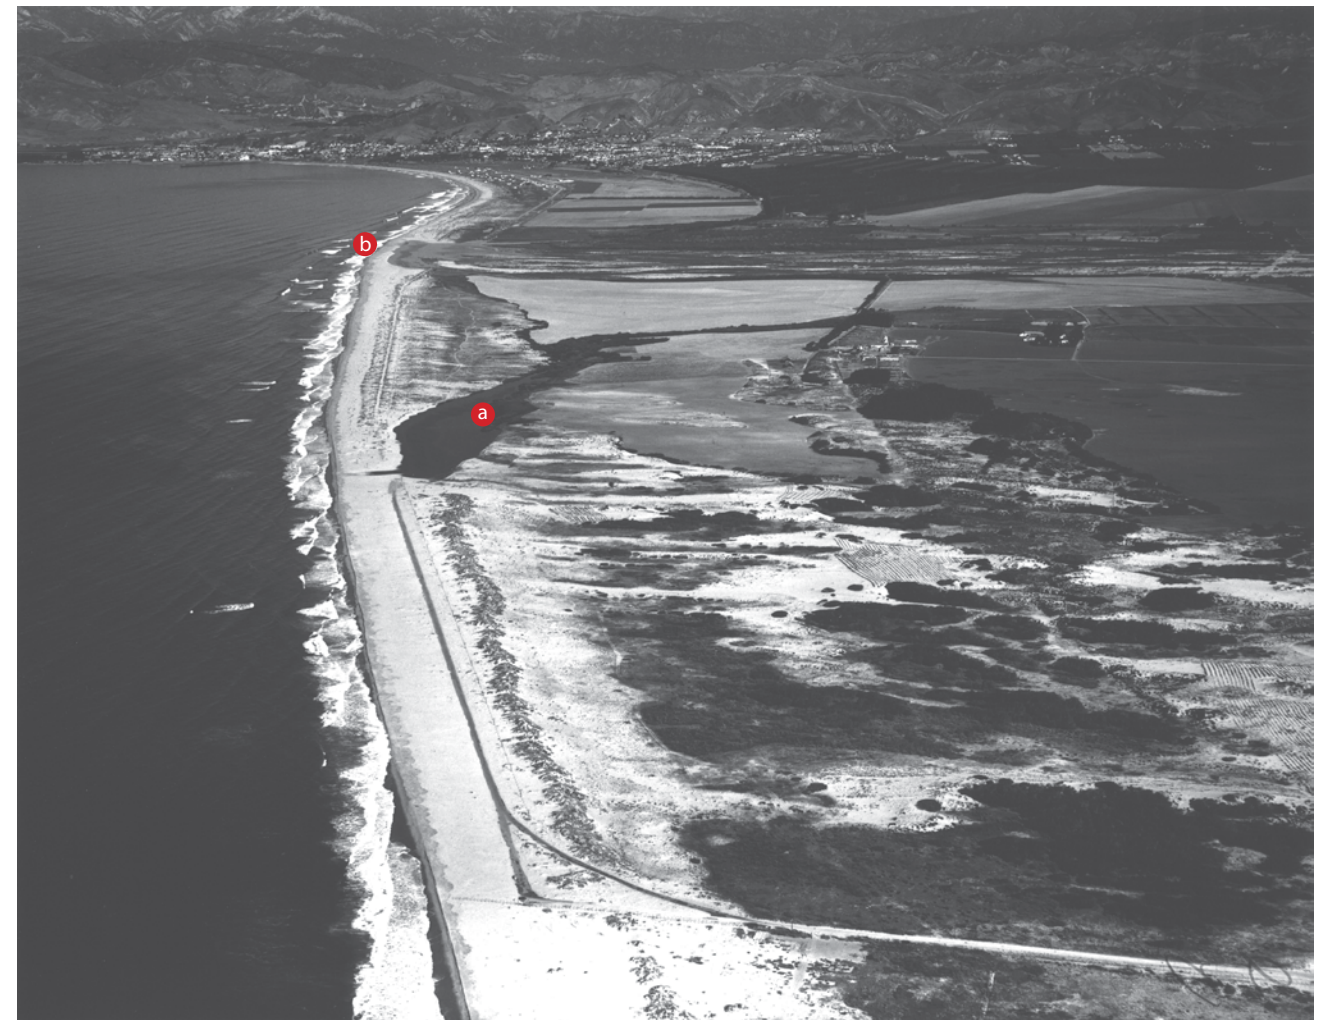
Fig. 6.11. This 1947 view of the coastline around the Santa Clara River mouth shows McGrath Lake (a) to the south of the closed river mouth (b) and the Pierpont lowlands to the north, together composing the low, broad floodplain of the river at its mouth. The city of Ventura can be seen in the background. (Spence Air Photos 1947, courtesy of the Benjamin and Gladys Thomas Air Photo Archives, UCLA Department of Geography)

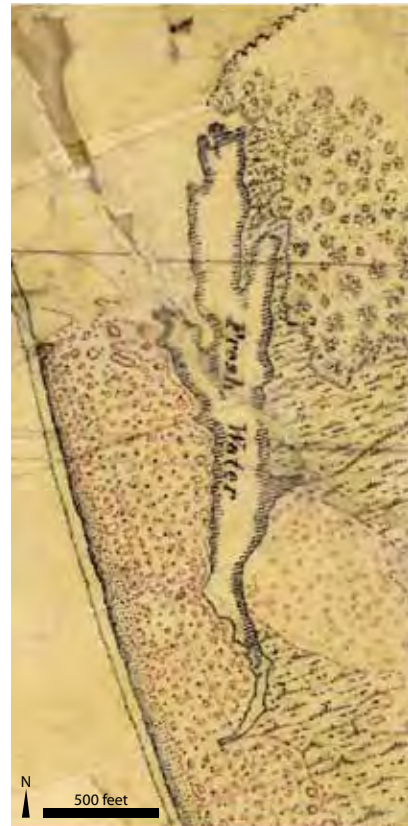
Fig. 6.12. McGrath Lake, 1855. The lake occurs at the boundary of two T-sheets, and is mapped by both. On this sheet, covering the area from McGrath Lake to Hueneme, the lake is labeled “fresh water,” a rarity on the Oxnard Plain. (Johnson 1855b, courtesy of the National Oceanic and Atmospheric Administration)

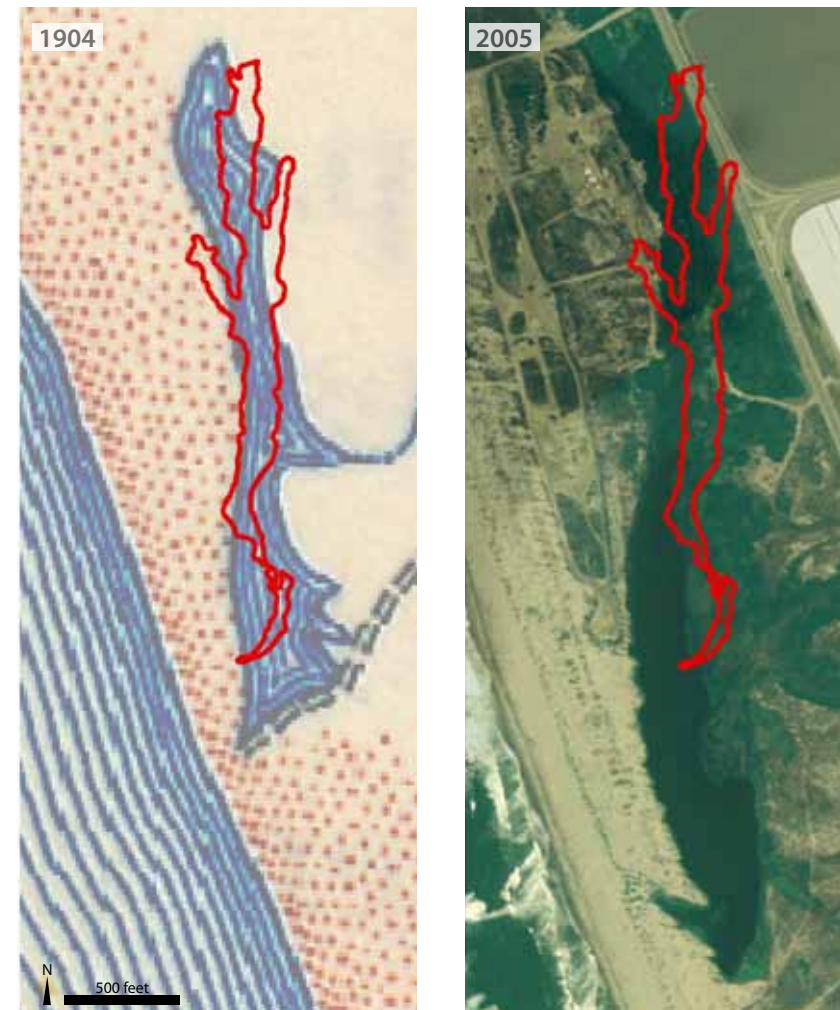
Fig. 6.13. Comparison of historical and modern location and extent of McGrath Lake. Between 1855 and 2005, McGrath Lake has shifted about 1,500 feet to the south. However, the extent of open water appears broadly comparable. The 1904 historical topographic quadrangle (at left) shows the lake covering a broad extent roughly comparable to the 1855 mapping (shown in red outline). (USGS 1904, courtesy of CSU Northridge Map Library; USDA 2005)

Though the appellation has persisted, the precise location of the lake has shifted substantially over the past 150 years. What was historically considered to be McGrath Lake is currently predominantly willow-cottonwood forest and developed land; only the tail of the historical lake overlaps with the current lake-marsh complex (fig. 6.13). It is unclear when this shift occurred, though it had clearly happened by the time the first aerial imagery was flown (1927) and the T-sheet resurveyed (1933). Both sources show an extent of open water almost identical to what was present in 2005, with a large area of marsh north of the lake and covering the lake’s former position (Fairchild Aerial Surveys 1927, Kelsh 1933b). Overall, the extent of the lake has increased from eight acres in 1857 to fifteen acres in 2005.

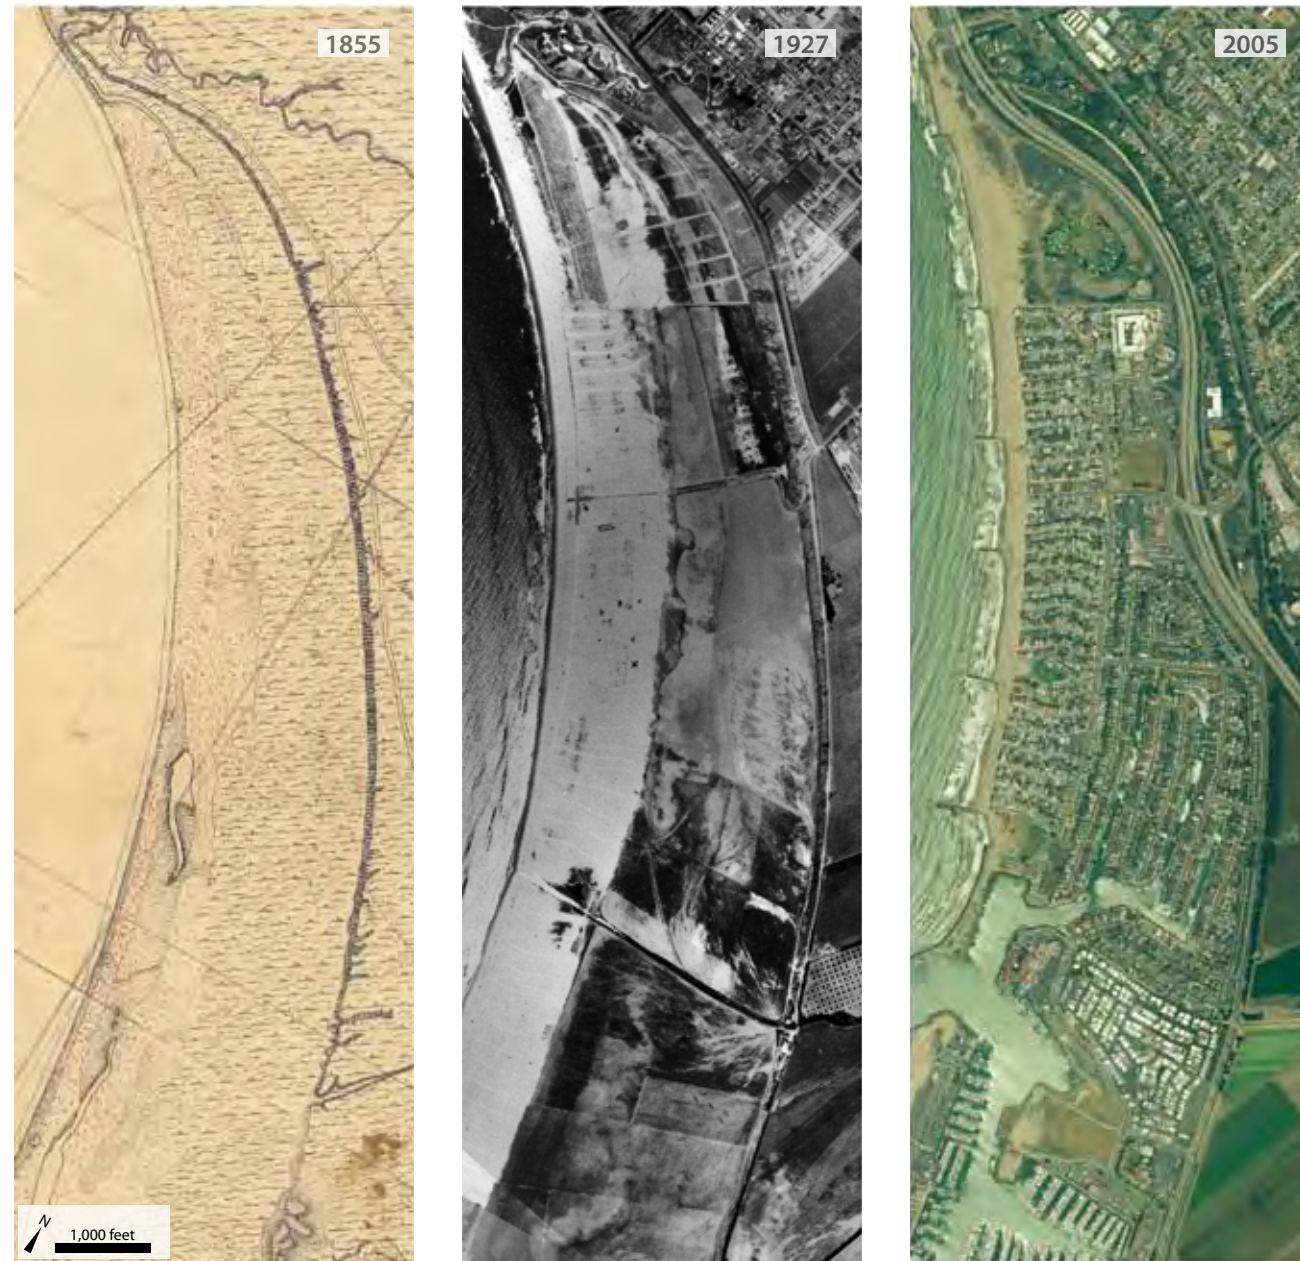
Fig. 6.14. Between 1855 and 2005, the seasonally inundated lowlands at Pierpoint have been heavily developed. The beginnings of a street grid can faintly be seen on the historical aerial in the dunes (middle); this same street pattern has persisted to the present day (right). Today, this area includes the Ventura Harbor. Note that a subdivision shown on the northern part of the Pierpoint lowlands is now part of San Buenaventura State Beach. (Johnson 1855c, courtesy of the National Oceanographic and Atmospheric Administration; Fairchild Aerial Surveys 1927, courtesy of Whittier College; USDA 2005)

To the north of the mainstem Santa Clara River, the Pierpont lowlands were a broad, low coastal flat extending more than 2.5 miles northward, nearly to the Ventura River, and comprising the westernmost extent of the Santa Clara River delta (fig. 6.14). Located between sand dunes and a bluff marking a former coastline, the flat trapped water from the Santa Clara River during floods, creating a large area of seasonally inundated wet meadow. This feature of the Pierpont area is captured by the early T-sheet survey, where “overflowed during winter” is written across the entire plain. The feature is a result of progradation, as Ventura River sediments were deposited north of the convex Santa Clara River mouth (Putnam 1942).
