HISTORICAL ECOLOGY of the lower Santa Clara River, Ventura River, and Oxnard Plain: an analysis of terrestrial, riverine, and coastal habitats

HISTORICAL ECOLOGY PROGRAM
CONTRIBUTION NO. 641 • AUGUST 2011

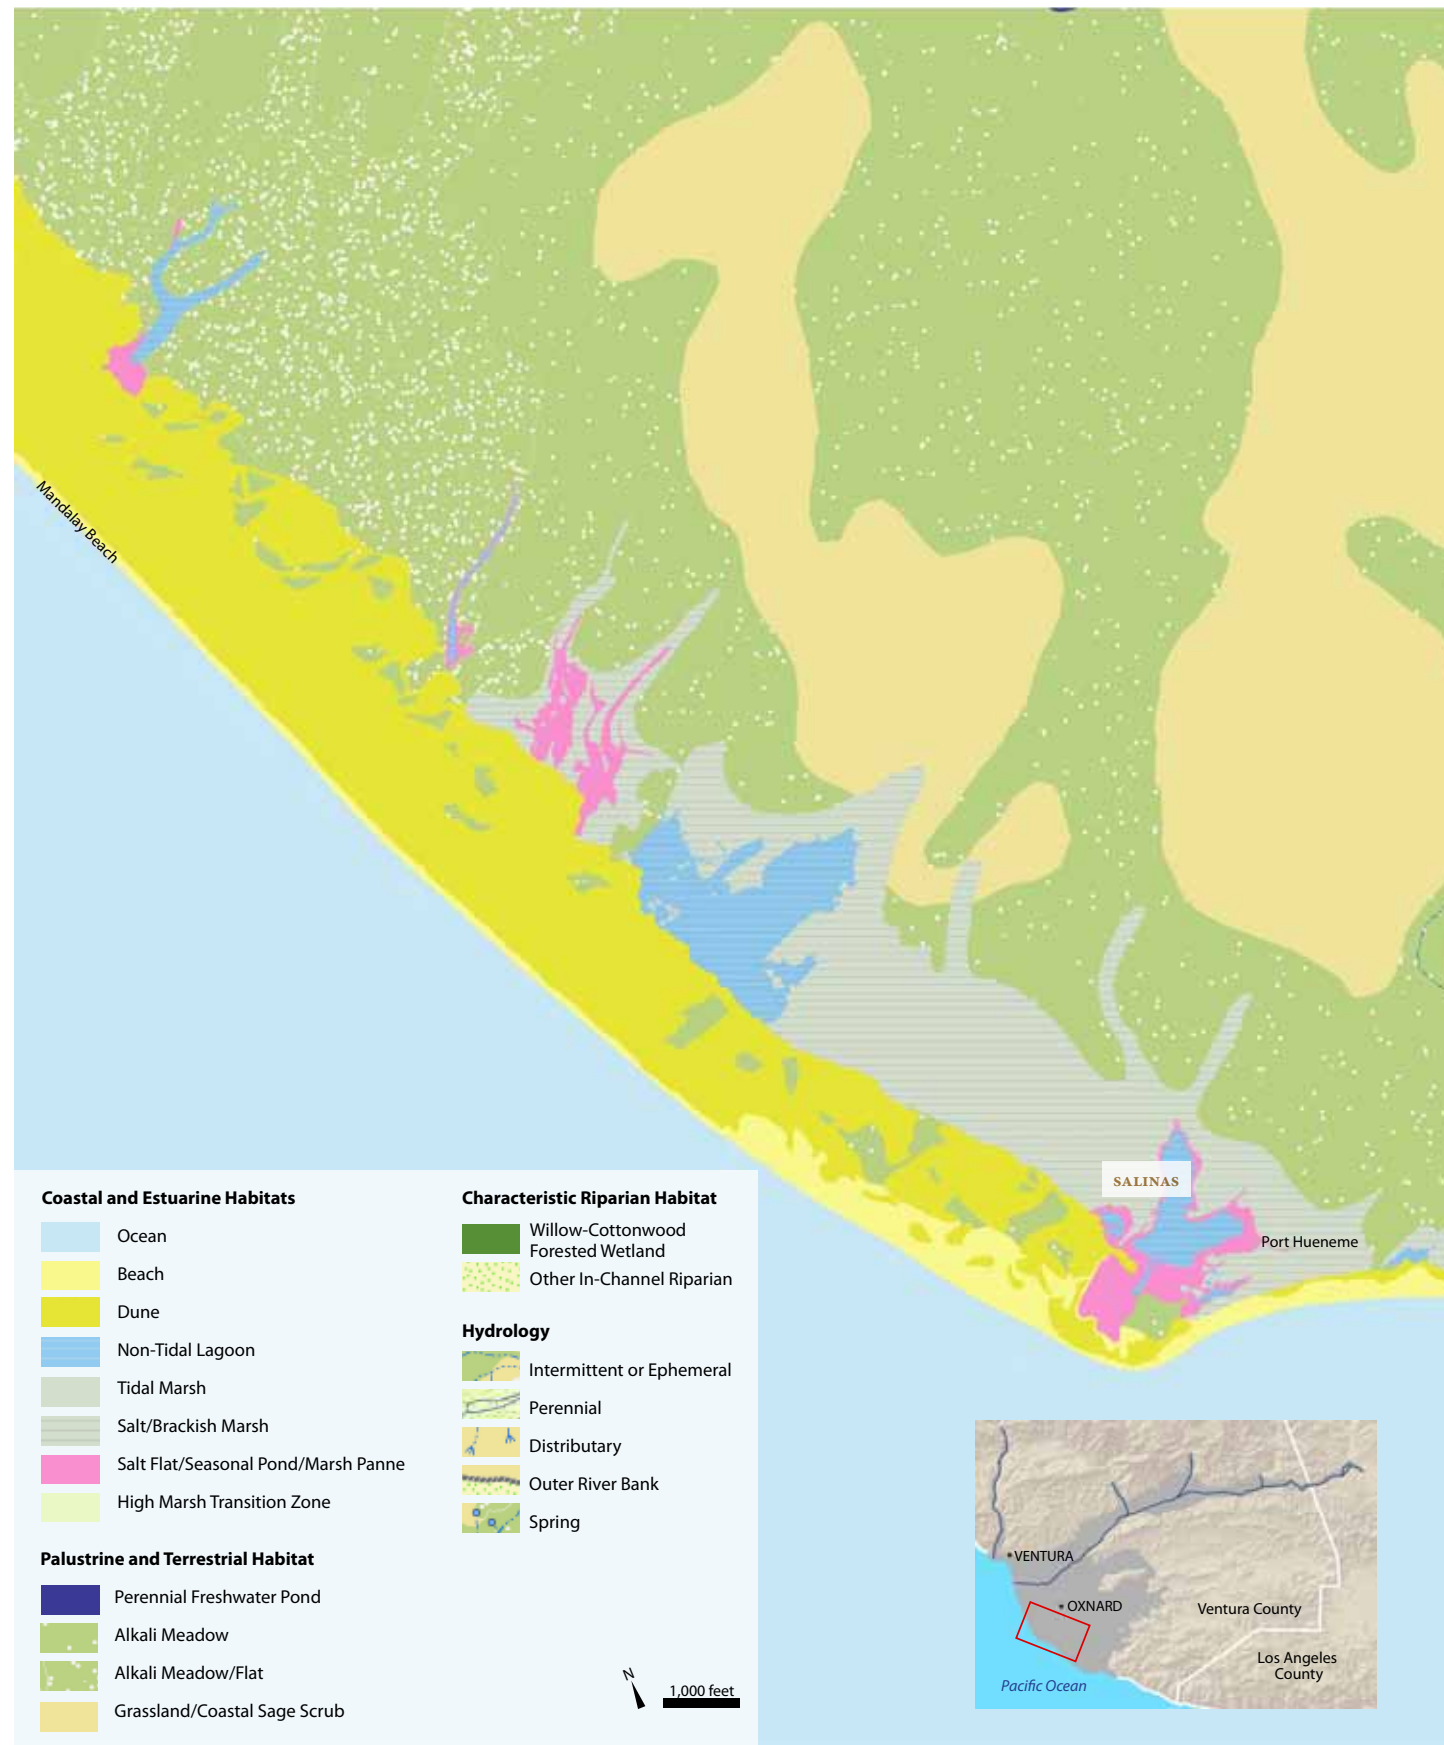
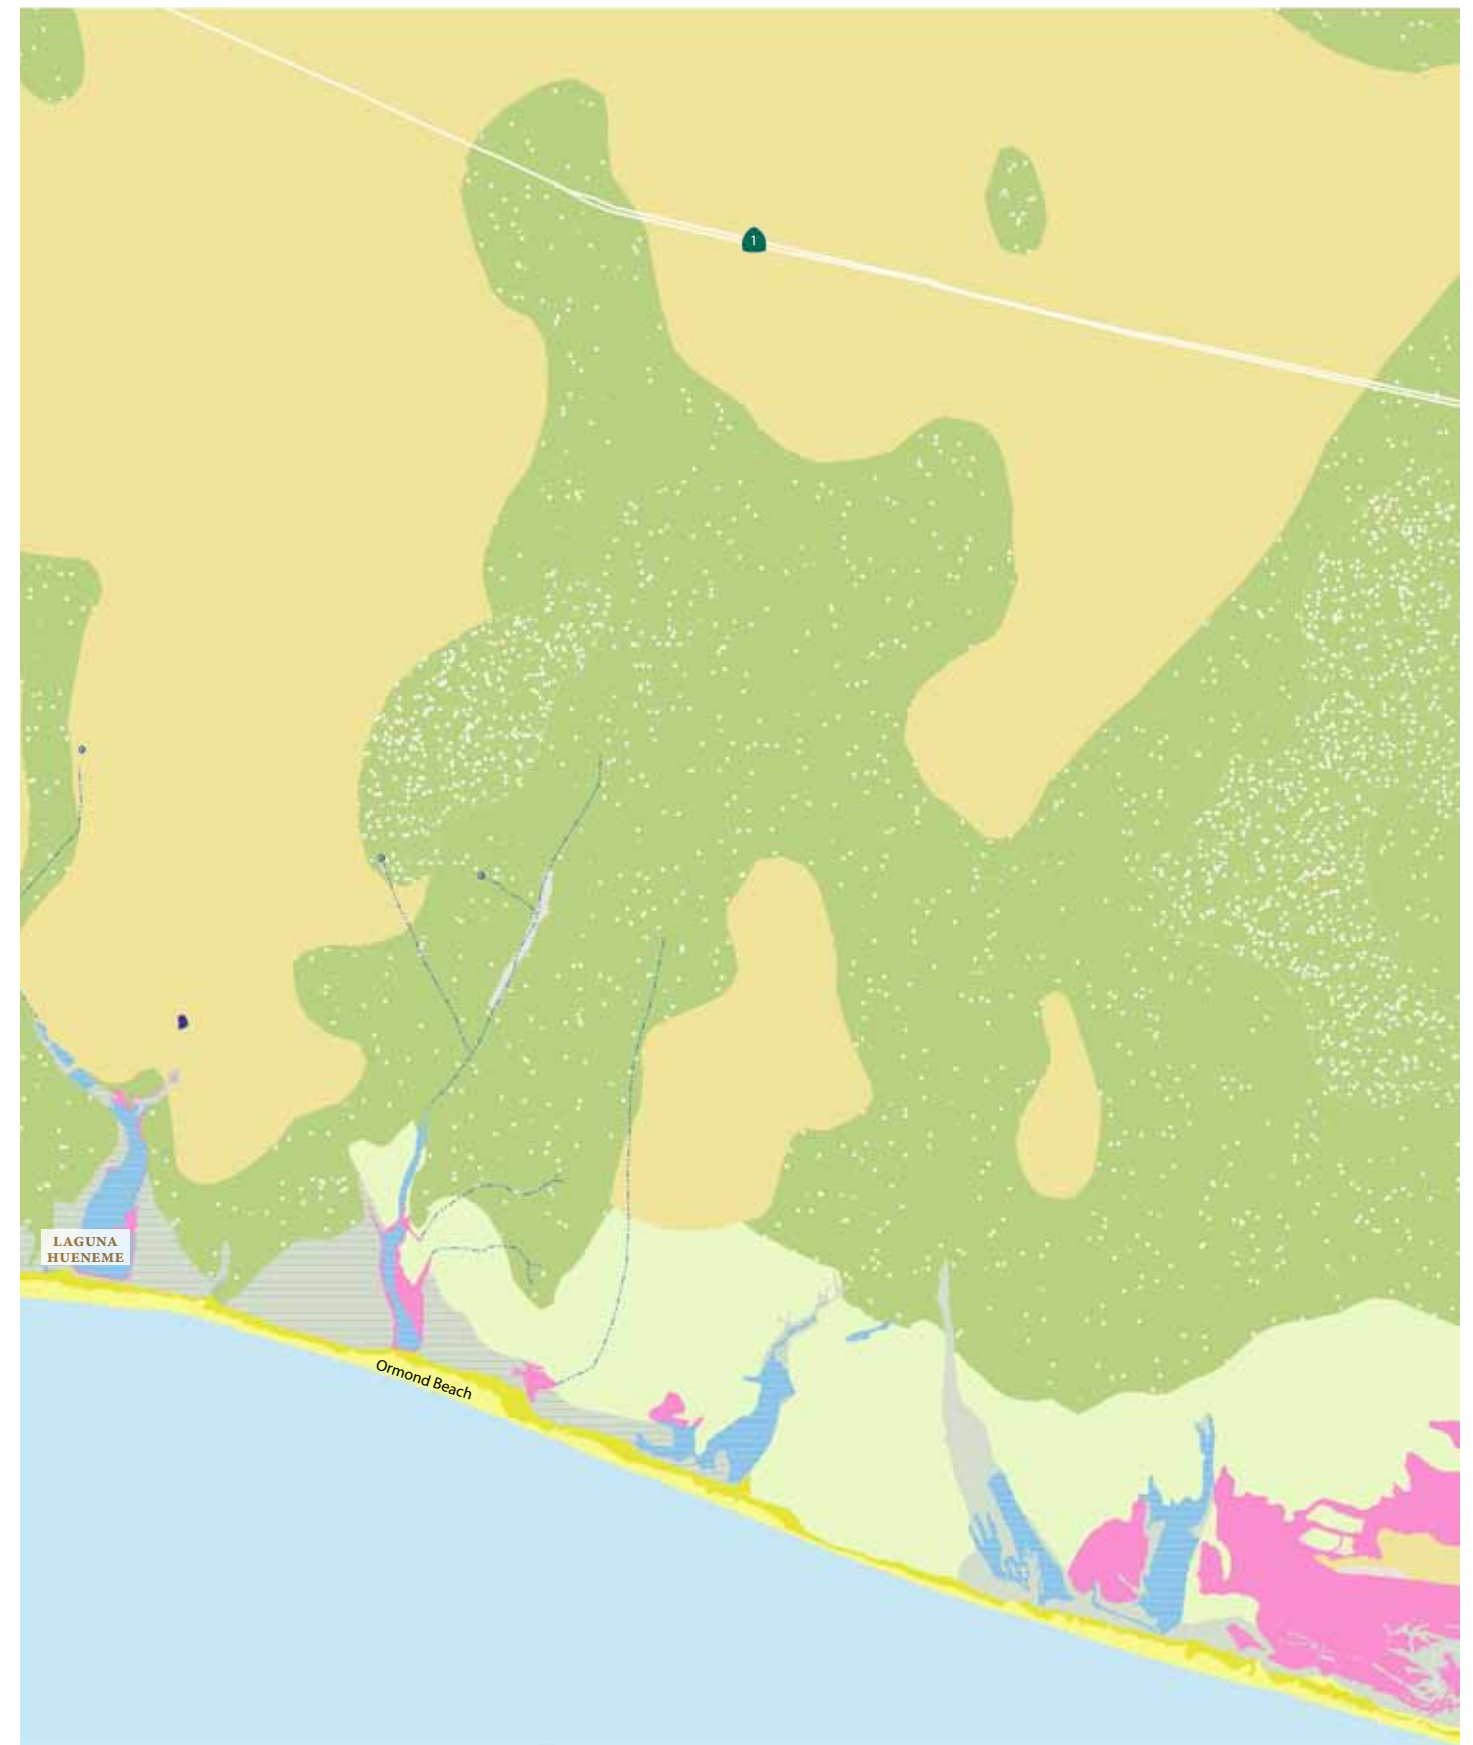
Fig. 6.15. A series of backbarrier lagoons, salt flats, and marshes stretched from south of the Santa Clara River mouth all the way to Mugu Lagoon (the western edge of which is at the right edge of this spread). Separated from the ocean by often extensive dunes, these systems were characterized by variable salinity, seasonality, and habitat proportions. (See fig. 6.24 for the modern aerial of this area.)

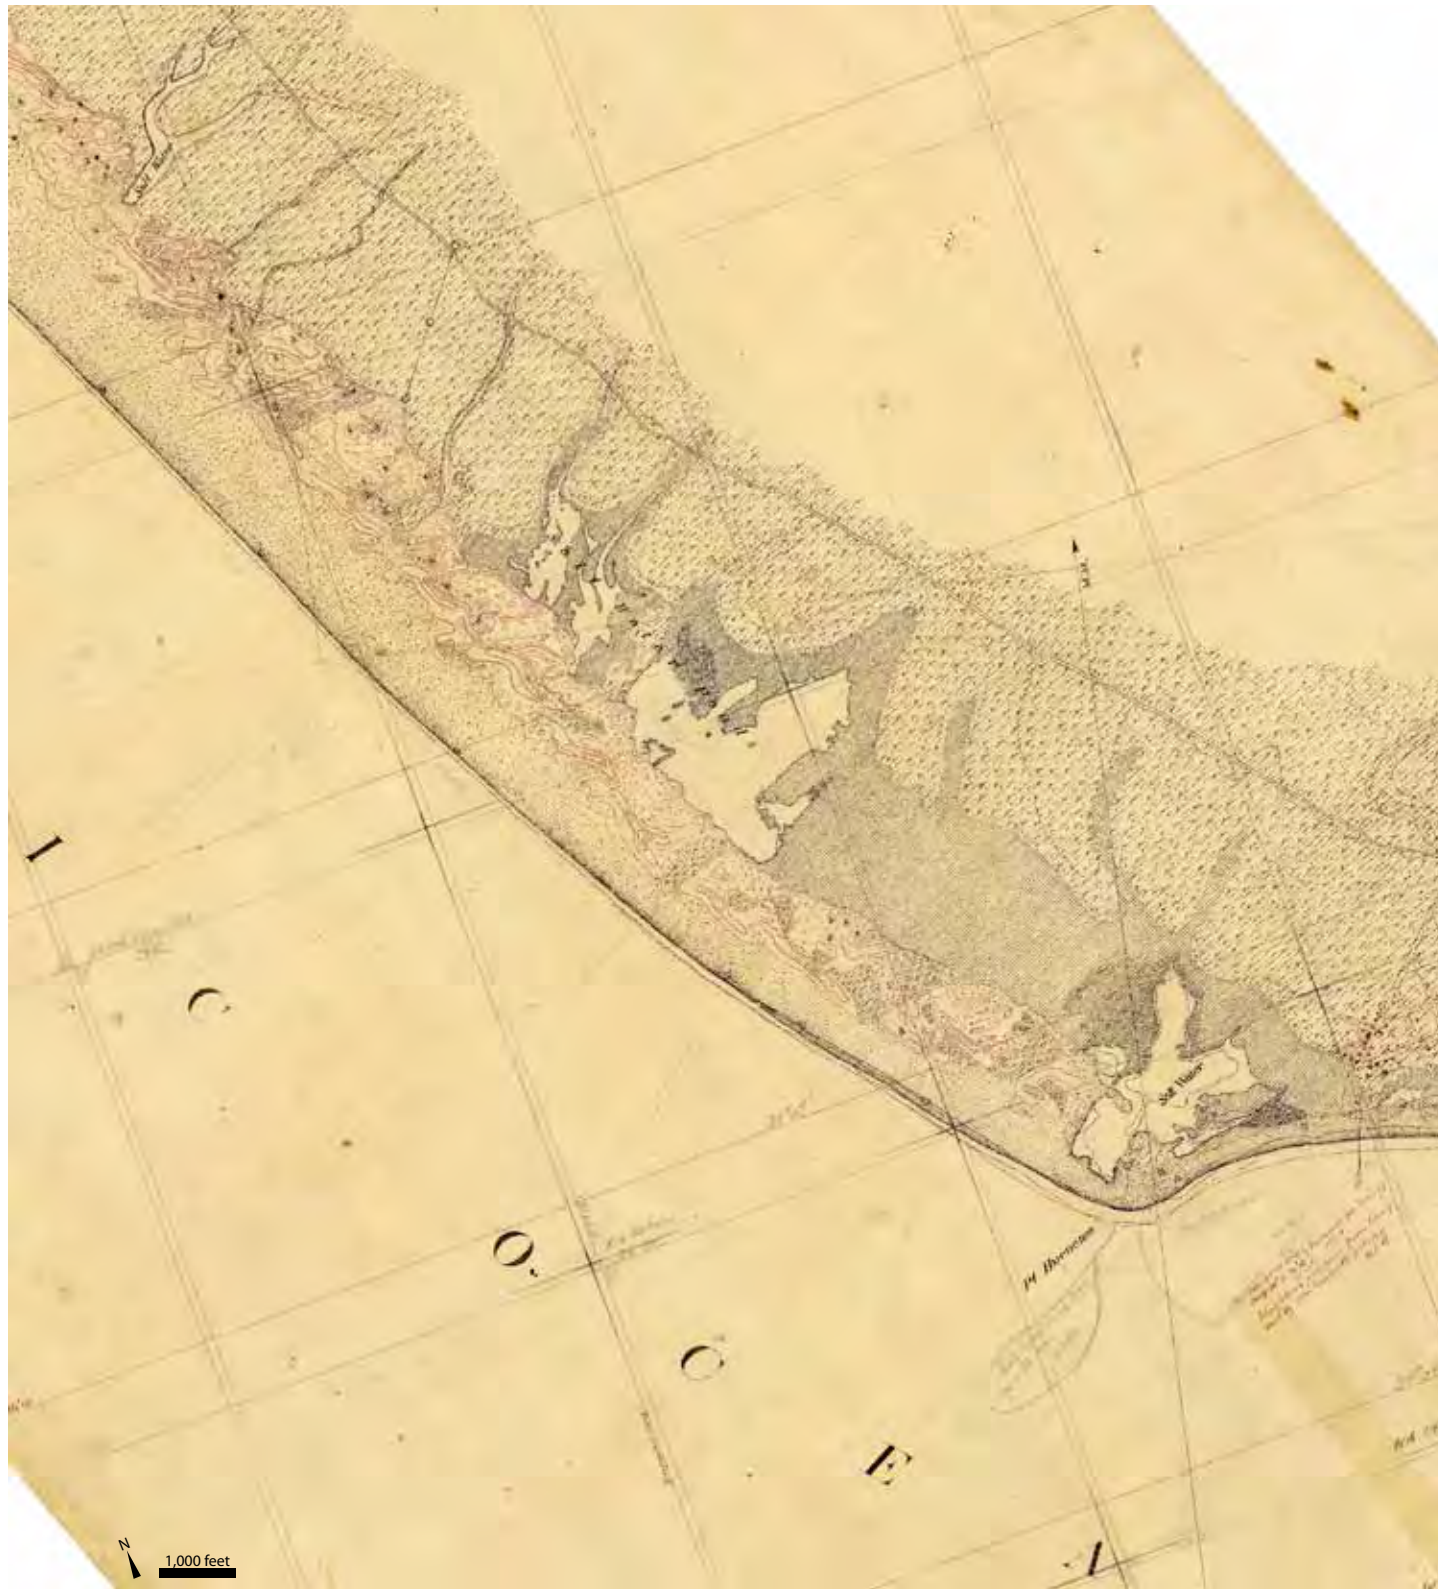
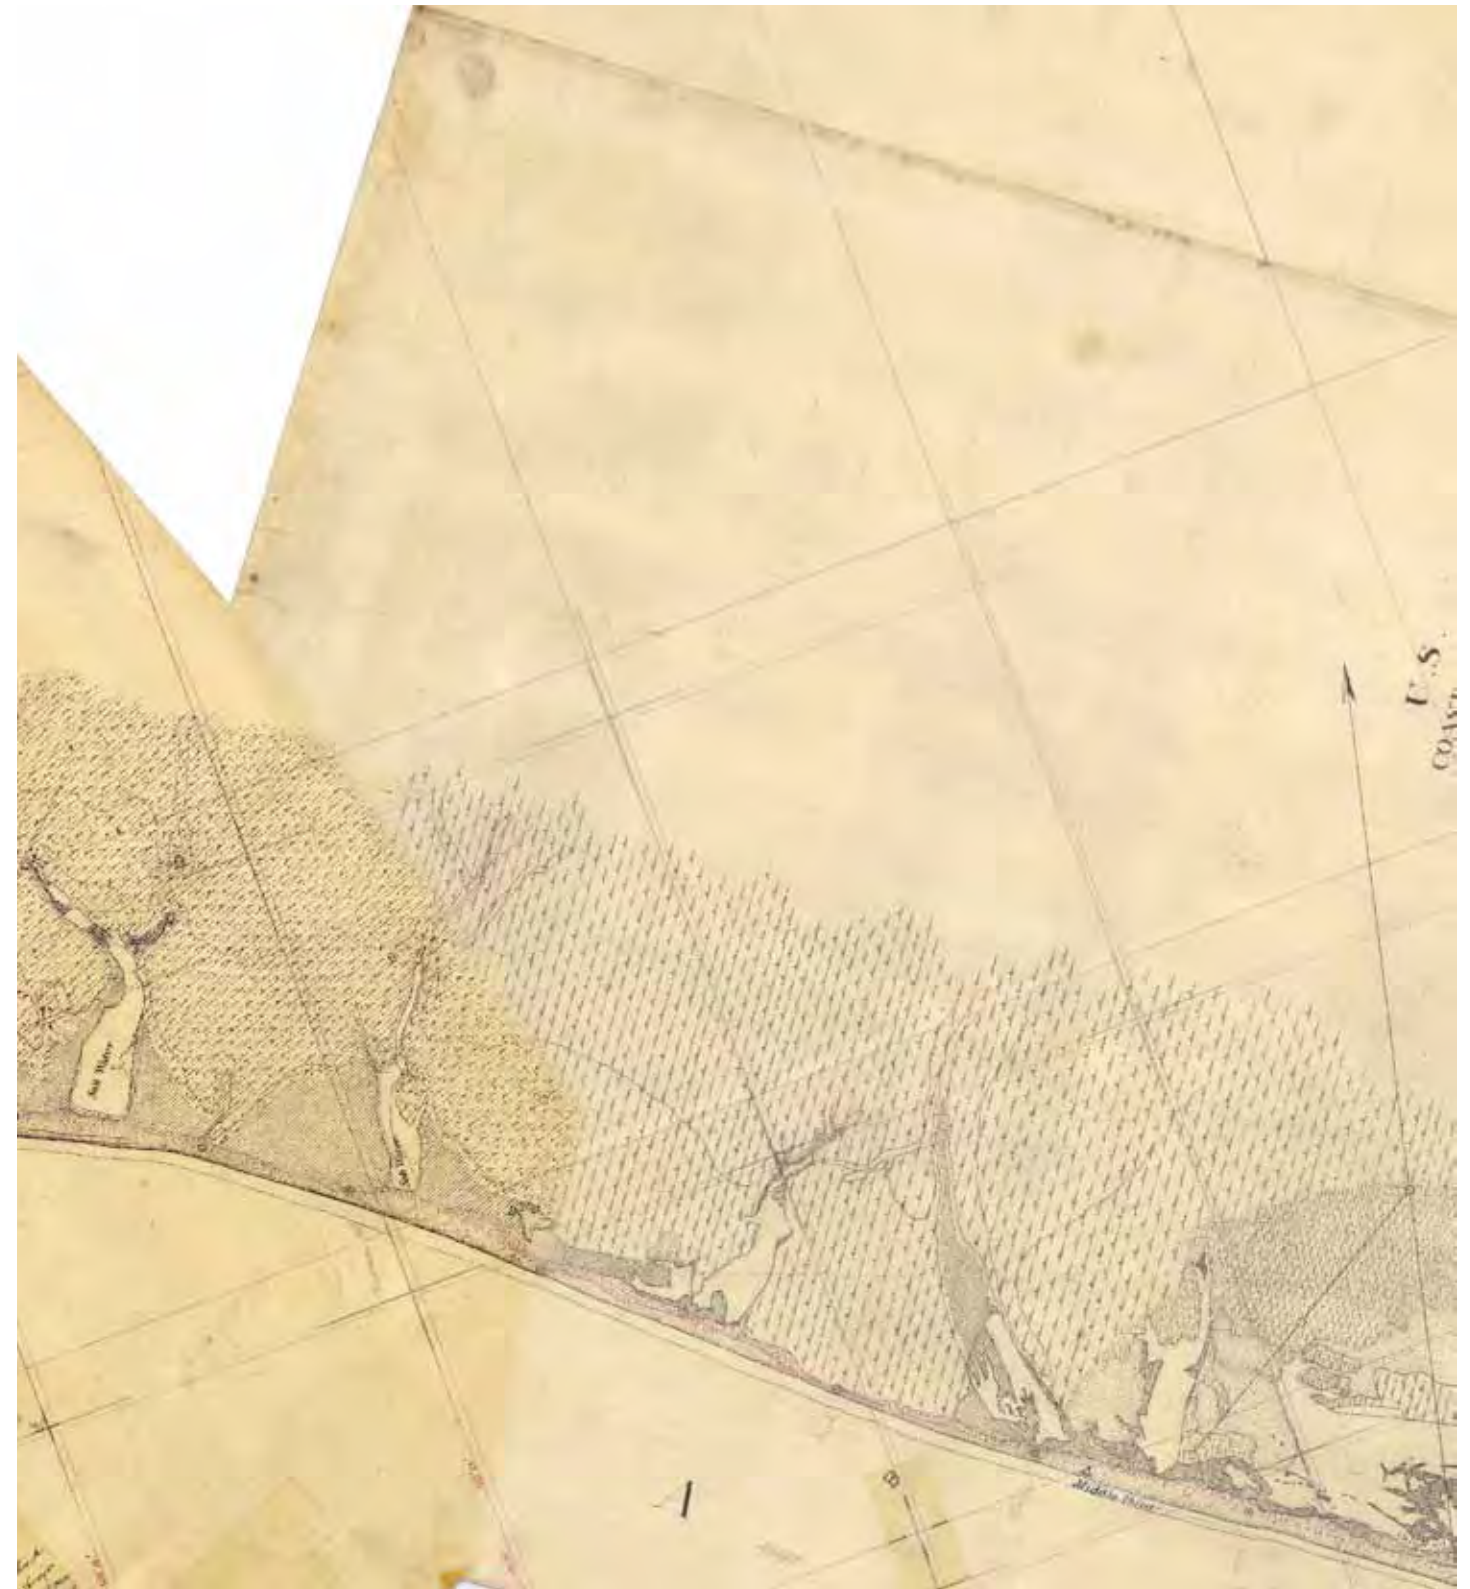
Fig. 6.16. The earliest detailed surveys of the Ventura shoreline, completed in 1855 and 1857, show the coastal wetlands with impressive precision. (Johnson 1855b and Johnson 1857, courtesy of the National Oceanographic and Atmospheric Administration)

By far the most detailed depiction of the suite of coastal lagoons is provided by a set of USCS T-sheets produced in the summers of 1855 and 1857, the maps upon which the bulk of our own historical habitat mapping is based (Johnson 1855b,c and Johnson 1857; fig. 6.16; see Grossinger 2011 for more discussion of these sources). These early surveys depict the lagoons as a series of open water/salt flat/marsh complexes separated from the ocean by sand dunes, which range from 300 to 3,300 feet wide and with high points consistently above 60 feet in elevation northwest of Hueneme. None of the lagoons are shown with a tidal outlet, and the lagoons' square-end shapes and the presence of the wide, vegetated barrier dunes suggests that these systems opened relatively infrequently. These systems, though

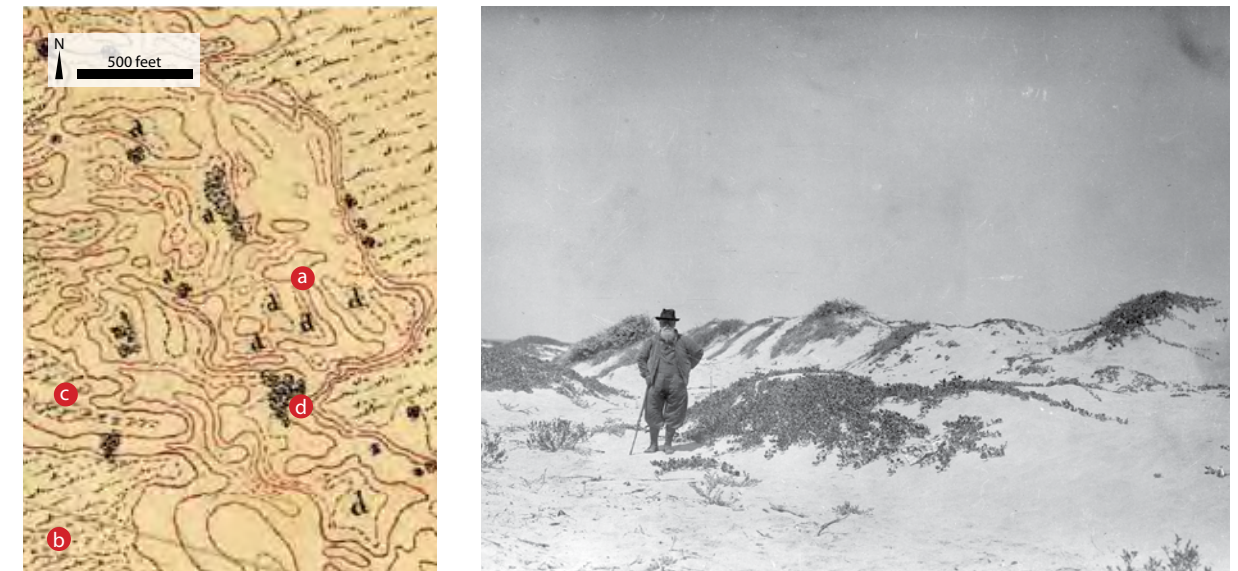
Fig. 6.17. Dune topography and vegetation near McGrath Lake, 1855 (left). Surveyors indicated a depression in the dunes with the letter “d” **a**, while the small red circles are thought to indicate dune tussocks **b** (Grossinger et al. 2011). The grassy symbol in some of the dune depressions (far left of image) is alkaline grassland **c**. A few willows are shown on higher portions of the dunes **d**. This detail is from the dunes north of West Fifth Street. (Johnson 1855/t-576, courtesy of the National Oceanic and Atmospheric Administration)

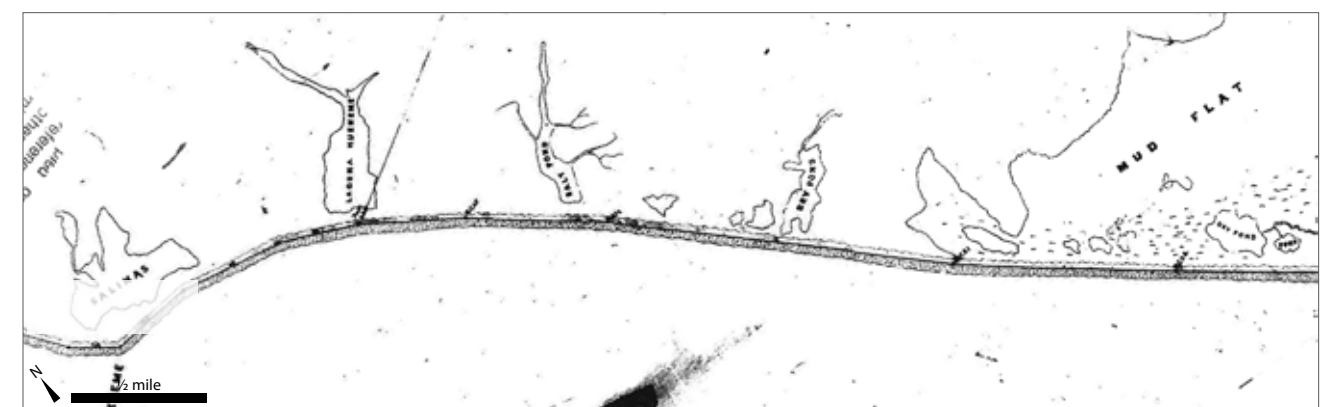
Fig. 6.19. Coastal lagoons near Point Hueneme, 1870. Four lagoons between Point Hueneme (at left) and Mugu Lagoon (western edge visible as “mud flat” at right). Though we mapped each feature as a non-tidal lagoon, note the labels on the lagoons—meaningfully, each of the four lagoons is labeled slightly differently. The Salinas was so known because of its use as a collection site for salt in the 19th century, suggesting substantial hypersaline and salt flat components. Similarly, the “dry pond,” though it would not have dried out completely every year, may have been shallower than adjacent lagoons. The “Laguna Hueneme” was well known for its freshwater inputs. The “salt pond” was found at the mouth of what is known today as the Oxnard Industrial Drain at Ormond Beach. Despite outward similarity, this map suggests substantial variation in hydrology and habitats across systems. (Bard 1870b, courtesy of The Bancroft Library, UC Berkeley)

These general observations are corroborated by annotations on an early map, which identifies some lagoons as “salt ponds” and another as “dry pond” (Bard 1870a; fig. 6.19). Remarkably, the T-sheet also has annotations describing summer conditions, written in exceptionally faint pencil within some of the lagoons and seasonal ponds. A few (for example, two seasonal ponds south of modern-day Channel Island Boulevard) are labeled “dry,” another portion of one as “salt land” (perhaps marking an exposed portion of the lagoon), while others are labeled “salt water.”

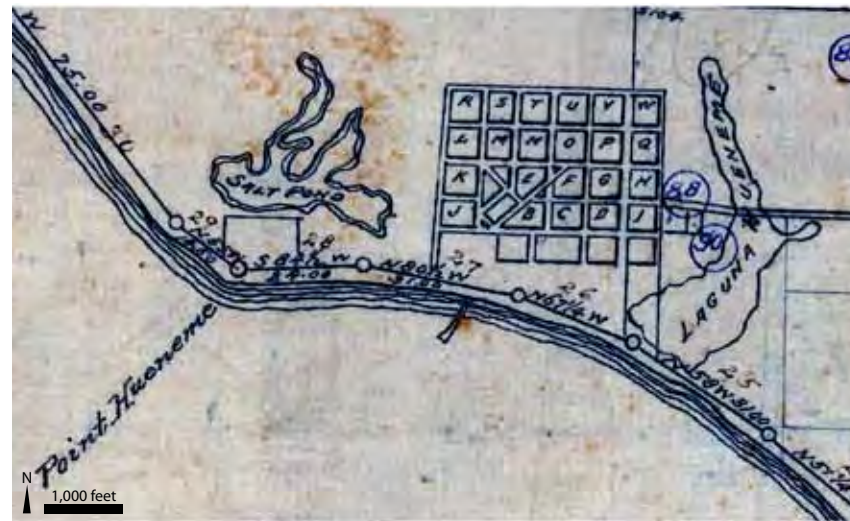
Fig. 6.20. Lagoons near Hueneme, 1877.

Two well recognized lagoons were found on either side of the town of Hueneme (shown in its nascent form here). The “salt pond,” to the west of town, was known as the Salinas. To the east was spring-fed Laguna Hueneme. (Stow 1877, courtesy of the Museum of Ventura County)

An extreme example of this variability is found in the two ponds formerly near Hueneme (fig. 6.20). Both lagoons were well known in the 19th century, with names preserved in the historical record. To the west of Hueneme, at the current site of the port of Hueneme, was a salt water lagoon called Siptip by the Chumash (Harrington 1913e) and La Buena Salina or the Salinas by Spanish-speaking residents (Harrington 1986a). The Salina was so called because of its use as a gathering place for salt, implying that substantial portions of the lagoon were shallow enough to dry out during the summer for salt harvesting (fig. 6.21). This lagoon was described as the place where early residents would gather salt, and which was “well known to and is designated by the older inhabitants as the place where a certain Dr. Poli, several years ago was accustomed to collect salt and to ship the same to San Francisco” (Bard 1869, Bard 1871). This is reflected in our mapping from the T-sheet, where the ratio of salt flat to open water is 1.4.

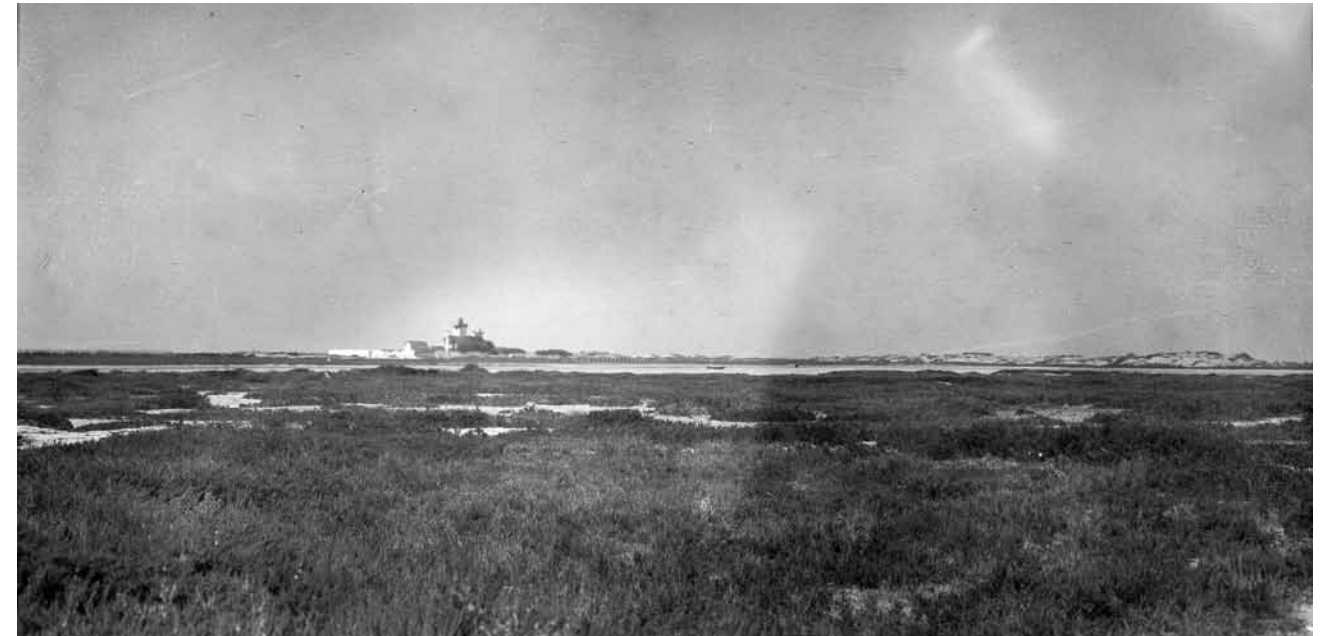
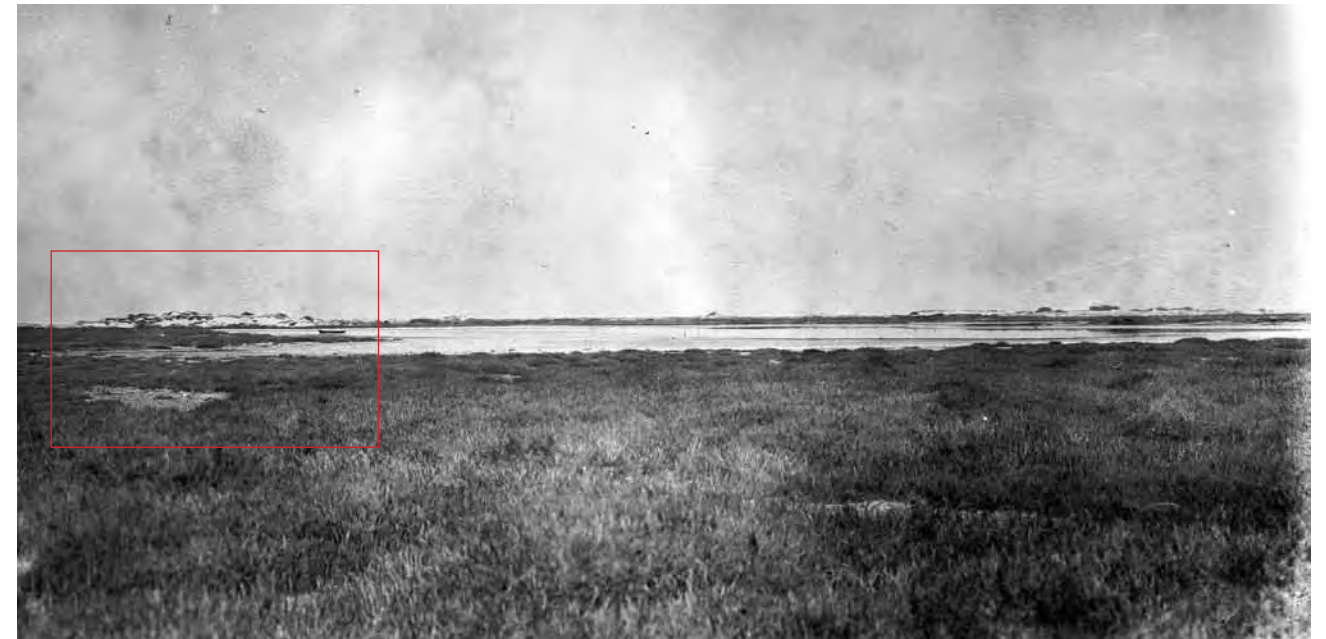
Fig. 6.21. The Salinas, 1913. These two images provide two different views of the Salinas lagoon, formerly located where the port is now. The view is generally southwest; high dunes (top and middle) and the Point Hueneme lighthouse (top; built in 1874) can be seen in the background. In the foreground, extensive salt marsh (mainly pickleweed, probably with some salt grass component and visible pannes) stretches toward the lake. A small boat (detail; at left) can be seen on the lagoon in both pictures, indicating some depth. (Harrington 1913b,d; courtesy of the Smithsonian Institution)

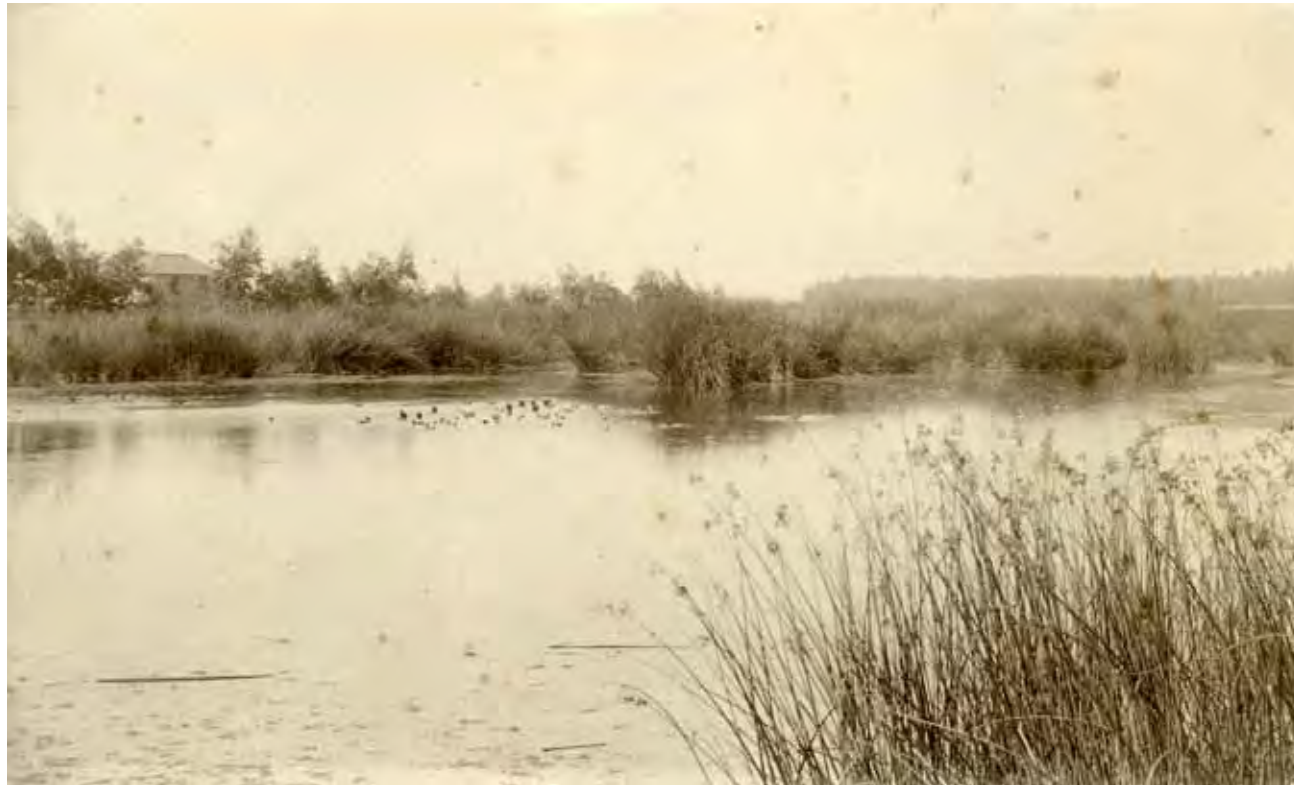
Fig. 6.22. “Duck shoot near Hueneme,” ca. 1889. This image shows a portion of Laguna Hueneme in the late 19th century. The lagoon is surrounded by tule (likely *Scirpus [Schoenoplectus] californicus*). What is likely sago pondweed (*Potamogeton pectinatus/ Stuckenia pectinata*) can be seen in the foreground (Collins pers. comm.). This photograph, also included as a lithograph in an 1889 article in *Overland Monthly and Out West* magazine on traveling in Ventura County, matches the description included in that article well: “spears of purple reeds [likely tule], with flocks of wild duck plowing luminous furrows across its steel-gray floor” (Eames 1889). (Brewster ca. 1889, courtesy of the Museum of Ventura County)

The most notable aspect of Laguna Hueneme, however, was its freshwater input from springs on the Oxnard Plain. Though this characteristic was not unique to the lagoon (it has also been documented for the lagoon immediately to the east; Parsons 2004), it is extremely well documented in this case. Early residents testified that the lagoon was “fed by springs of fresh water” (Bard 1871). This characteristic of Laguna Hueneme is a product of its status as a former mouth of the Santa Clara River, relatively recently occupied and still the recipient of substantial freshwater flows (see page 71). Though Laguna Hueneme itself is long gone, this is still the case today: the Hueneme Drain/Bubbling Springs Drain, a man-made channel which occupies the location of the former slough which fed into the lagoon, has perennial flow today as a result of springs (HDR Engineering 2009).

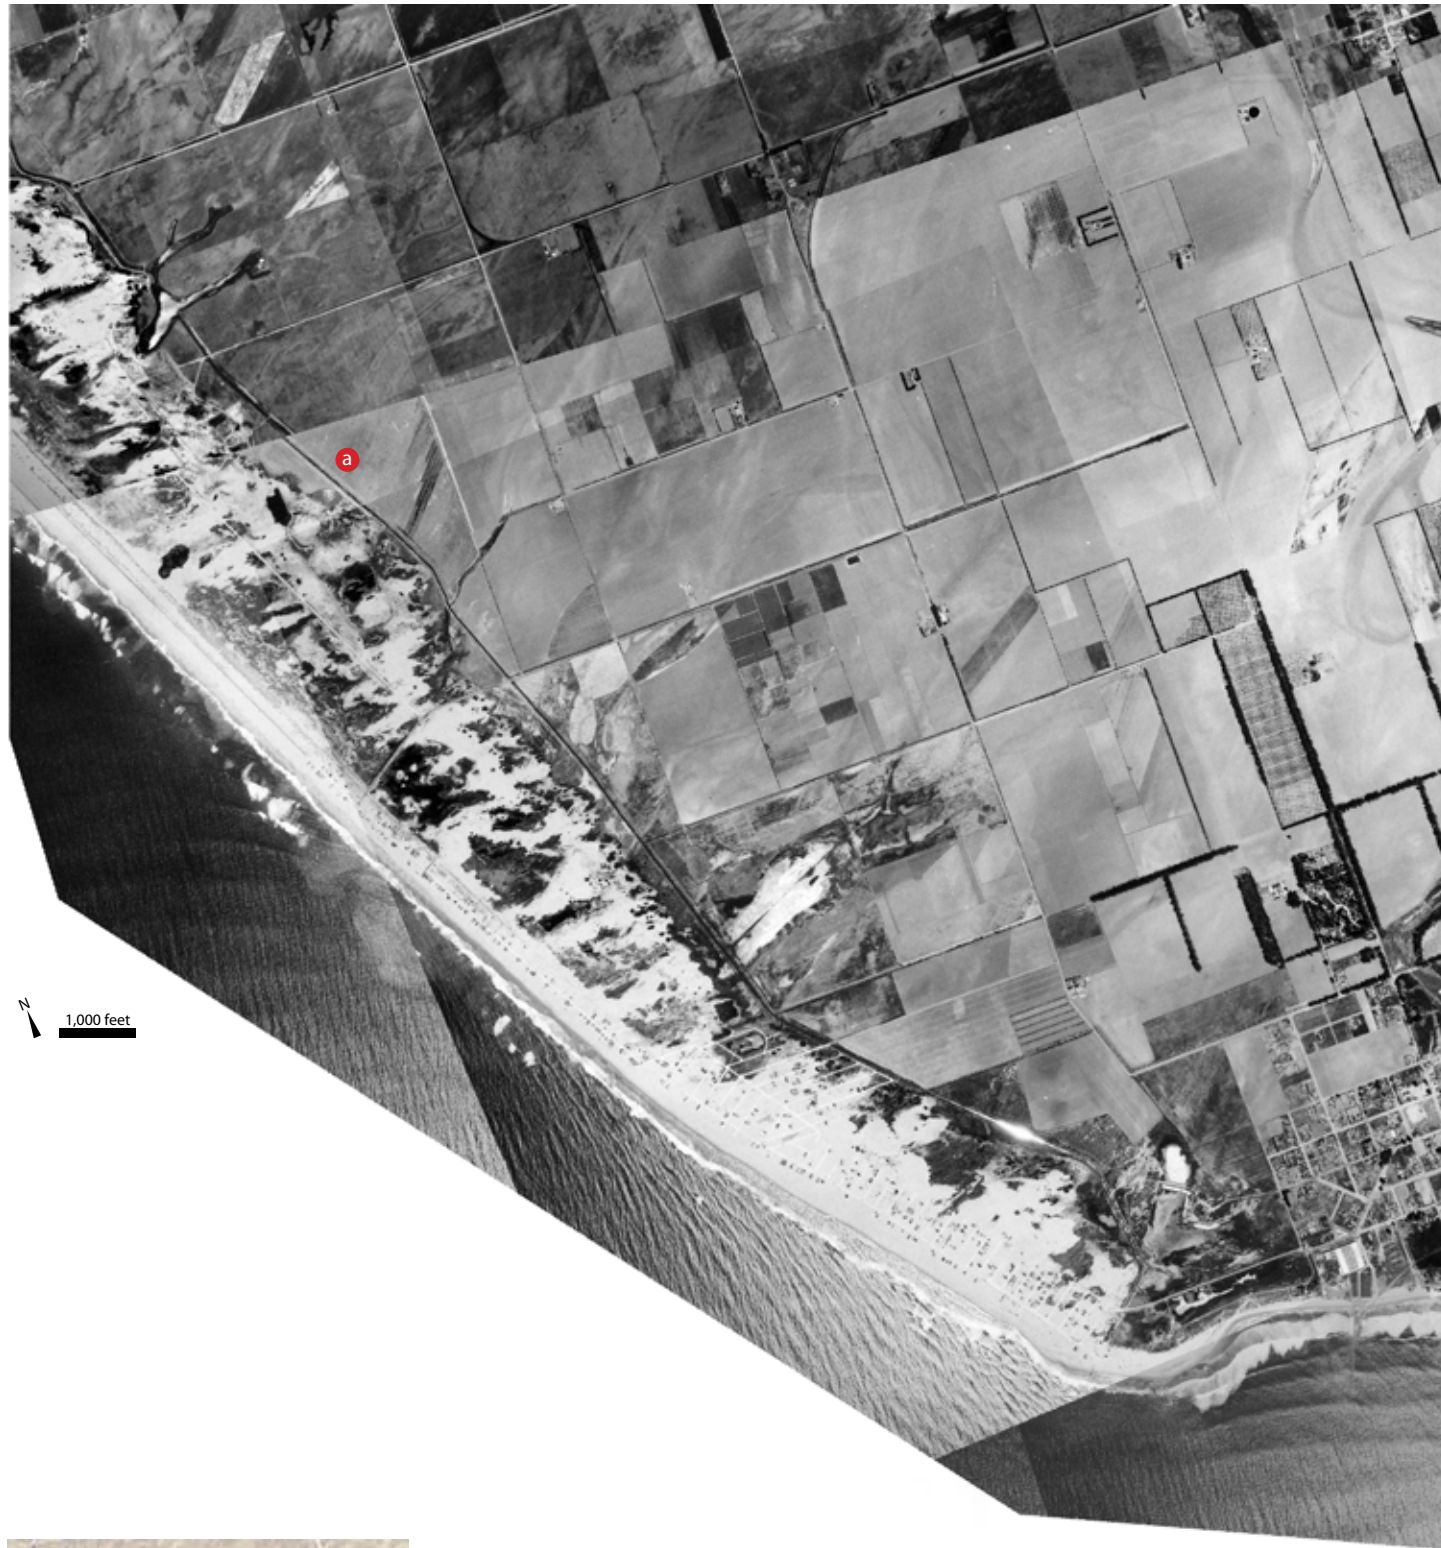
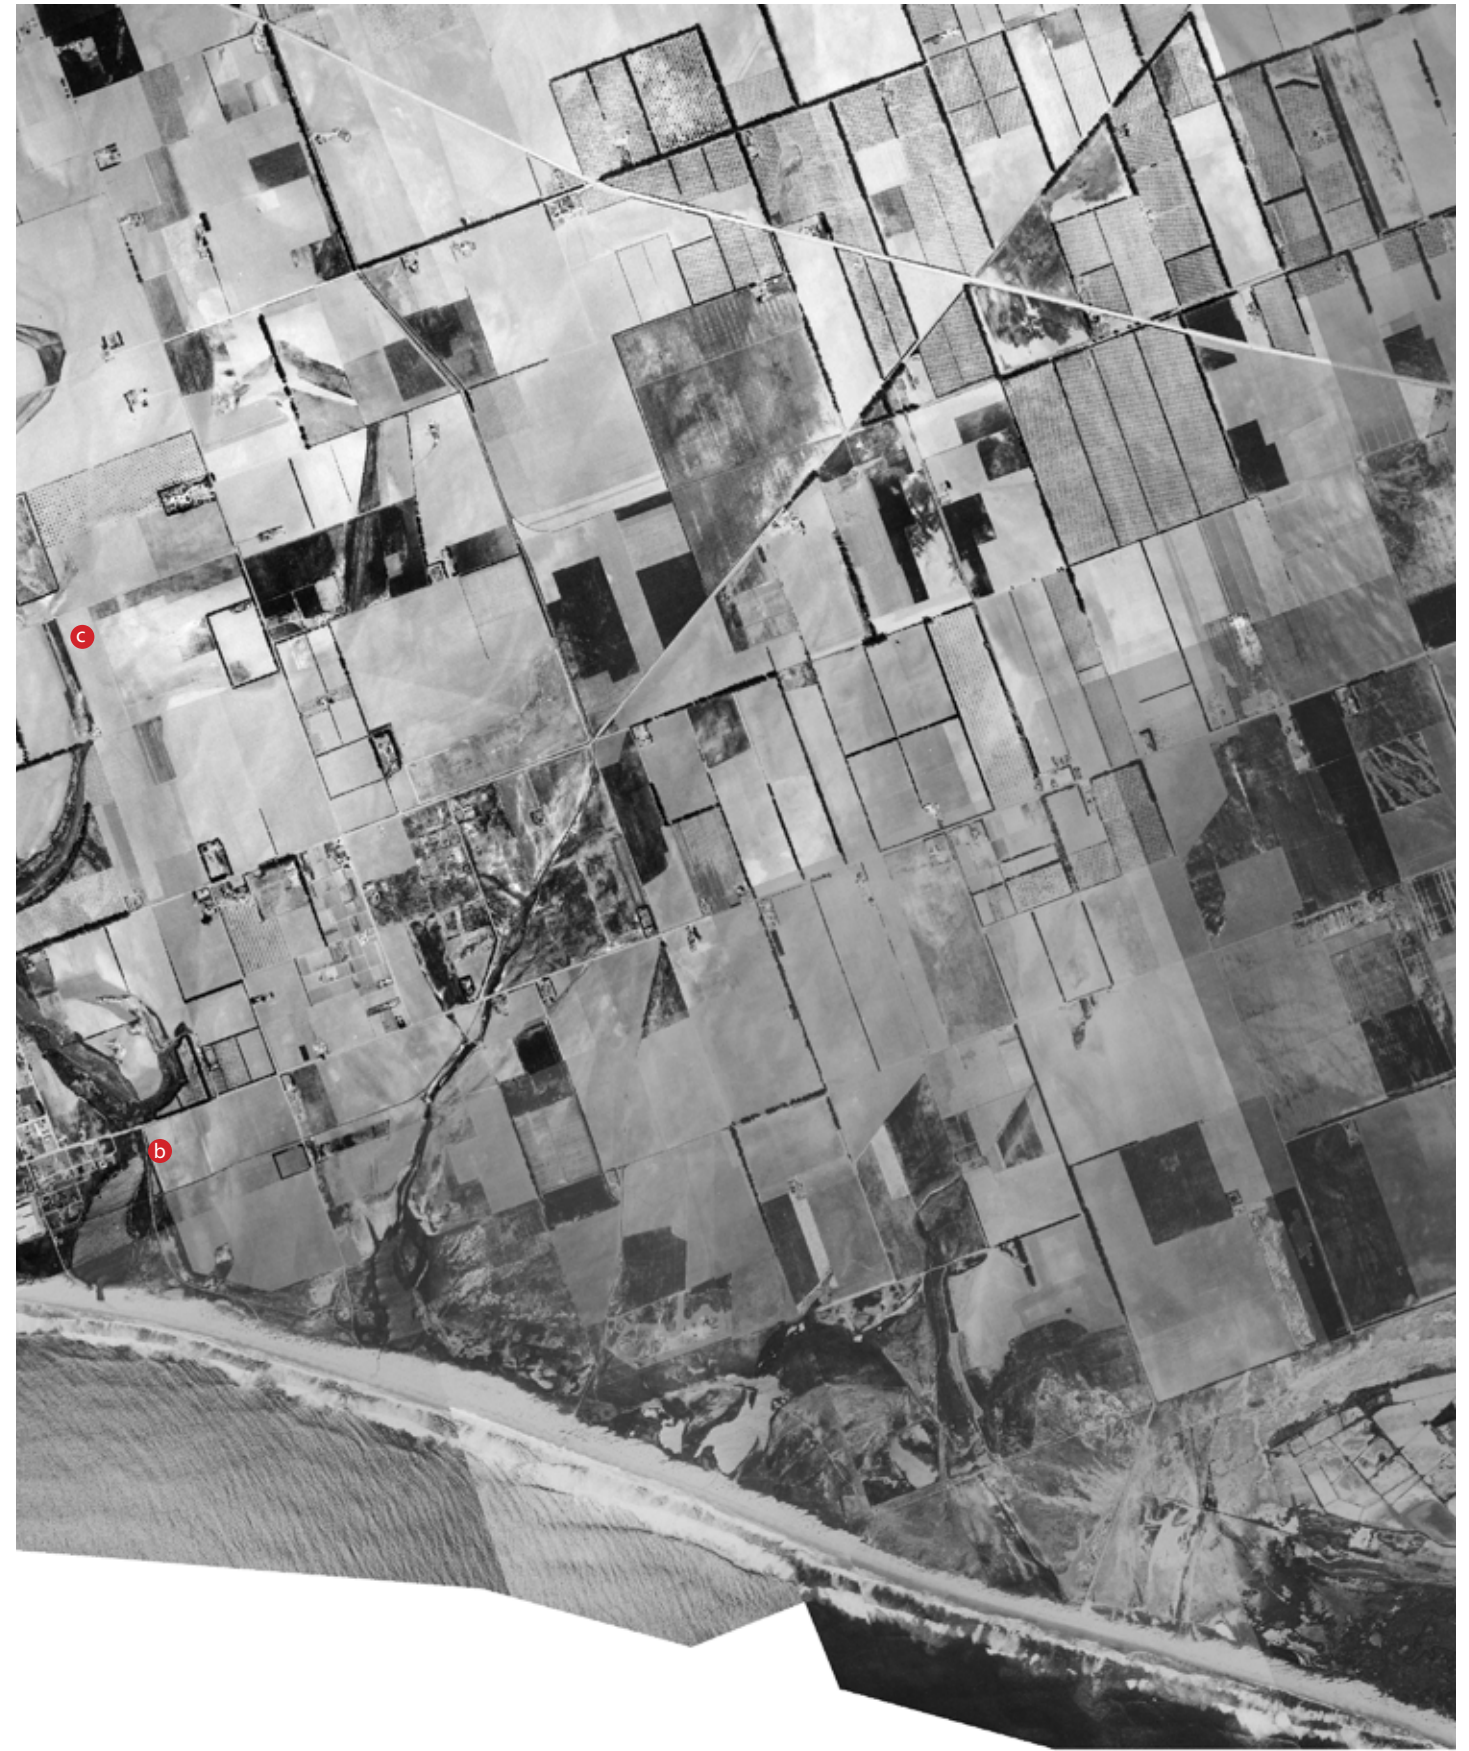
Fig. 6.23. Oxnard Plain shoreline, 1927/1938. Traces of most of the 19th century lagoon complexes are still visible at the time these photos were taken in the 1920s and 1930s, though it is clear that many are in the process of being drained by the long canal seen at left **a**. A few lagoons, such as Laguna Hueneme **b** and the adjacent lagoon to the east, still appear to be filled with water. Traces of the former Santa Clara River channel are clearly visible at **c**, feeding into Laguna Hueneme. (Fairchild Aerial Surveys 1927, courtesy of Whittier College, USDA 1938, courtesy of Ventura County)
