HISTORICAL ECOLOGY of the lower Santa Clara River, Ventura River, and Oxnard Plain: an analysis of terrestrial, riverine, and coastal habitats

HISTORICAL ECOLOGY PROGRAM
CONTRIBUTION NO. 641 • AUGUST 2011

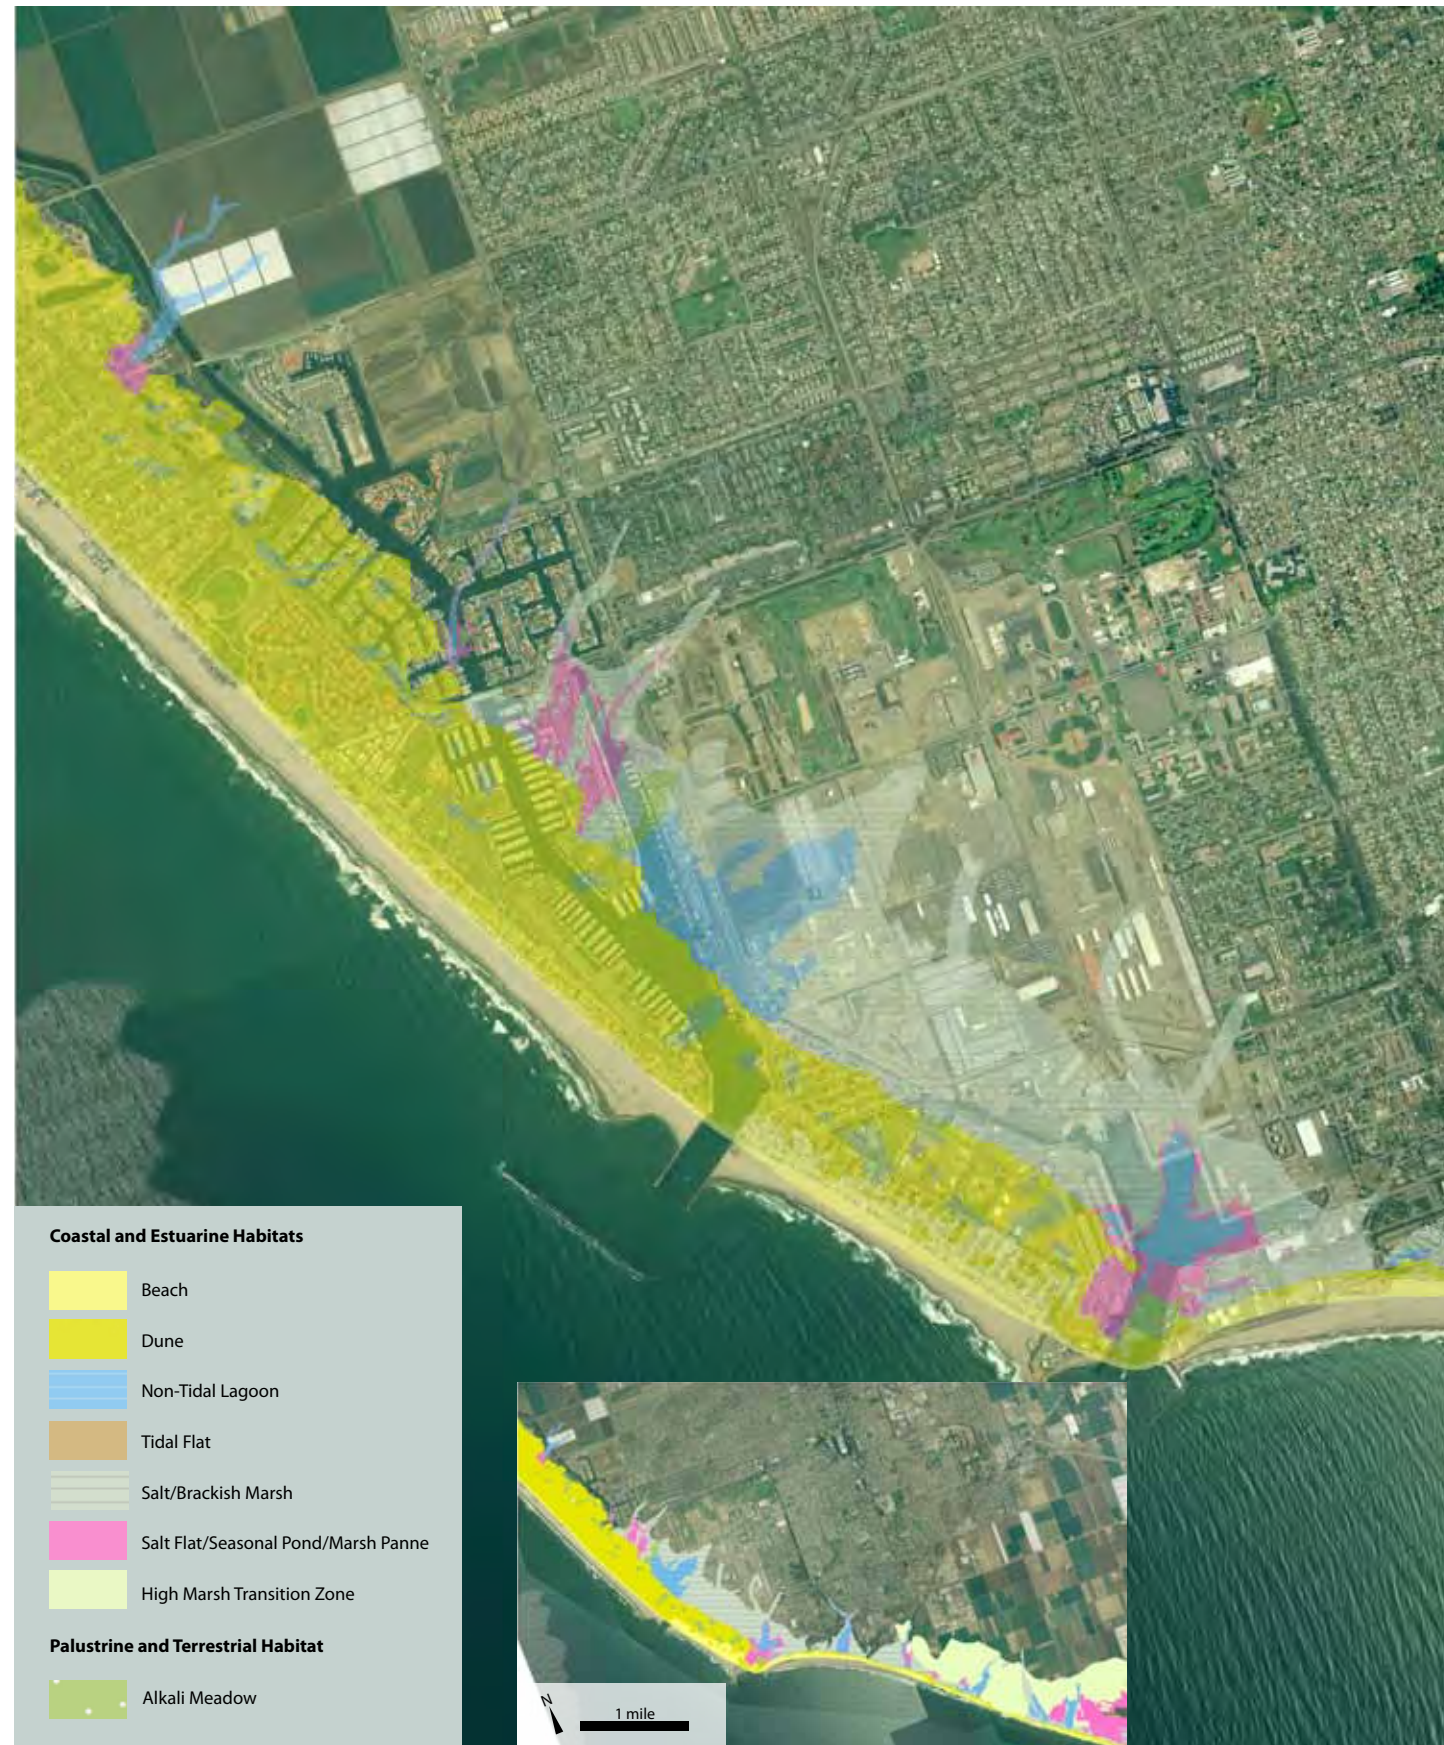
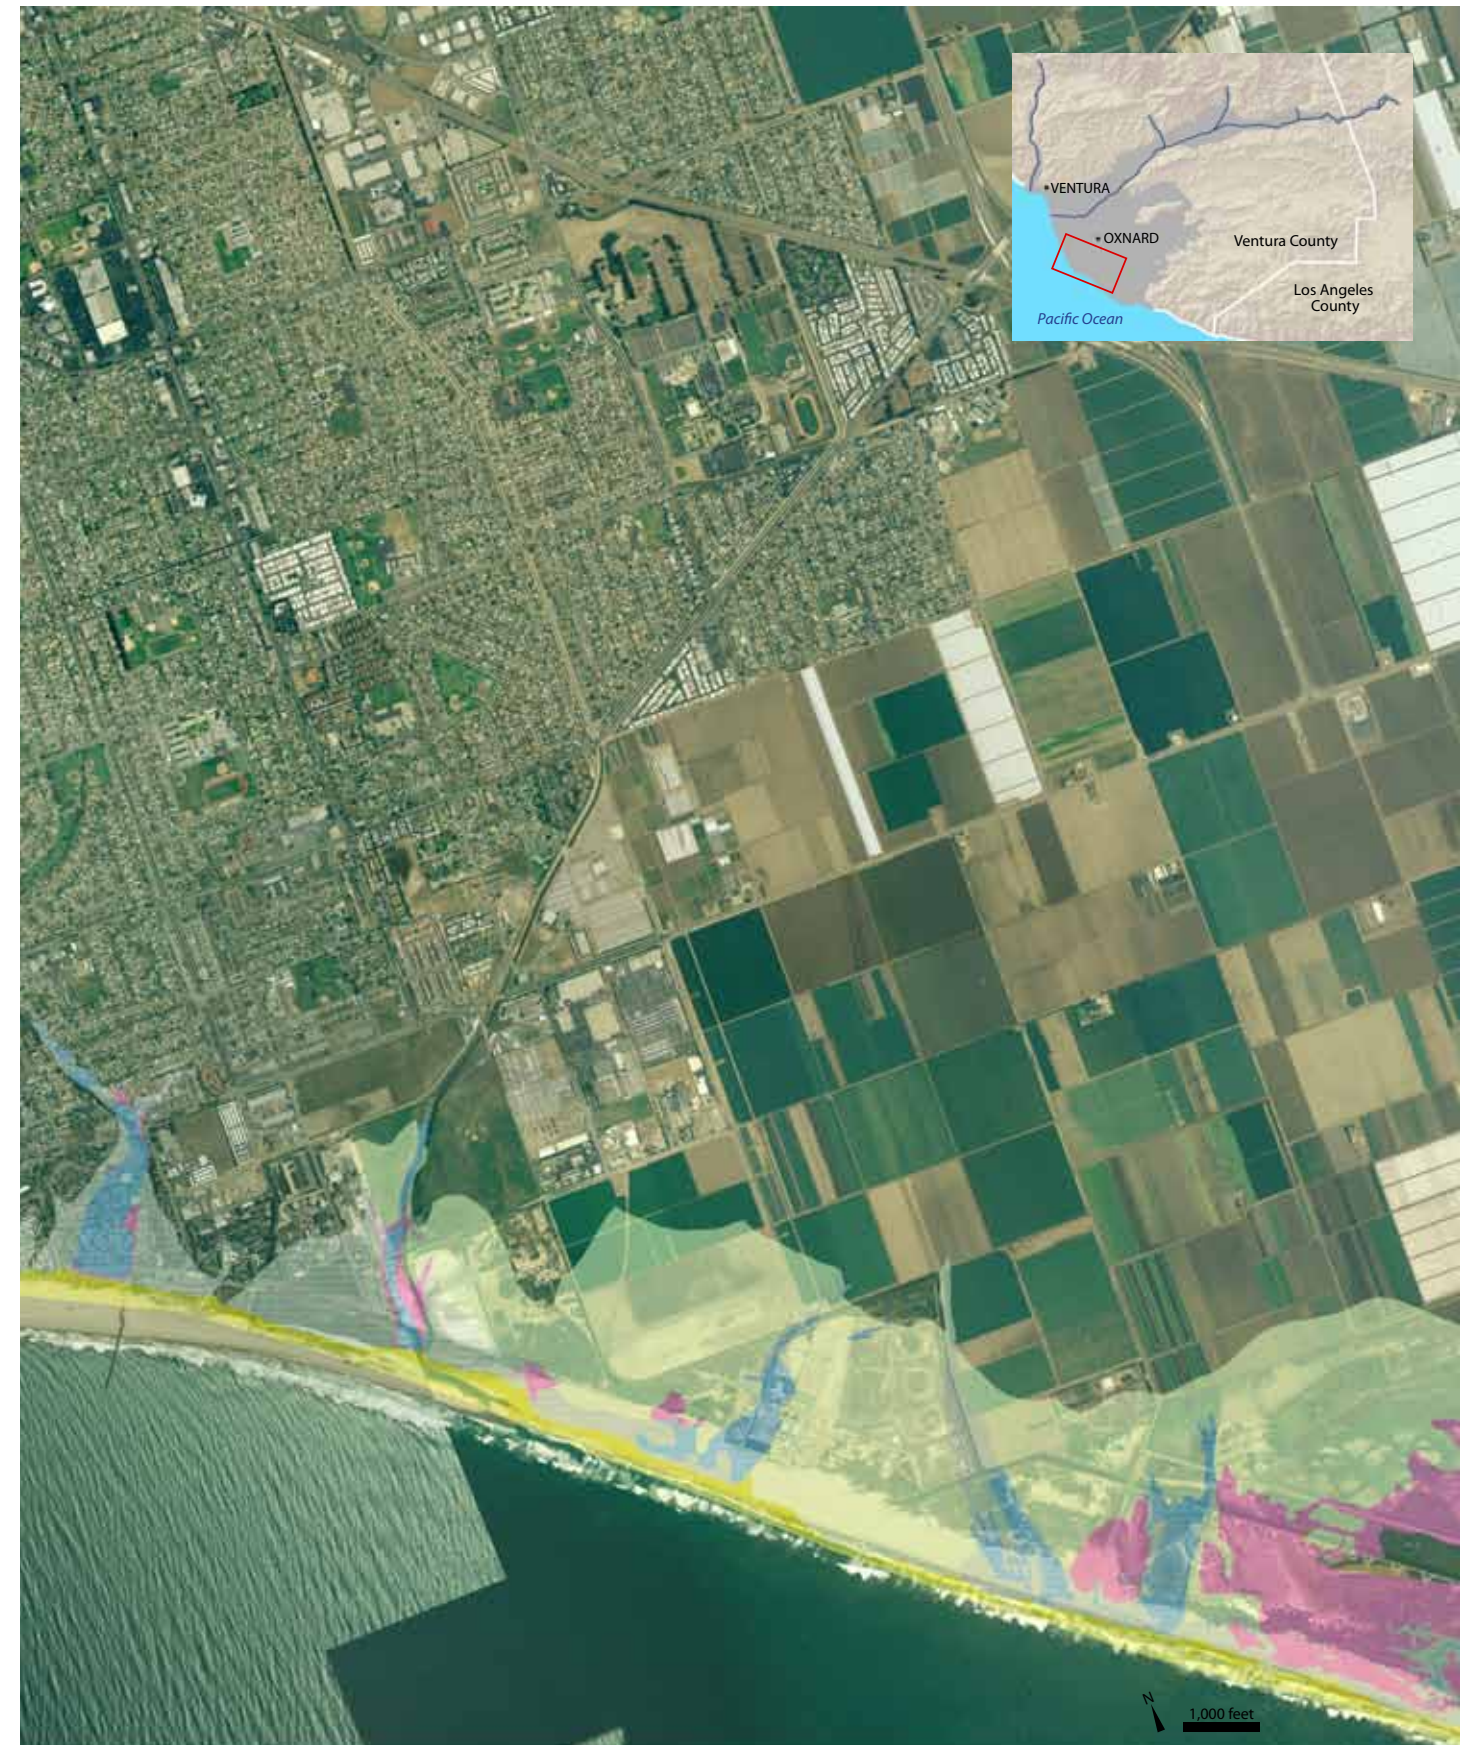
Fig. 6.24. Oxnard Plain shoreline, 2005. By 2005, most traces of the former lagoon complexes have been erased. A few markers remain, such as sloughs near Ormond Beach that used to empty into lagoons (portions of which have been repurposed as the Oxnard Industrial Drain and the Hueneme Drain). A lagoon similar to former features has formed to the east of Laguna Hueneme at Ormond Beach. (USDA 2005)

Most traces of the other lagoon complexes have been completely obliterated over the past 100 years (figs. 6.23 and 6.24). Much of this change had already happened by the early 1930s, by which time a five mile long drainage ditch, stretching from south of the Santa Clara River all the way to its outlet at Hueneme and bisecting the former locations of many of the coastal lagoons, had been constructed to drain the area.

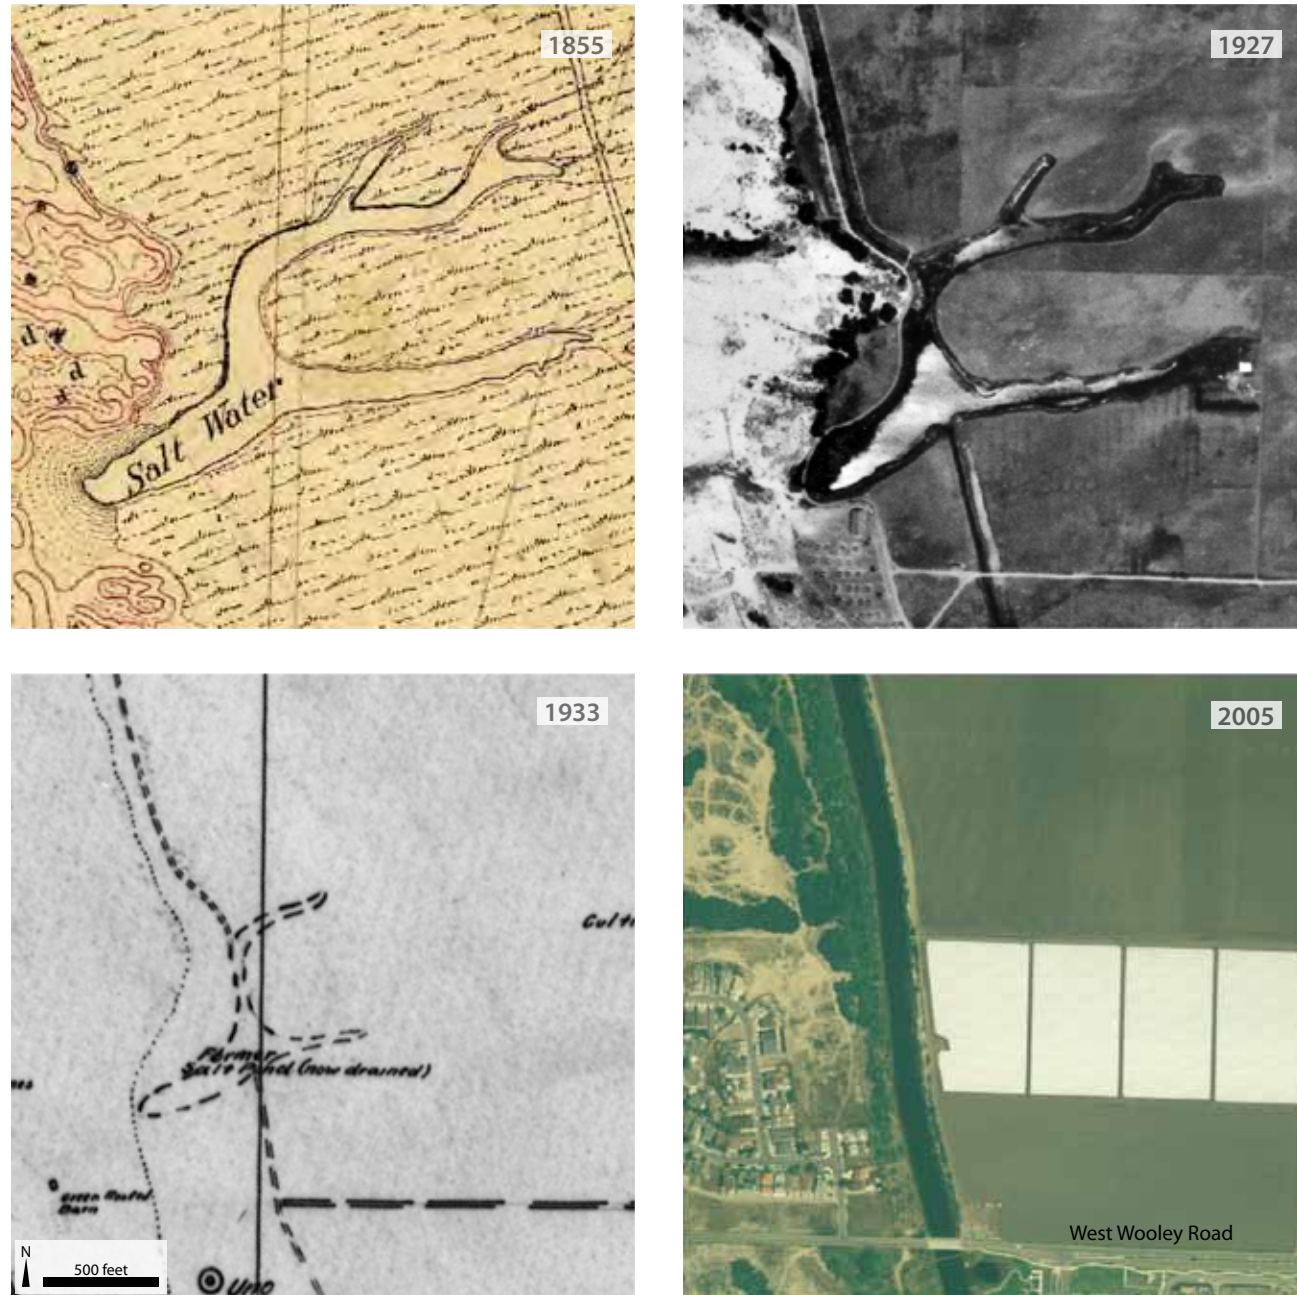
Fig. 6.25. In 1855, a small (14 acre) coastal lagoon was recorded by the U.S. Coast Survey, at what is now the end of West Wooley Road at Mandalay Bay (top left). Nearly 80 years later, in the descriptive report accompanying the T-sheet resurvey, the cartographers note that a drainage ditch (visible here on the aerials; top right) “has drained the salt pond shown on the former work... although the general shape as a dry hole is still apparent” (bottom left; Kelsh and Green 1934c). By 2005 all traces of the lagoon have been erased: only the drainage ditch remains (bottom right). (Johnson 1855b, courtesy of the National Oceanic and Atmospheric Administration; Fairchild Aerial Surveys 1927, courtesy of Whittier College; Kelsh 1933b; courtesy of IMC; USDA 2005)

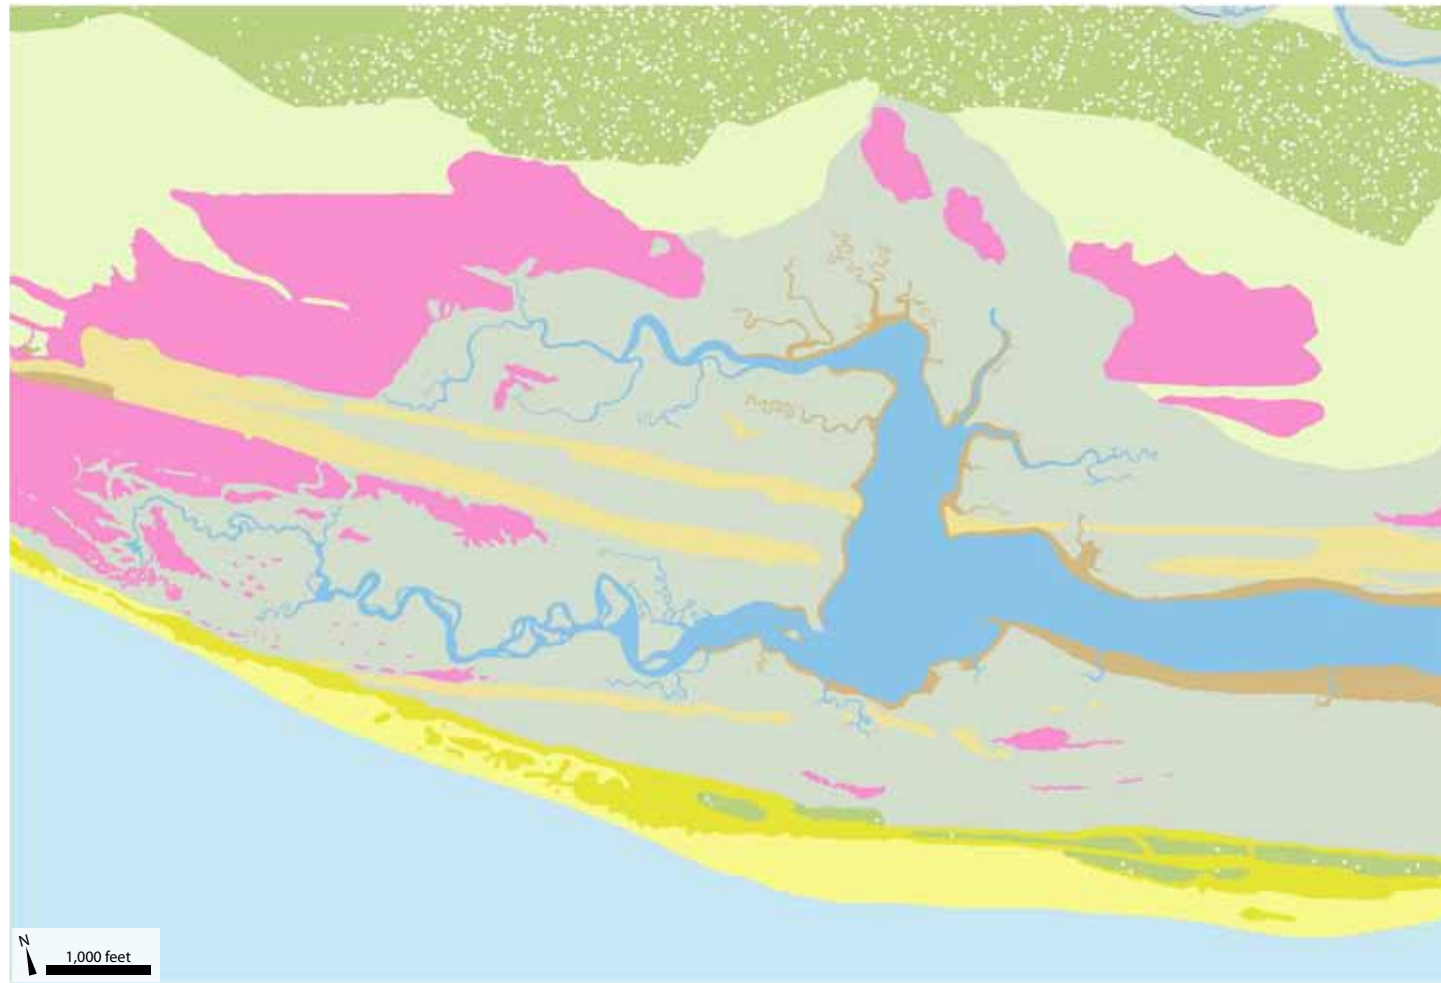
Fig. 6.26. Habitats of Mugu Lagoon, early 1800s. The historical habitat mosaic surrounding Mugu Lagoon included substantial amounts of subtidal habitat, tidal flat, tidal marsh, tidal channels, marsh pannes, salt flat, vegetated former dune strands, and high marsh-alkali meadow transitional zones.

The historical habitat mosaic at Mugu Lagoon included substantial amounts of subtidal habitat, tidal flat, tidal marsh, tidal channels, salt pannes/seasonal ponds, salt flat/playa, vegetated former dune strands, and high marsh-alkali meadow transitional zones (fig. 6.26). Most of these features are shown in detail in the 1857 US Coast Survey T-sheet (Johnson 1857; fig. 6.27). The predominant habitat type at this time was tidal marsh (58%), with the remainder of the area distributed among subtidal water (14%), tidal flat (12%), salt flat/marsh panne (10%), and open water ponds (5%).

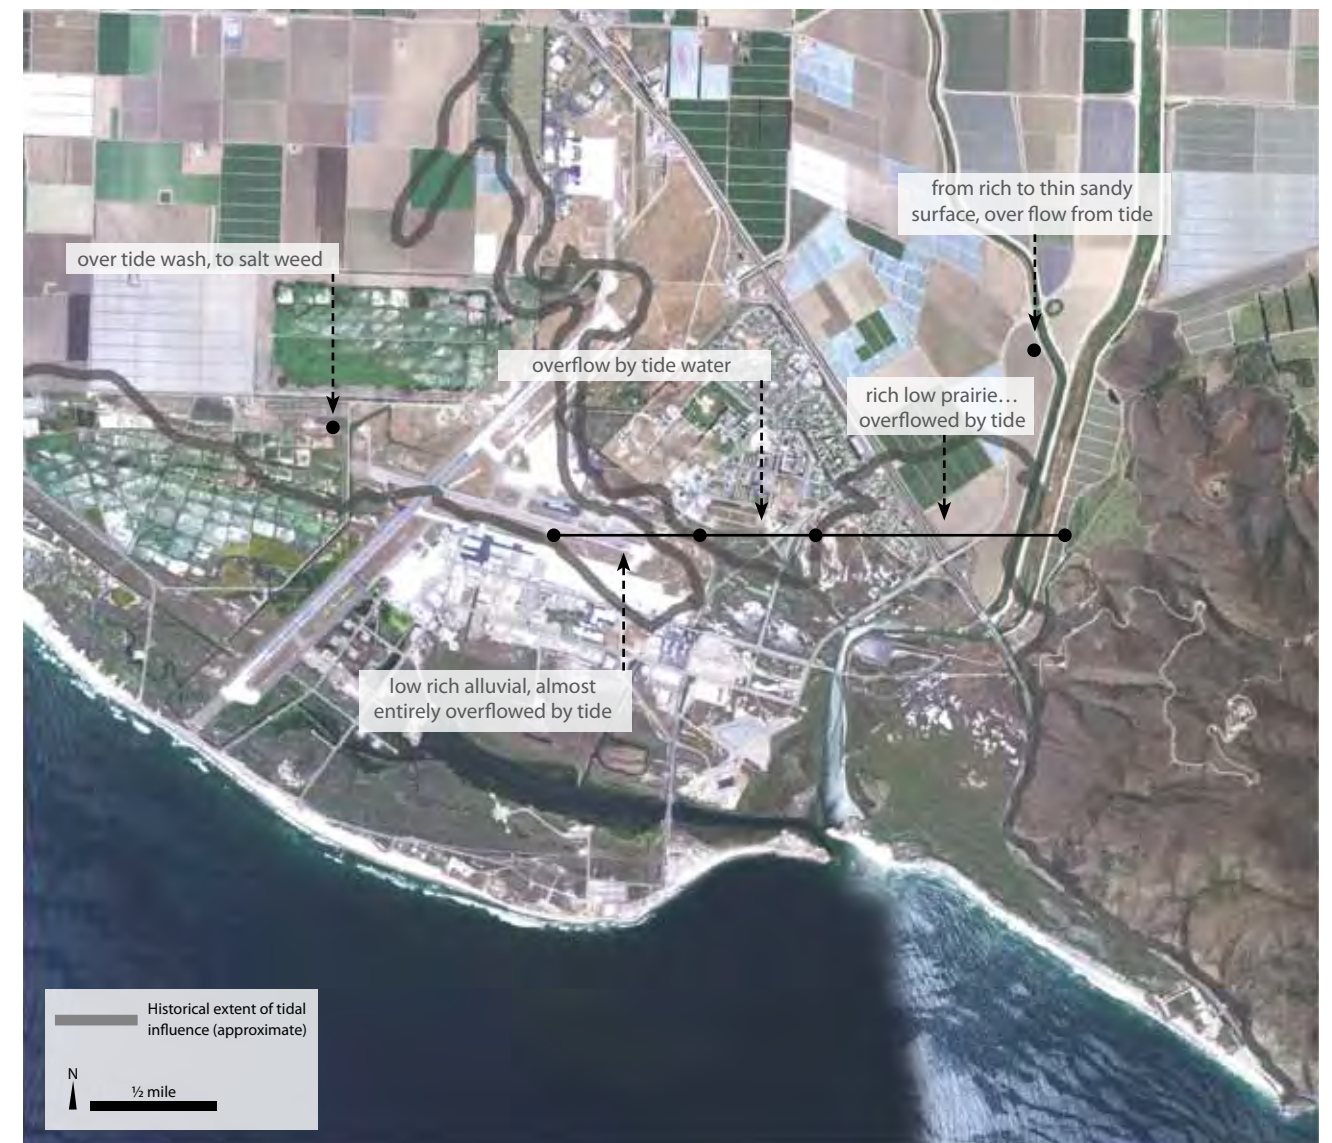
Fig. 6.28. Historical extent of tidal influence at Point Mugu, early 1800s. The Mugu Lagoon wetland complex, including high marsh transition zone areas, extended quite far inland in the 19th century compared to its current extent. Early surveyor’s notes hint that the tidal zone may have extended even further inland, as shown by the excerpts above. Excerpts along the survey line refer to a line segment rather than an individual point. (USDA 2009)

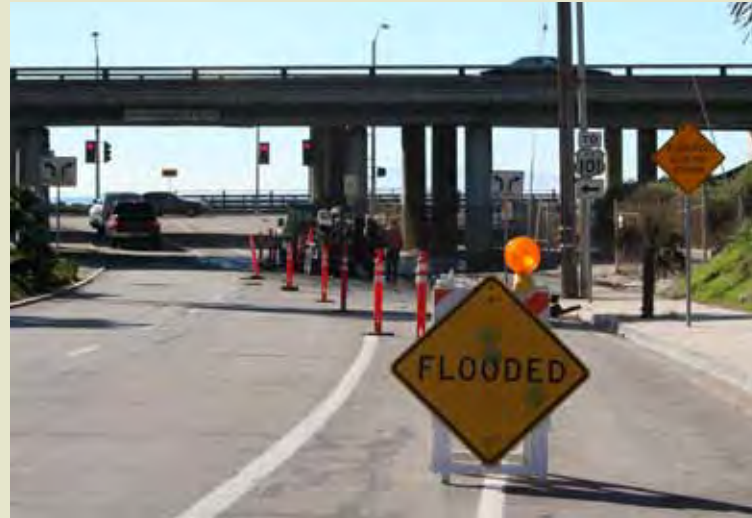
Fig. 6.29. San Jon Road at Highway 101, looking west. Areas of the Pierpont lowland are still susceptible to flooding, as shown in this December 2008 photograph.

By the turn of the 20th century, the seasonal wetland between the dunes and the bluff was under cultivation with beets and barley, though the area must have still been frequently flooded (Waud ca. 1899). By the late 1920s, the northern portion of the lowlands had been subdivided and a few houses built on the wetland and dunes, though evidently not without trouble—the T-sheet records that “small streets beyond those shown [are] buried in sand” (Fairchild Aerial Surveys 1927, Kelsh 1933b; see fig. 6.14). This area is what would become the modern subdivision at Pierpont Bay, north of the Ventura Marina. Flooding is still an issue in portions of the Pierpont area, and wetlands are still present at Alessandro Lagoon at the northeastern end of the lowlands (see fig. 6.29).
