Item 4B - Monitoring Well Program

Item 4C - Sustainable Management Criteria

Sensitivity of Groundwater-Dependent Riparian Woodlands to Water Table Declines

United's 2020 Conservation Release Results

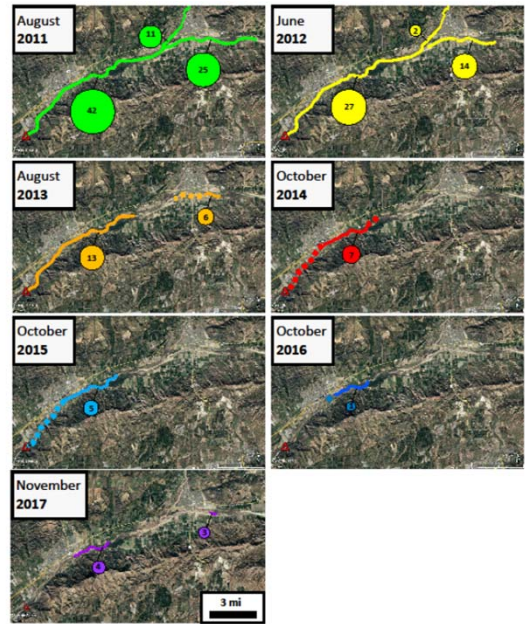
Figure 5.2-2. Length of wetted areas (colored lines) in the lower Santa Clara River, upstream of the Freeman Diversion (indicated by red triangle). Reaches where the end of the wetted area is uncertain are indicated by dotted lines. Flow rates (cfs) are indicated in circles, scaled according to magnitude.

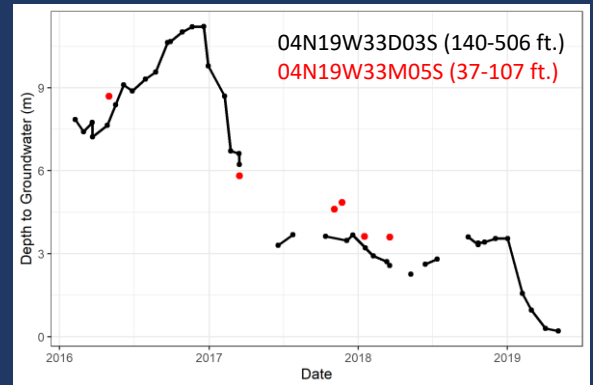
- Selected shallow wells with complete time series when possible
- Otherwise, benchmarked deeper wells against shallow wells with limited data
- Fillmore Cienega: 04N19W33D03S
- Sespe Confluence: 03N20W02A01S
- East Grove: 03N21W12B02S

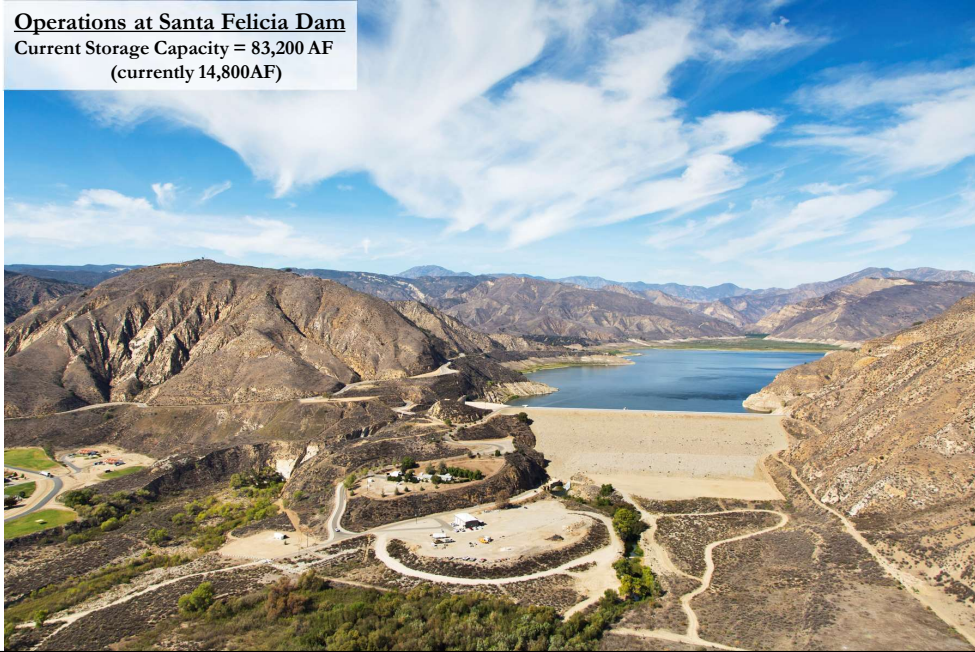
Operations at Santa Felicia Dam
 Current Storage Capacity = 83,200 AF
 (currently 14,800AF)
